Accelerated FGD

CORROSION

Understanding the Cause, Finding a Solution

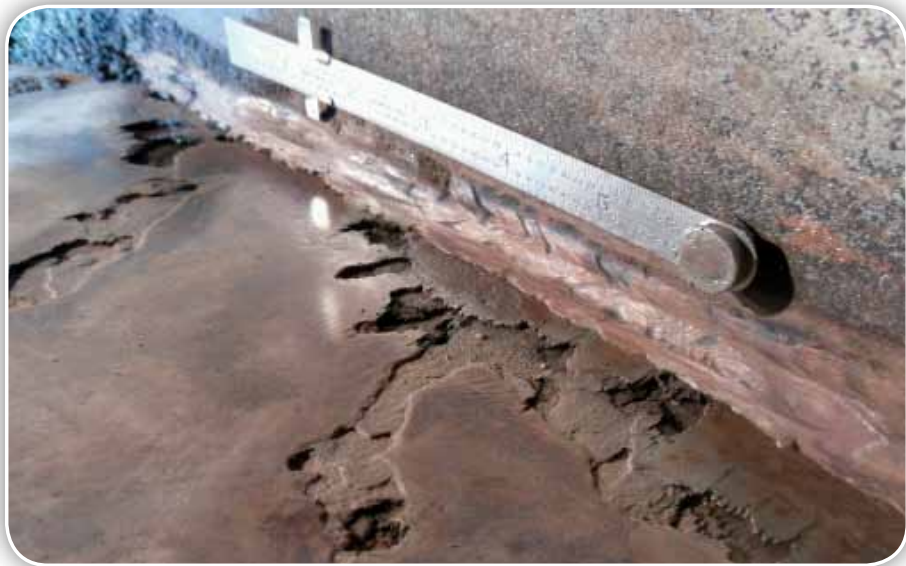
Corrosion damage at a wall and floor joint
