Accelerated Crevice Corrosion of Duplex Stainless Steels in Wet Limestone FGD Environments

Deba Maitra,
Special Metals Corporation
PCC Energy Group

Premature Failure of Absorber Vessels due to Corrosion

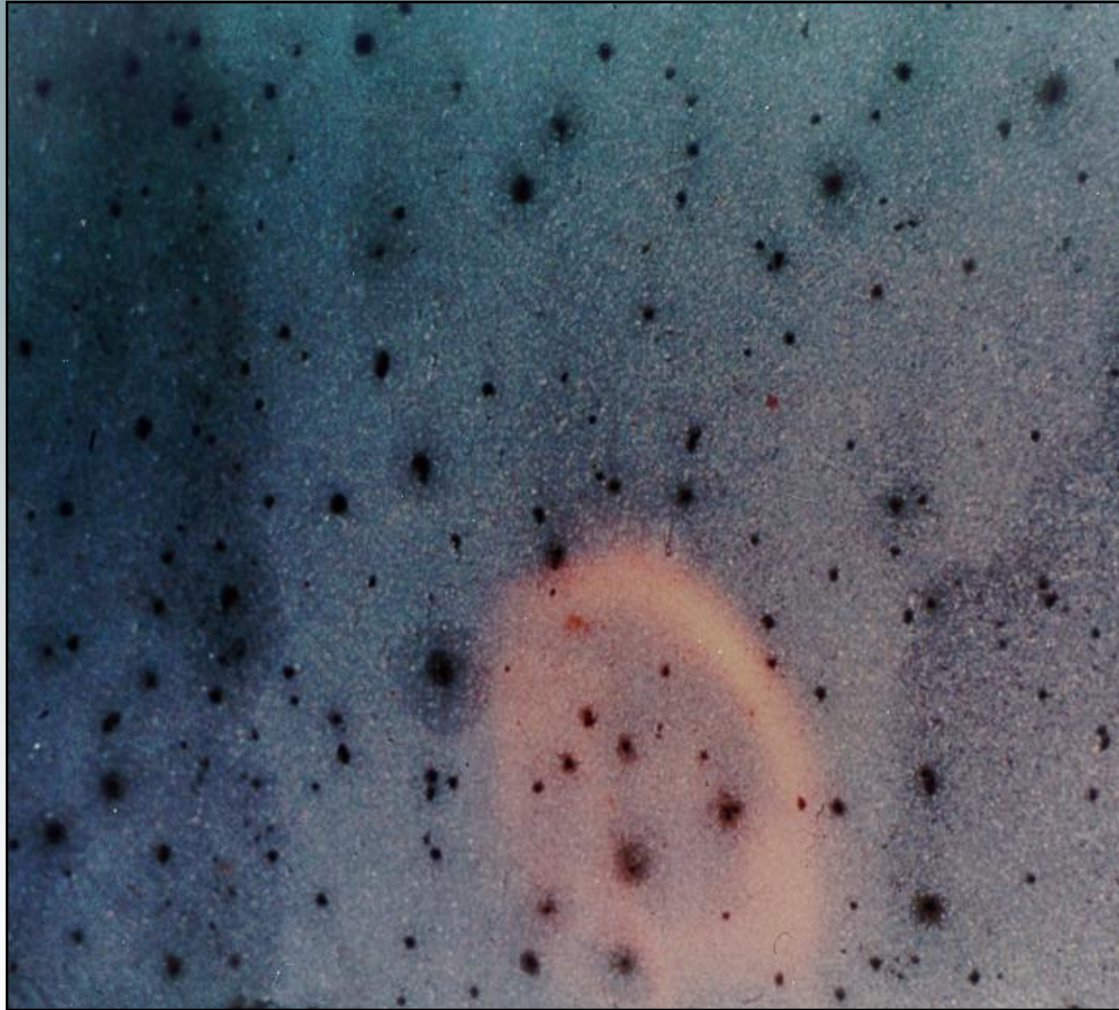
Pitting Corrosion

Isolated pits widespread across surface

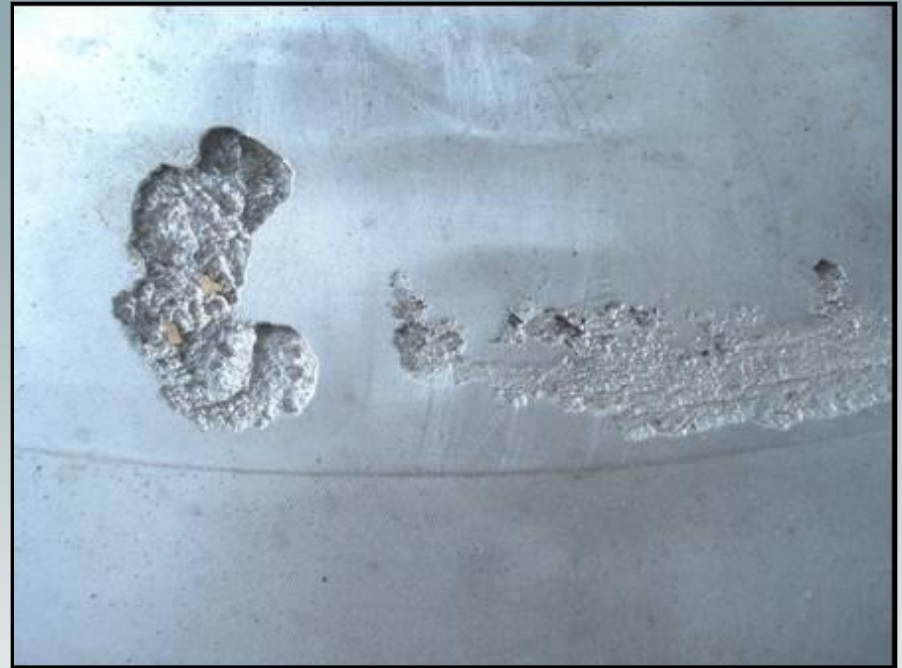
Crevice corrosion under the seal of 2205 duplex steel (S31803) entry cover of a wet limestone FGD absorber vessel after less than one year of operation

**HAZ
Attack**

**Widespread
crevice
corrosion
under deposits**

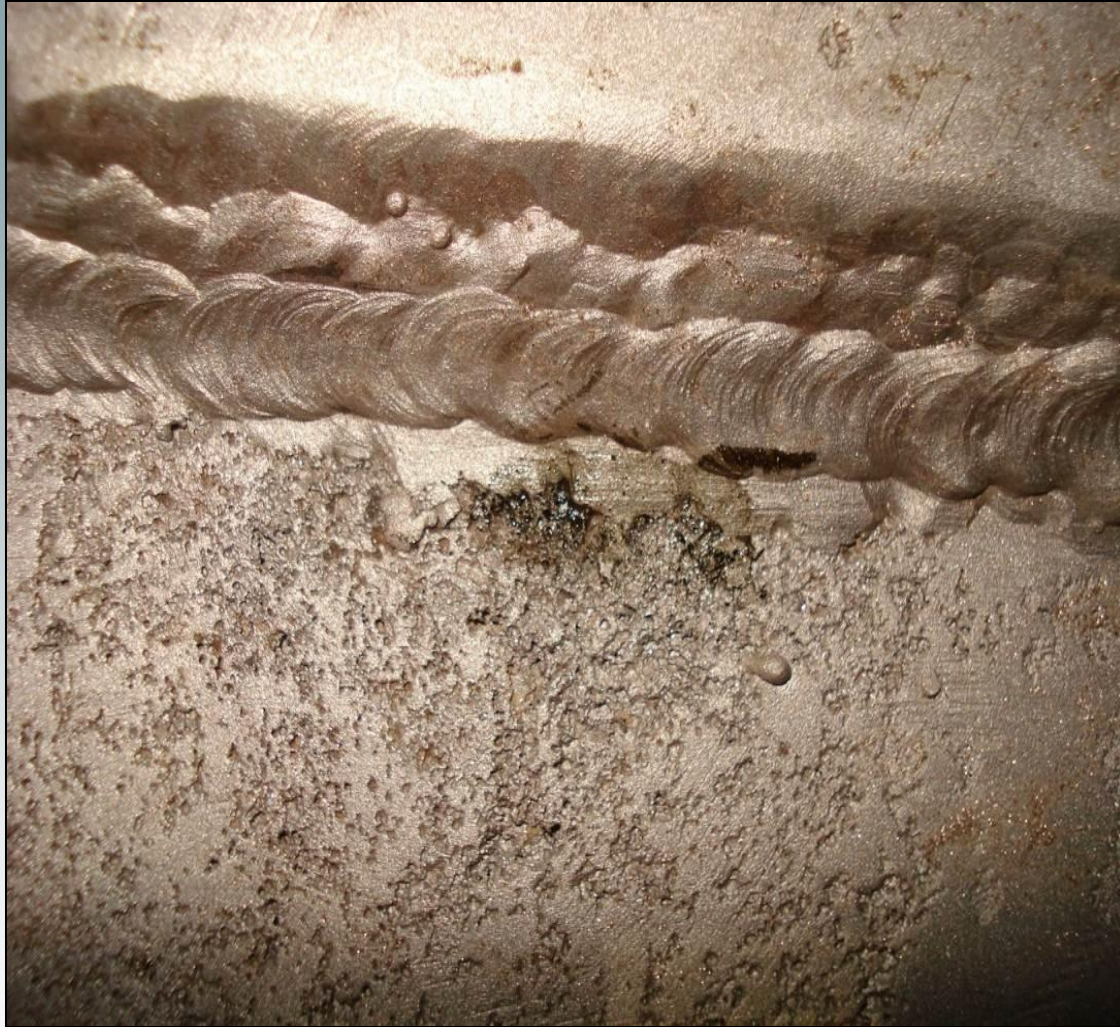
Attack of 2205 duplex steel absorber. Bottom plate is original construction. Upper plate is repair. Weld is alloy 625.
