Recent Experience with Stainless Steels in FGD Air Pollution Control Service

Special Metals Corporation, Huntington, WV

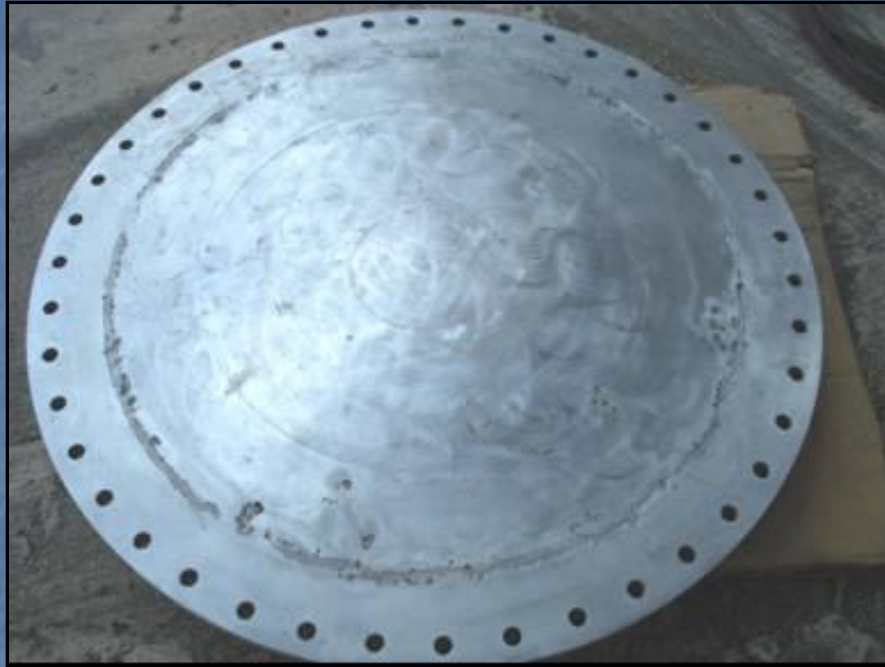
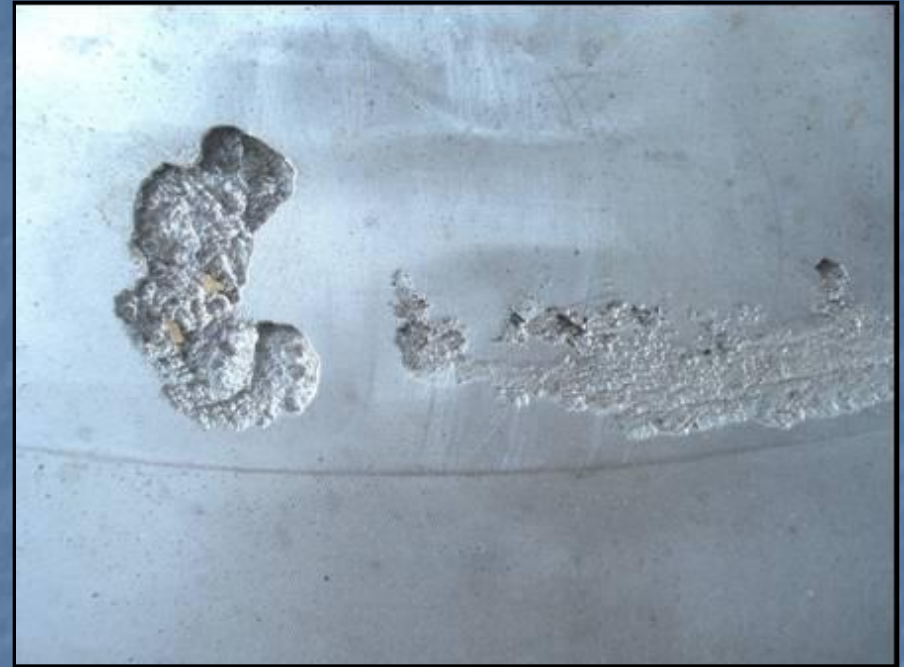
- Two wet limestone FGD absorber vessels constructed of grade 2205 duplex steel were found to be severely corroded after only 7 months of operation.
- Appears to be result of crevice corrosion both near and away from weldments.
- One scrubber was shut down for repair

Crevice corrosion under the seal of a duplex steel entry cover of a wet limestone FGD absorber vessel after less than one year of operation

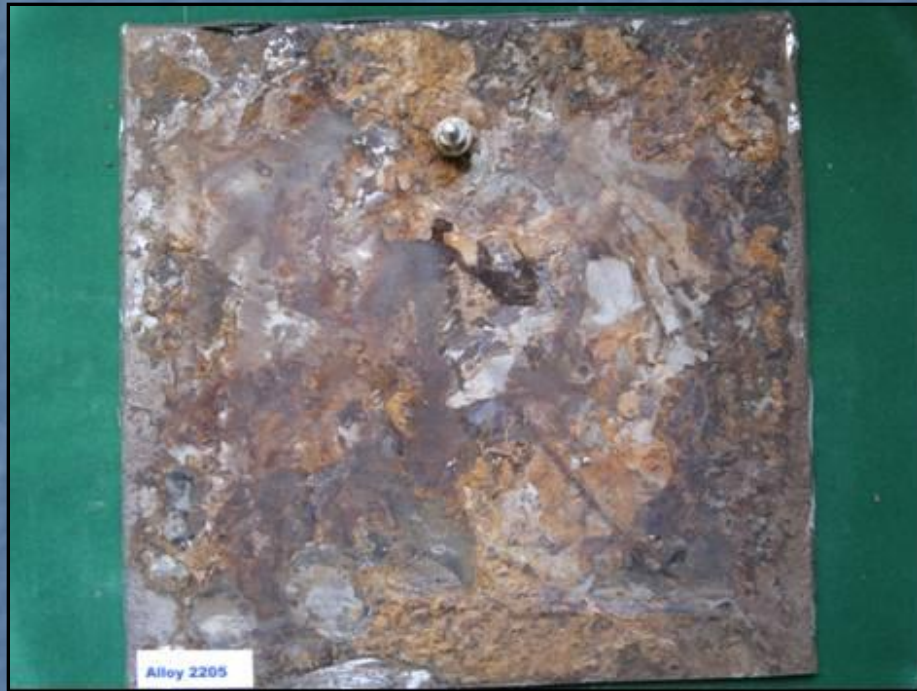
Duplex steel 2205

Test panels exposed 7 months on the absorber vessel wall.
Mineral buildup might have resulted in crevice conditions

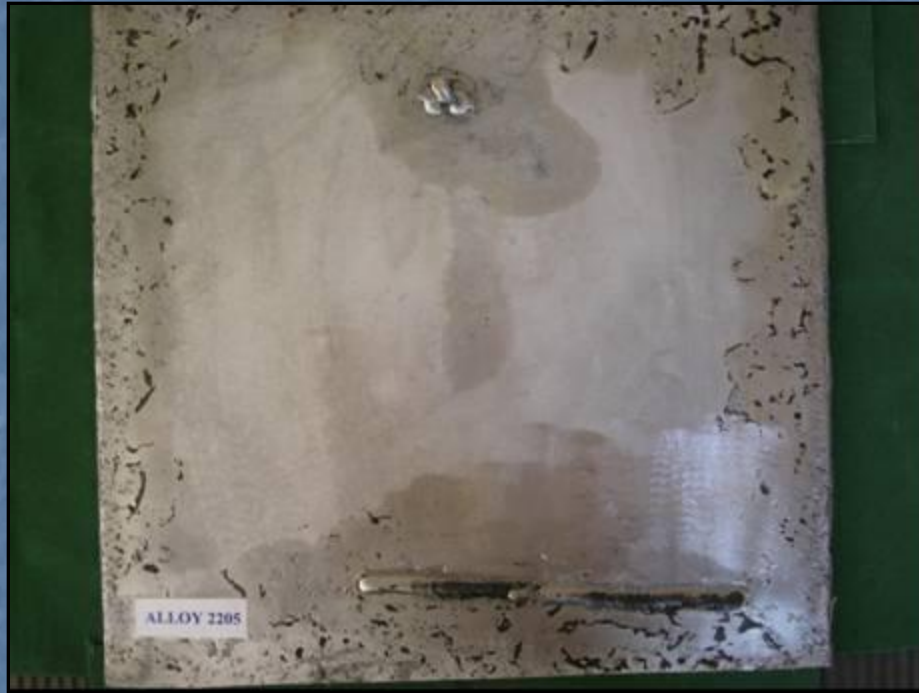
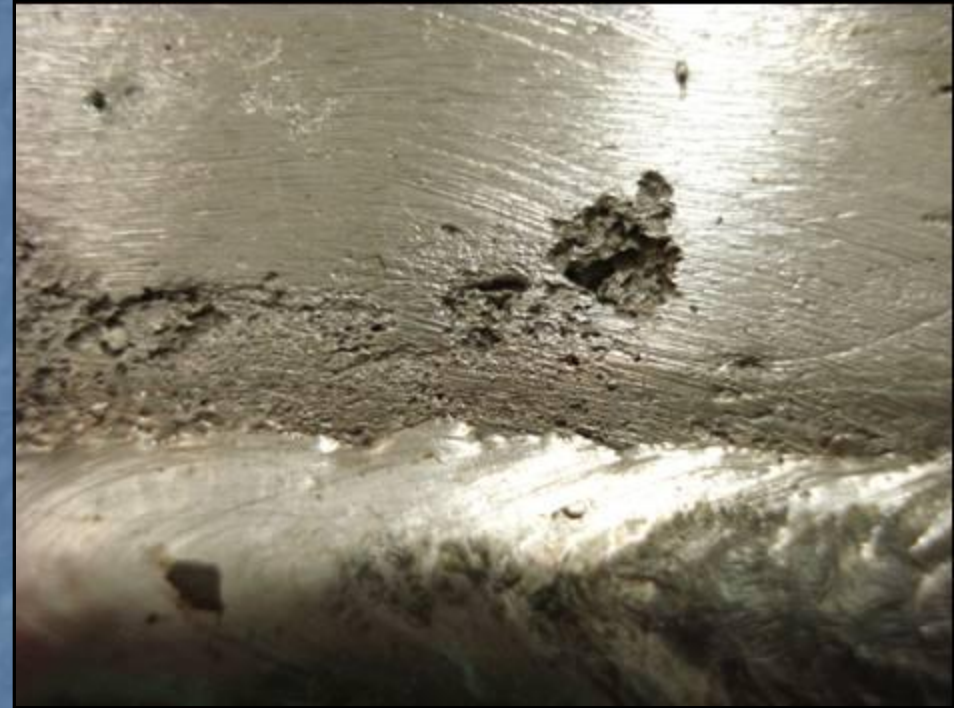
Cleaned Duplex stainless steel 2205 test panel exposed
7 months on the absorber vessel wall

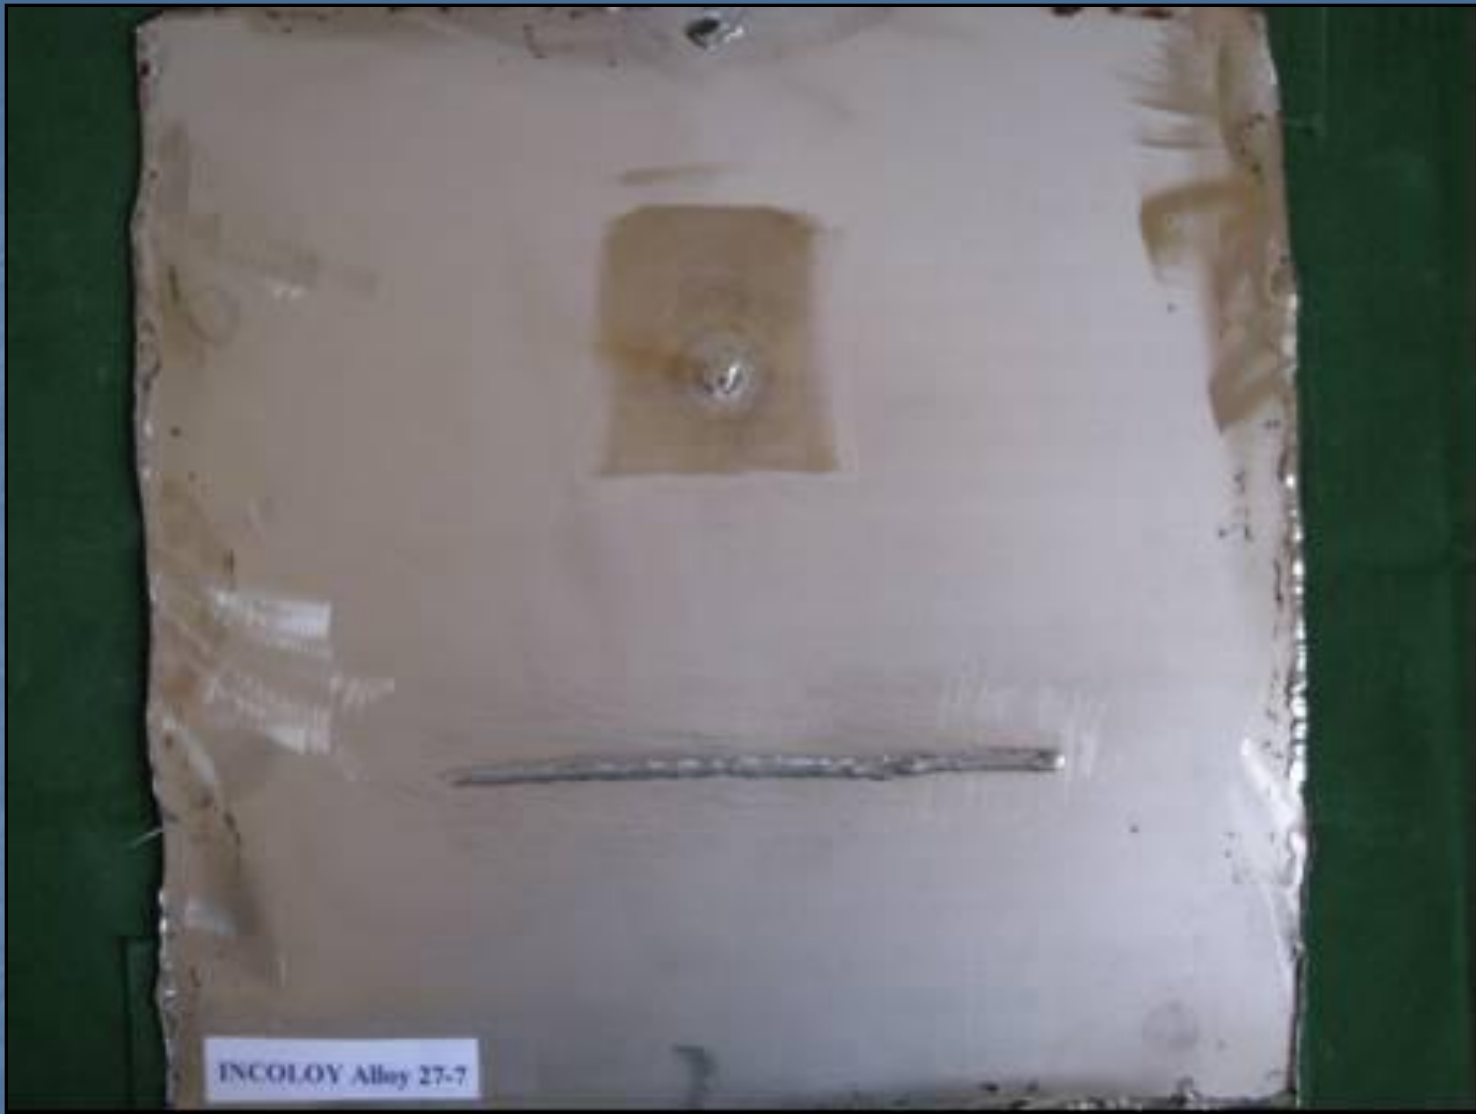
Super-austenitic steel (Alloy 27-7Mo) test panel after cleaning.
No attack was found.

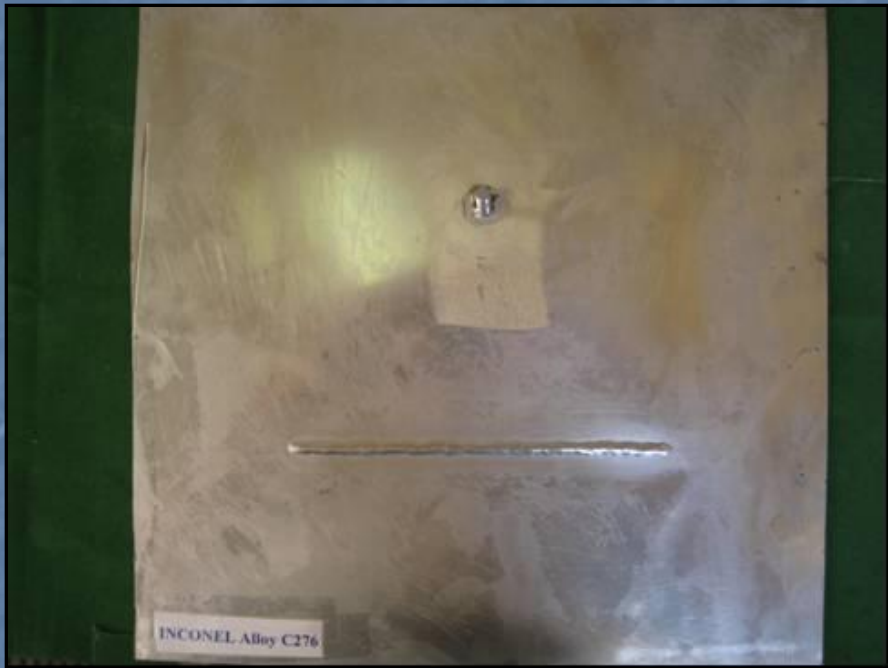
Alloy C-276

NiCrMo alloys test panel after cleaning. No attack was found.
