# Accelerated Crevice Corrosion of Duplex Stainless Steels in Wet Limestone FGD Environments

JIM CRUM,  
Special Metals Corporation  
PCC Energy Group

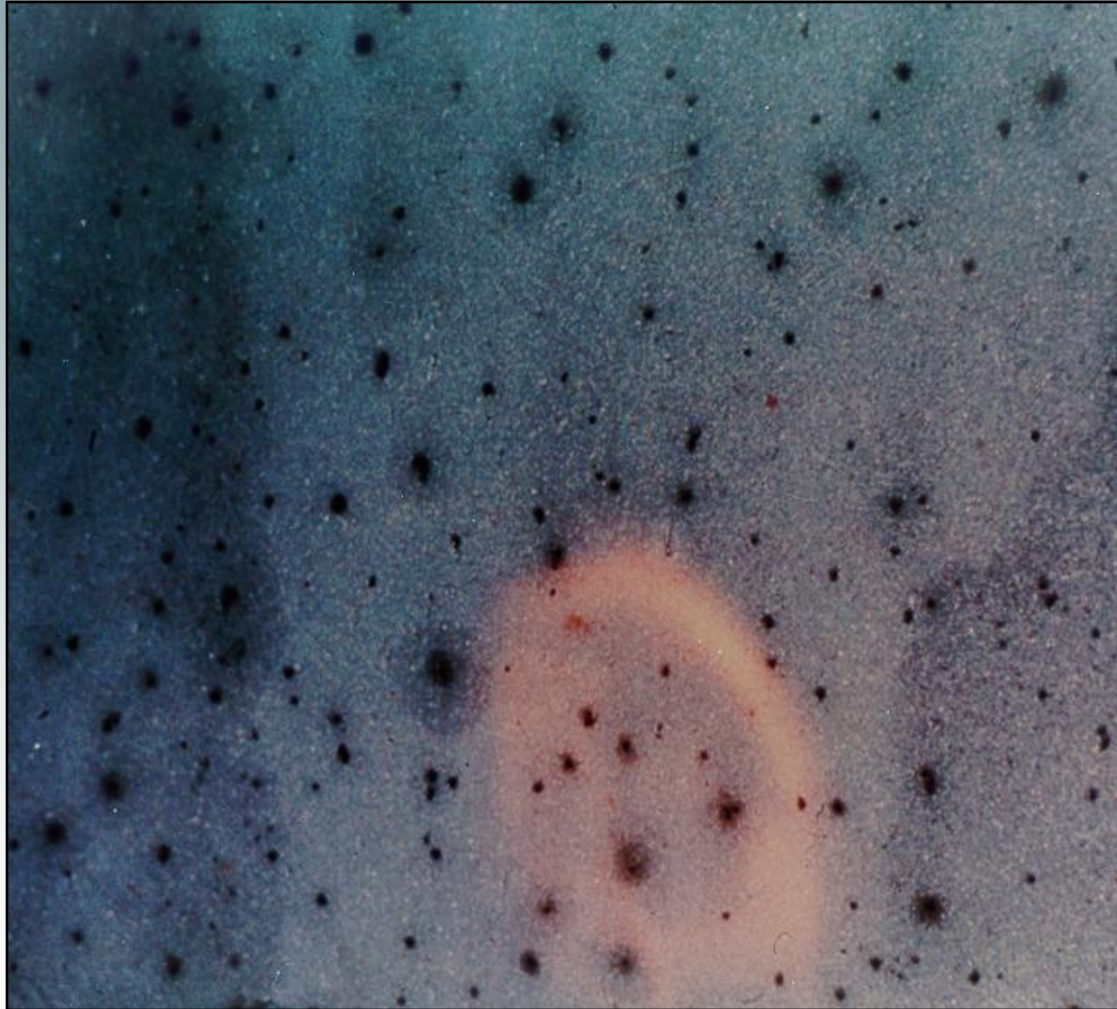
# Pitting Corrosion

**Isolated pits widespread across surface**

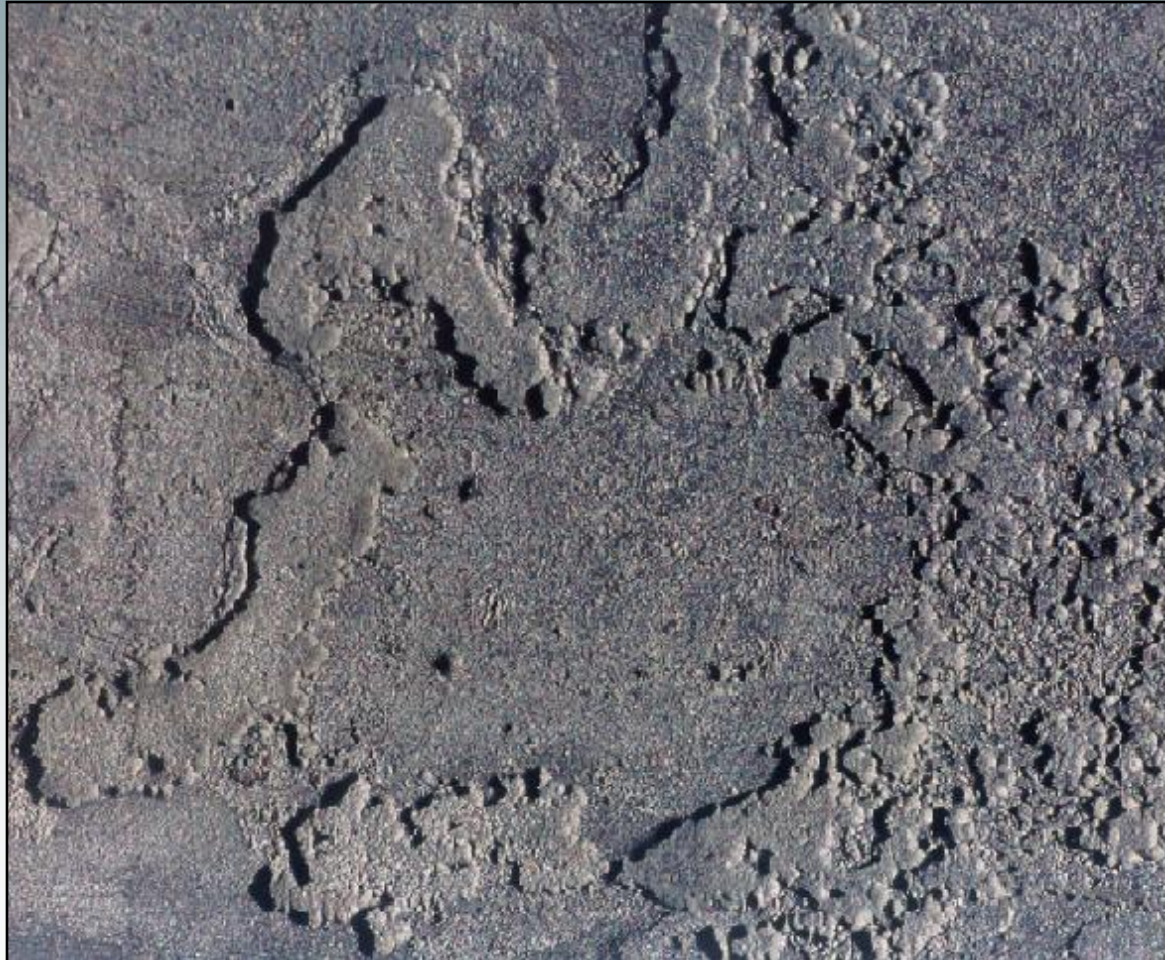
# Crevice Corrosion

**Corrosion under ash deposit**

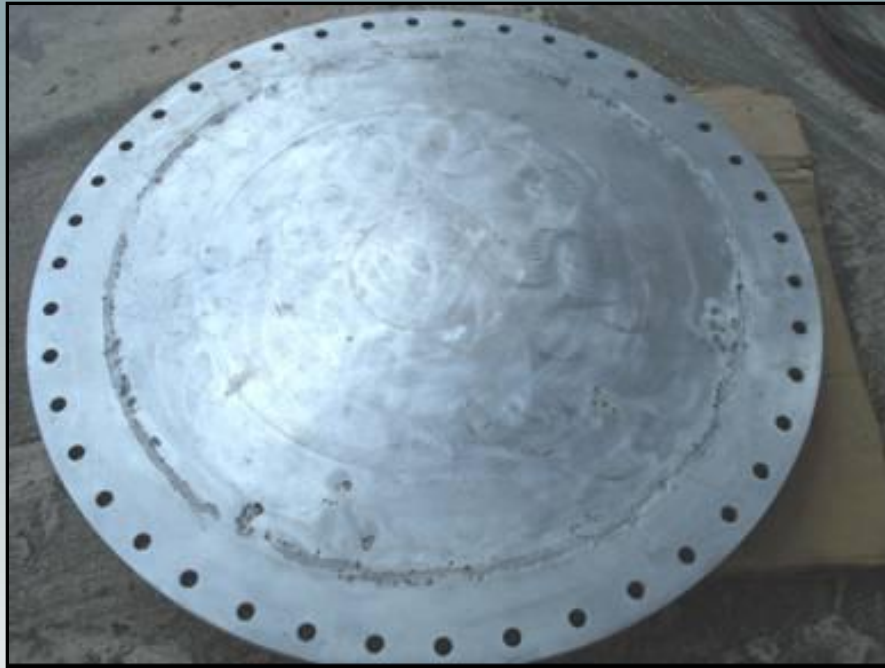
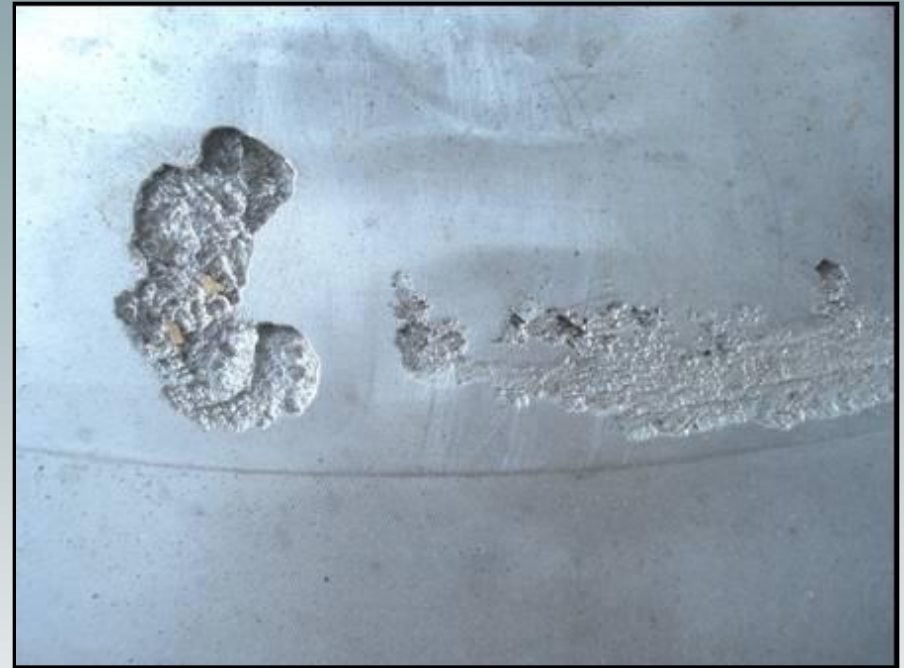
**Crevice corrosion under the seal of 2205 duplex steel (S31803) entry cover of a wet limestone FGD absorber vessel after less than one year of operation**

**HAZ  
Attack**

**Widespread  
crevice  
corrosion  
under deposits**

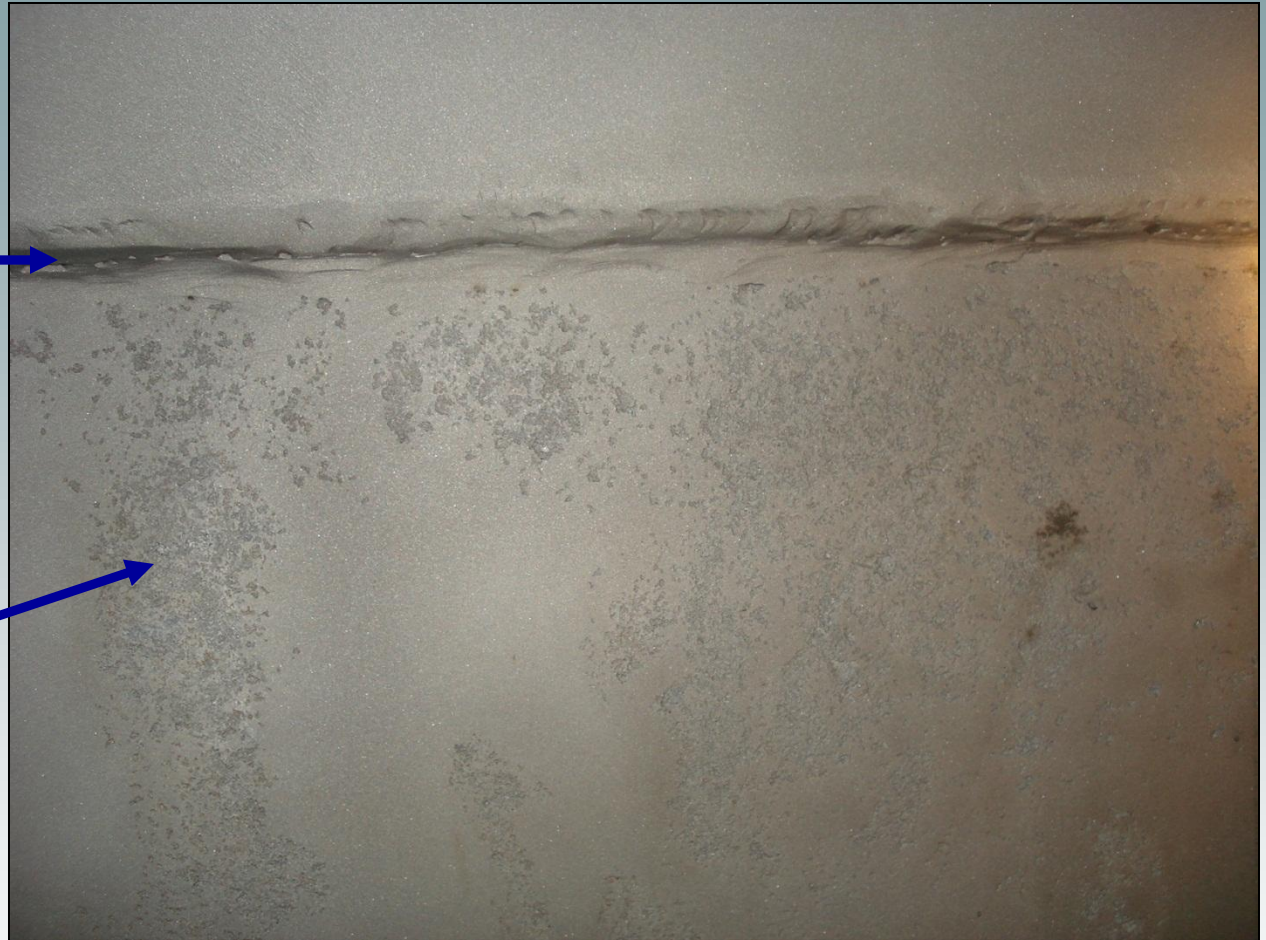
**Crevice corrosion of duplex steel  
absorber wall adjacent to alloy 625 weld**

**Alloy 625 weld nugget**

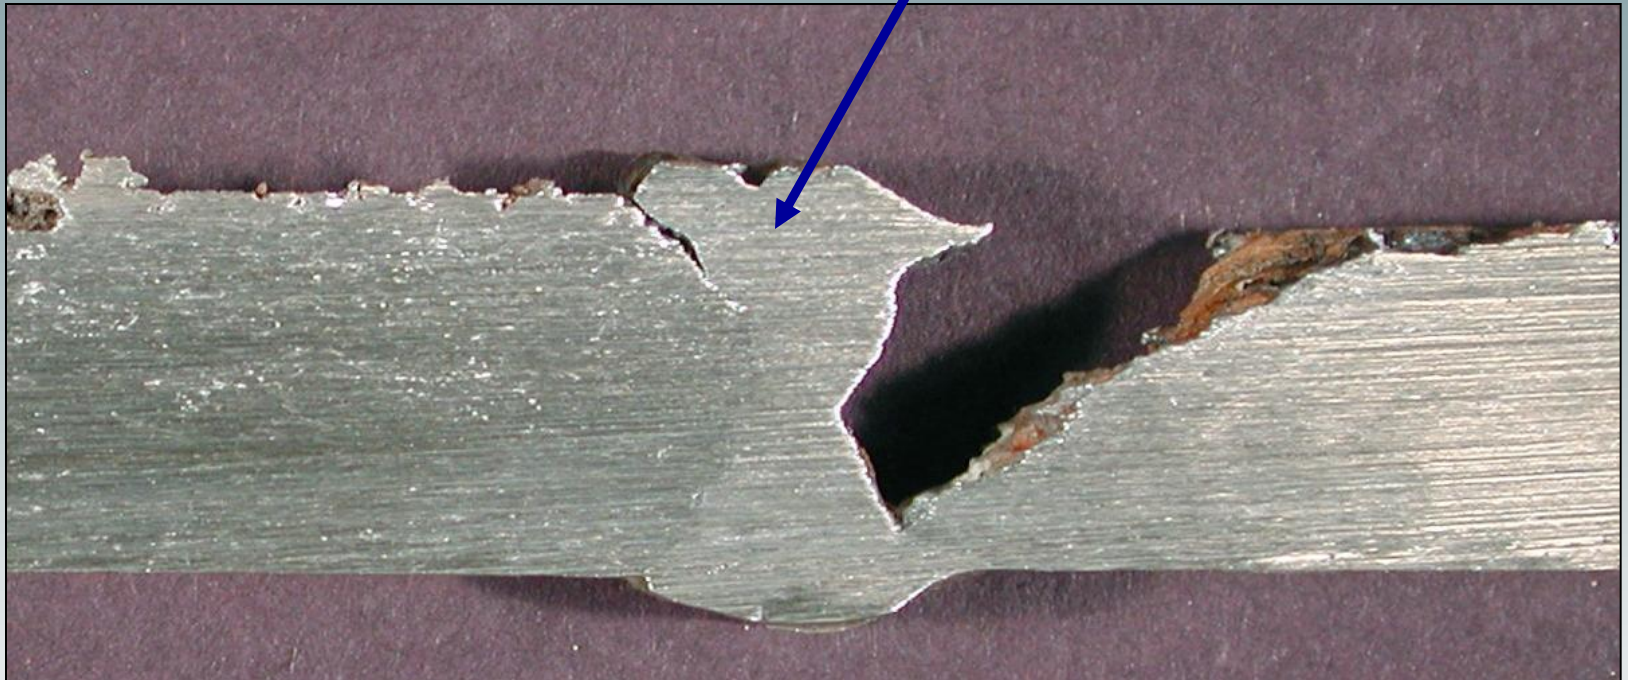
**Corroded duplex stainless steel absorber wall joined with NiCrMo 625 welding product. The weld nugget was not attacked but the base metal was nearly penetrated at the HAZ.**

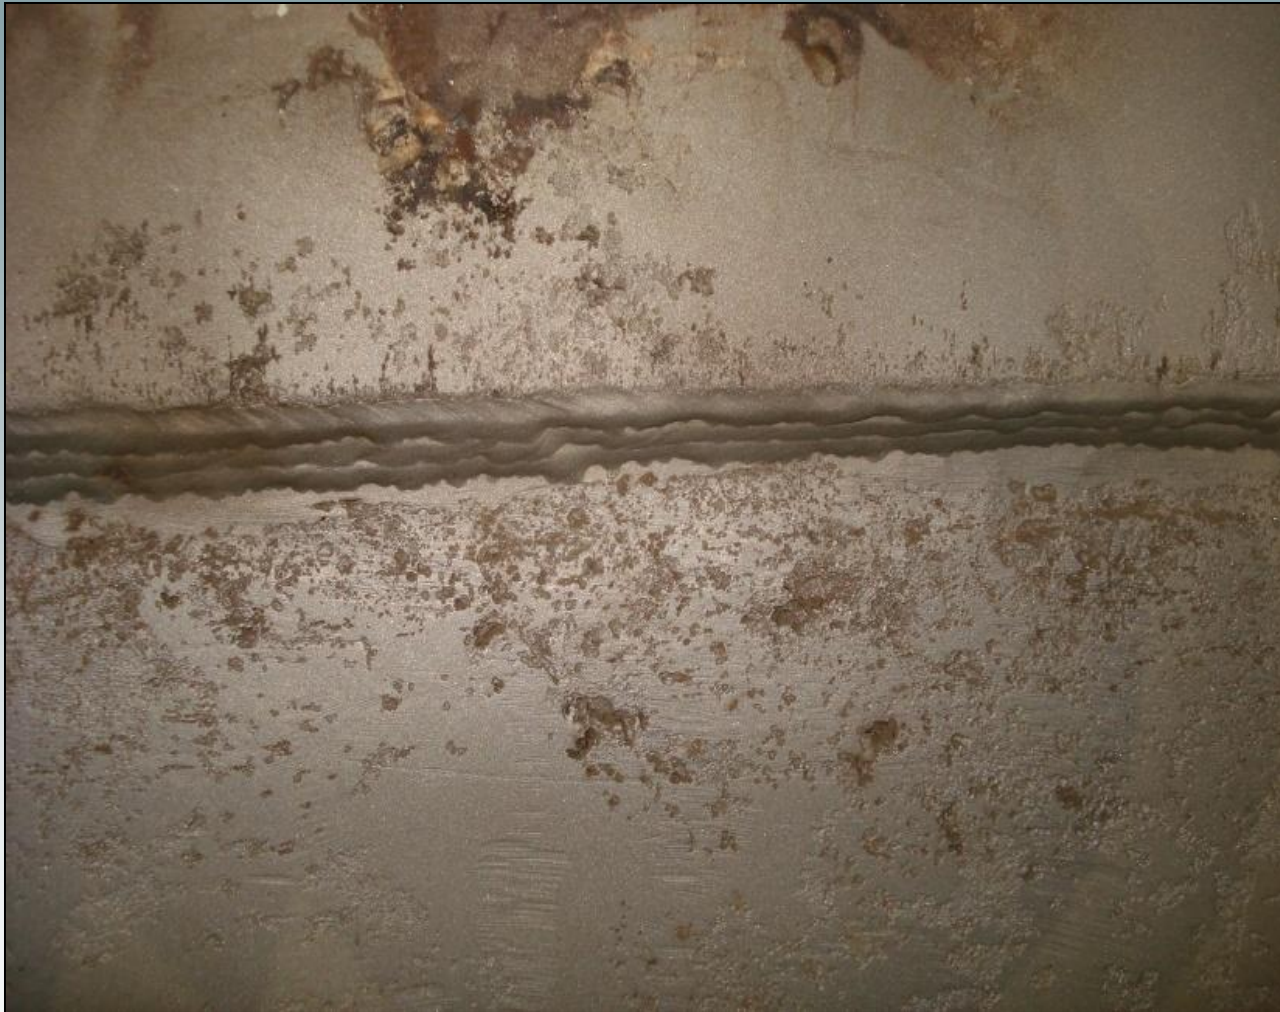
**Corrosion of duplex steel absorber vessel. The nickel alloy 625 weld was not attacked.**

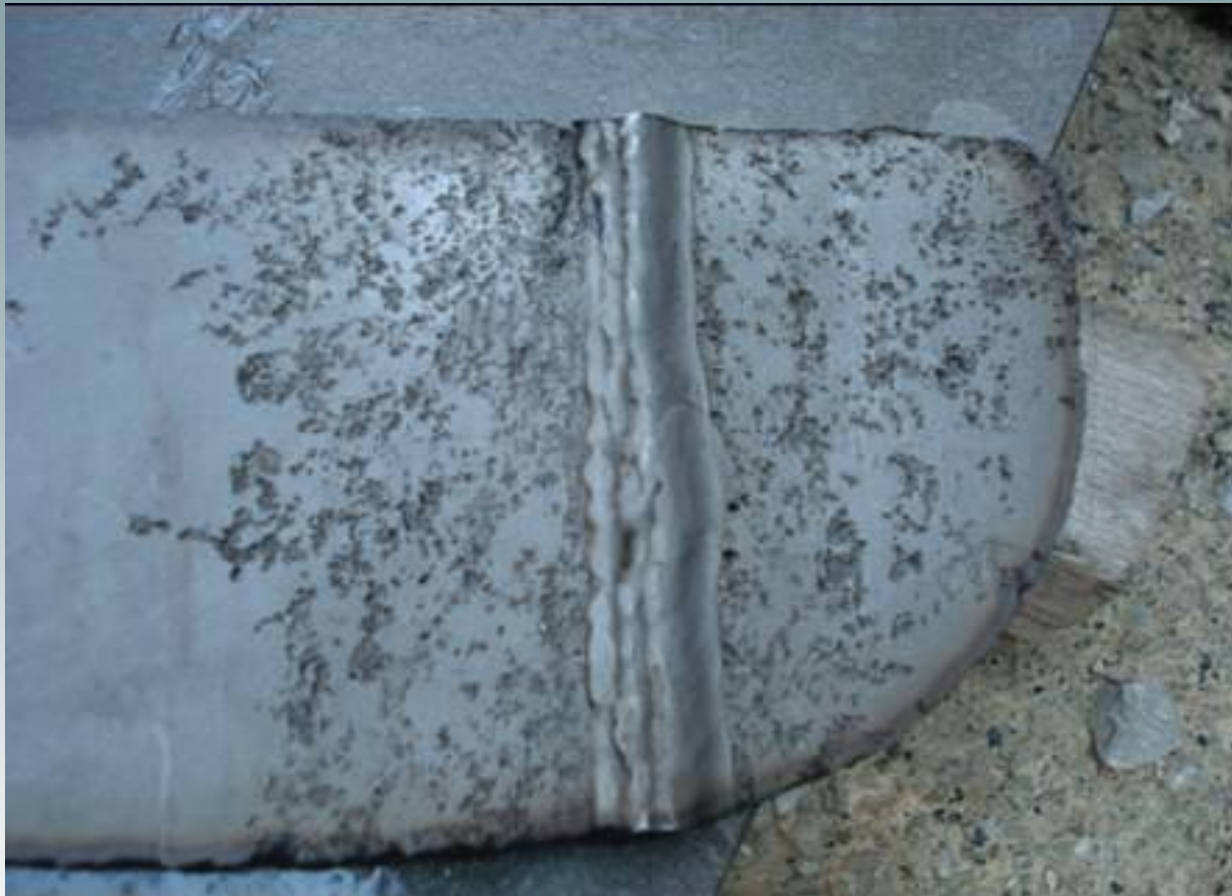
**Crevice corrosion of a section of the duplex steel absorber wall that appears to be weld-related, perhaps due to mineral deposit build-up by “proud” welds. The alloy 625 weld metal was not attacked.**

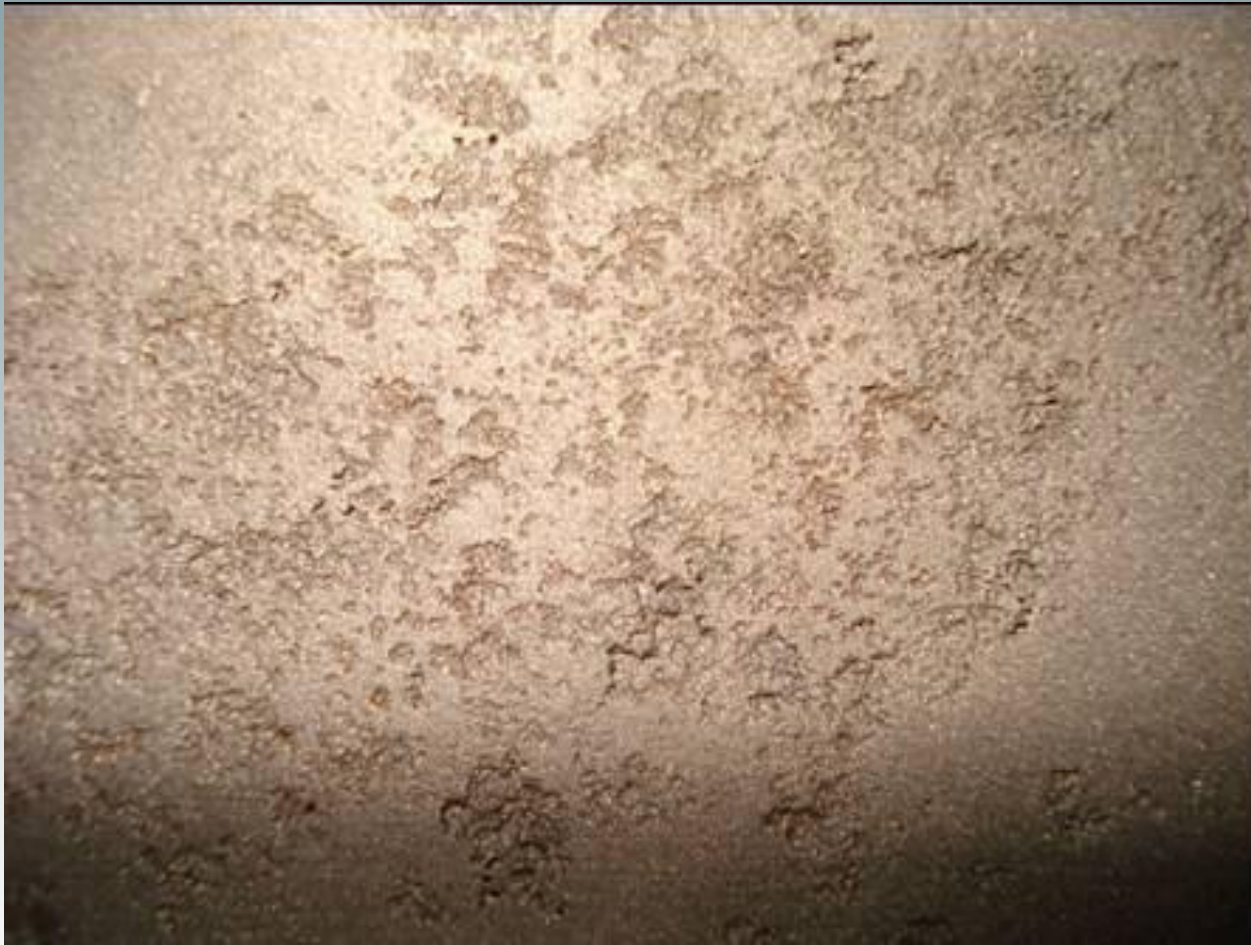
**Crevice corrosion of duplex steel absorber vessel wall  
located well away from weldment**

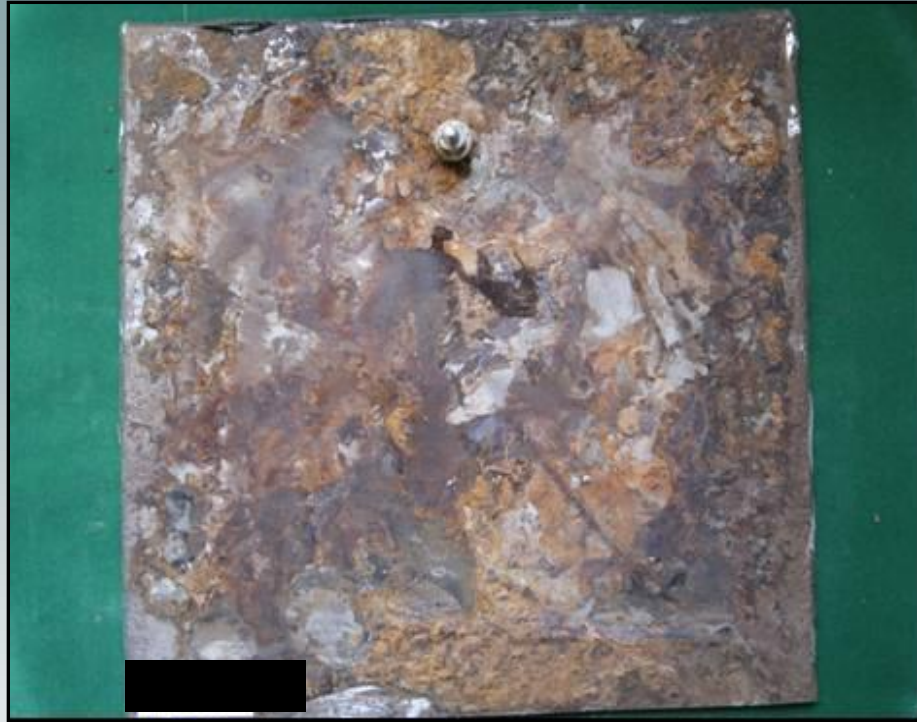
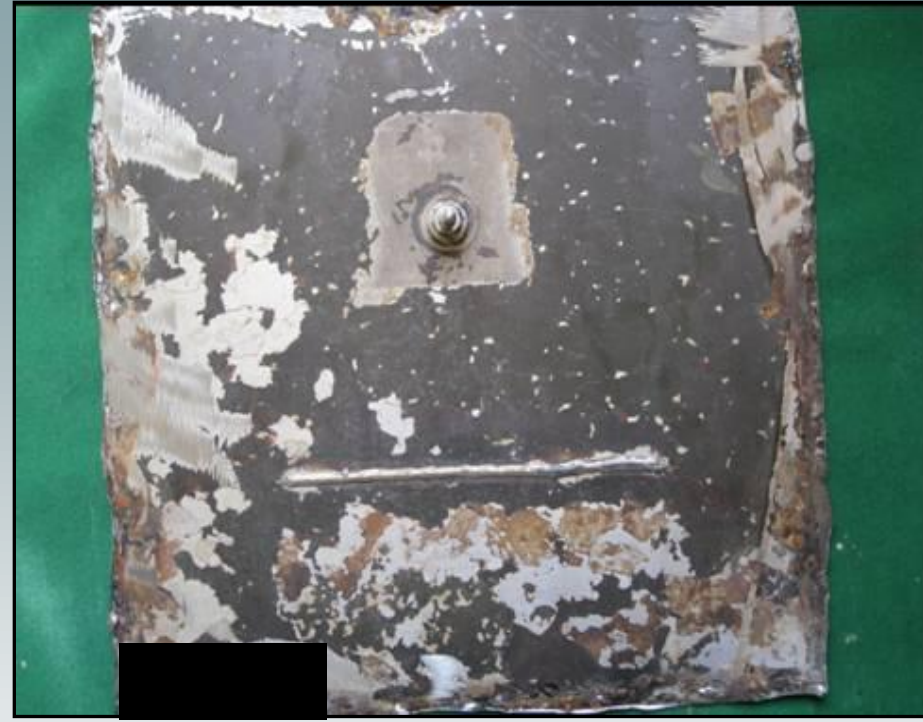
**Duplex Steel (S31803)**

**Super-Austenitic Steel (S31277)**

**Test panels exposed 7 months on the absorber vessel wall.  
Mineral buildup is believed to have induced crevice condition.  
Note adherent black film.**

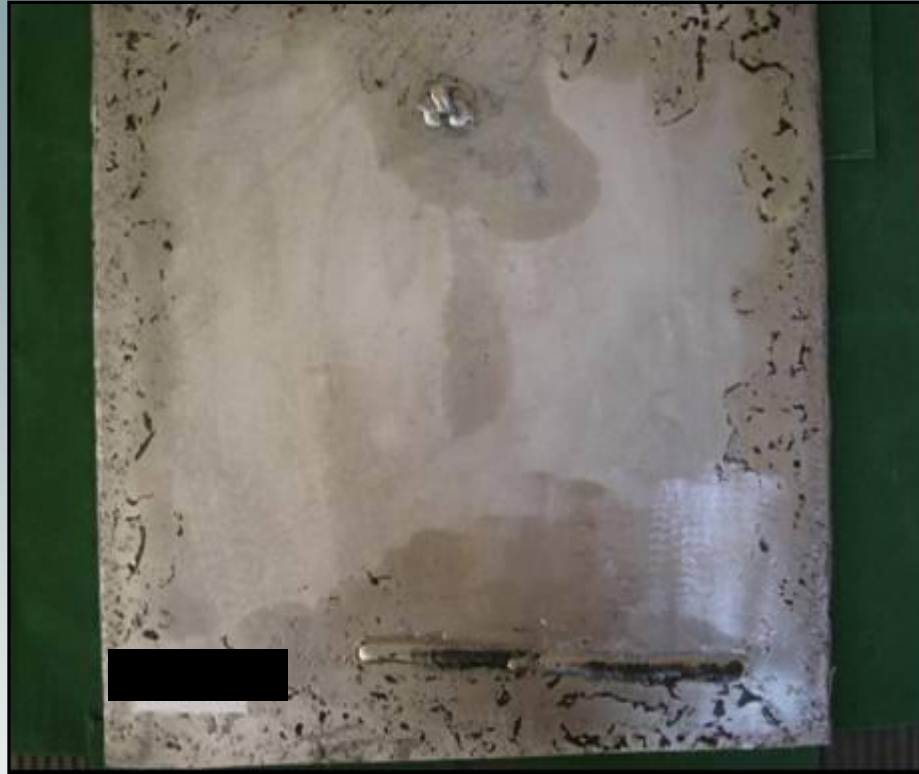
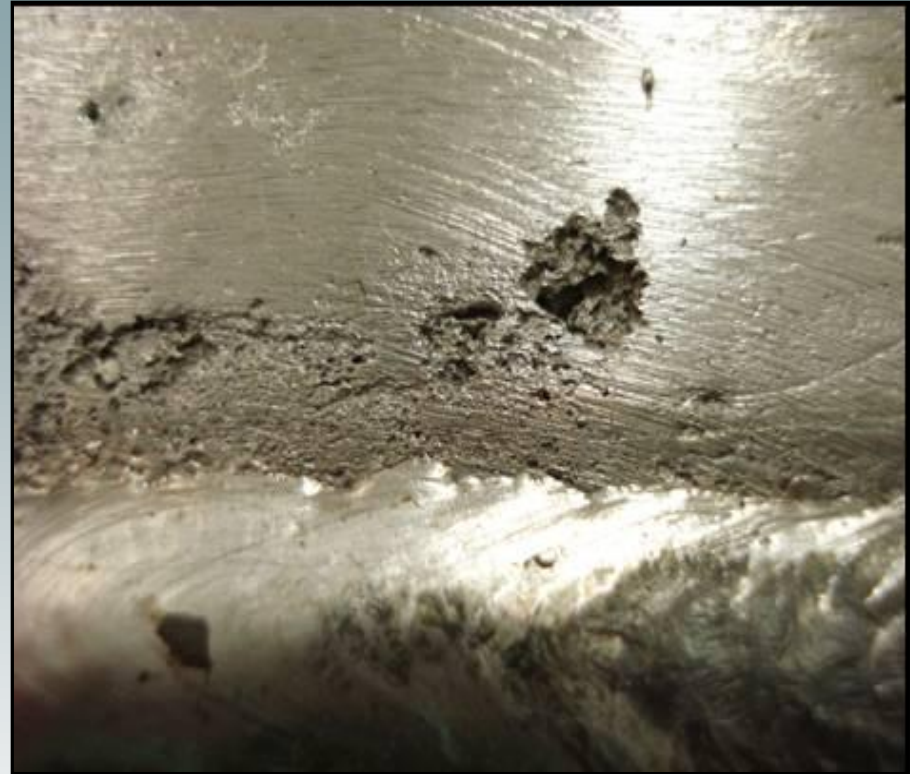
**Duplex steel test panel after cleaning. Attack is evident, especially near the weld.**

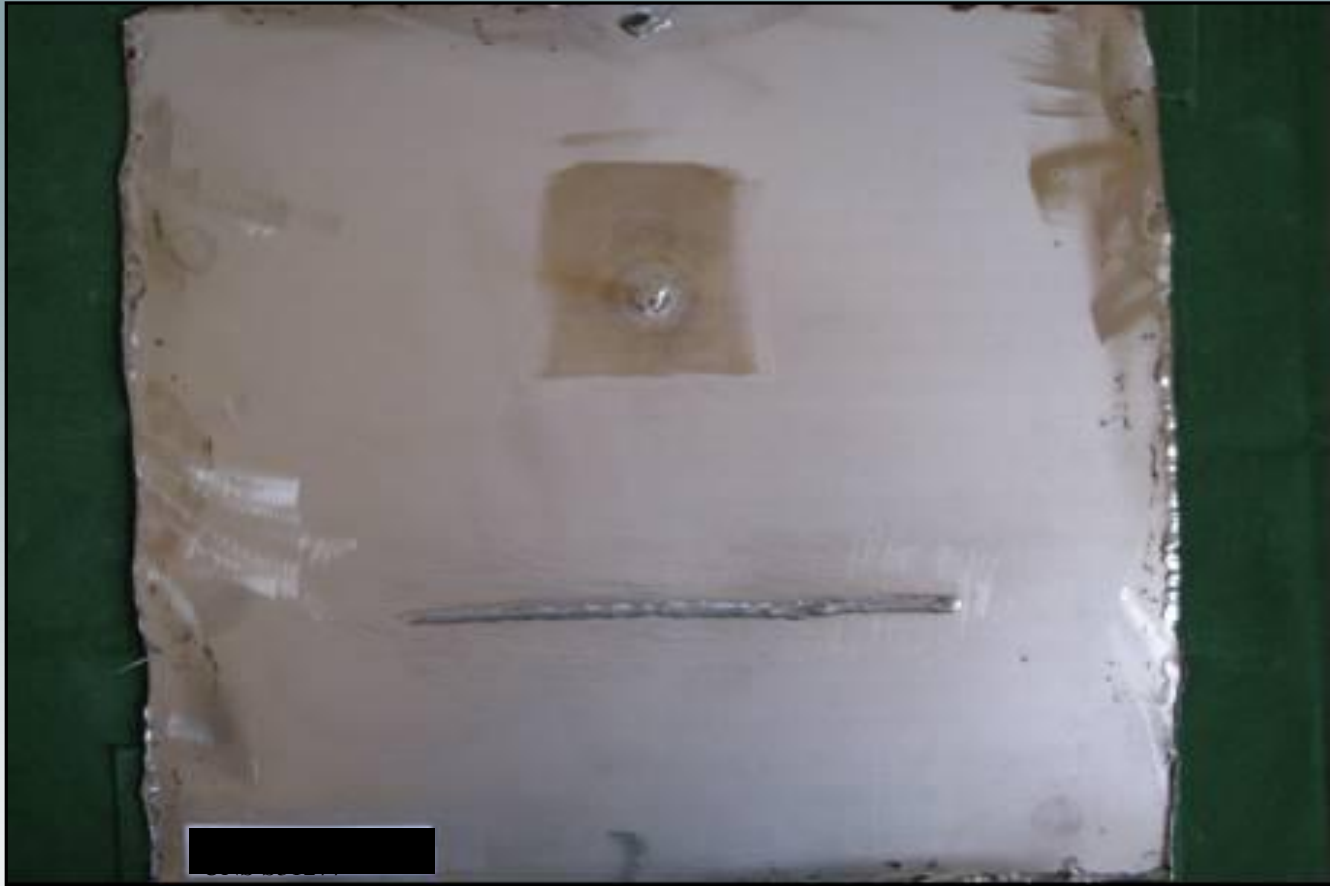
**Super-austenitic steel (S31277) test panel after cleaning. No attack was found.**

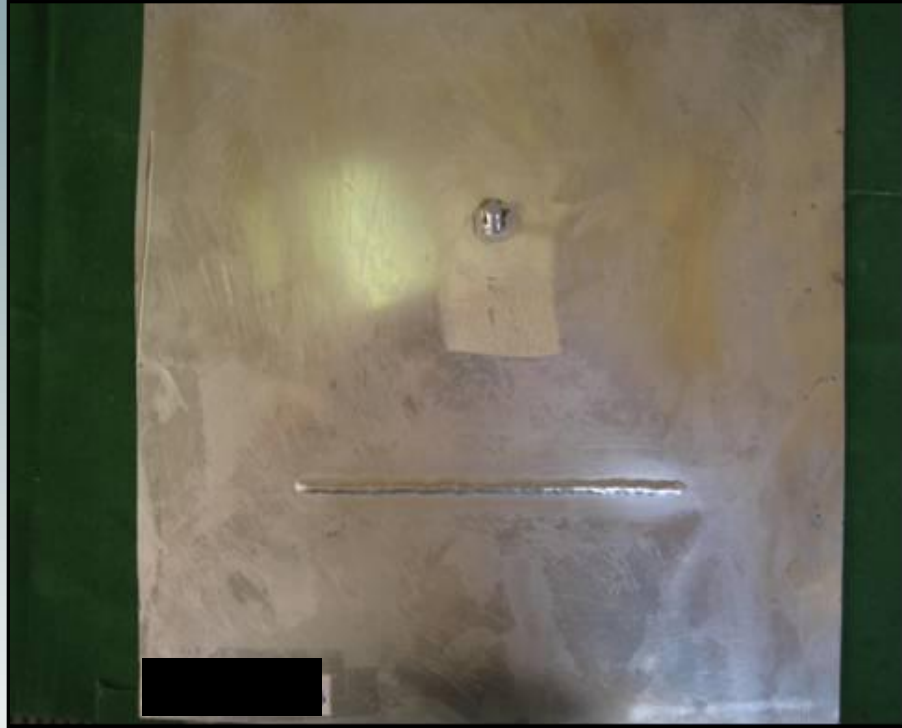
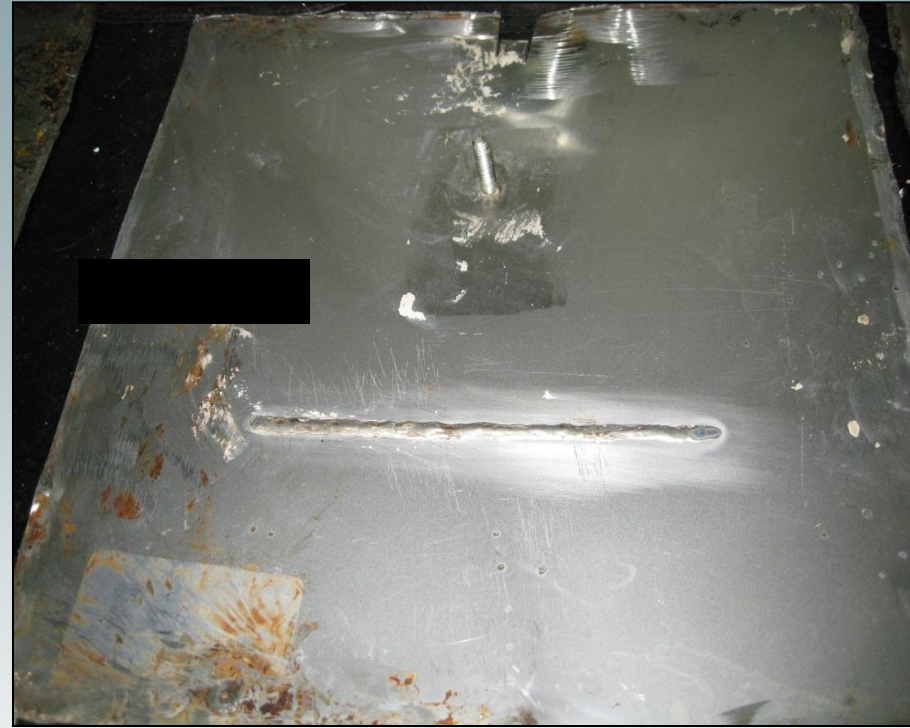
**NiCrMo alloy N10276**

**NiCrMo alloy N06686**

**Ni-base alloy test panels after cleaning. No attack was found.**

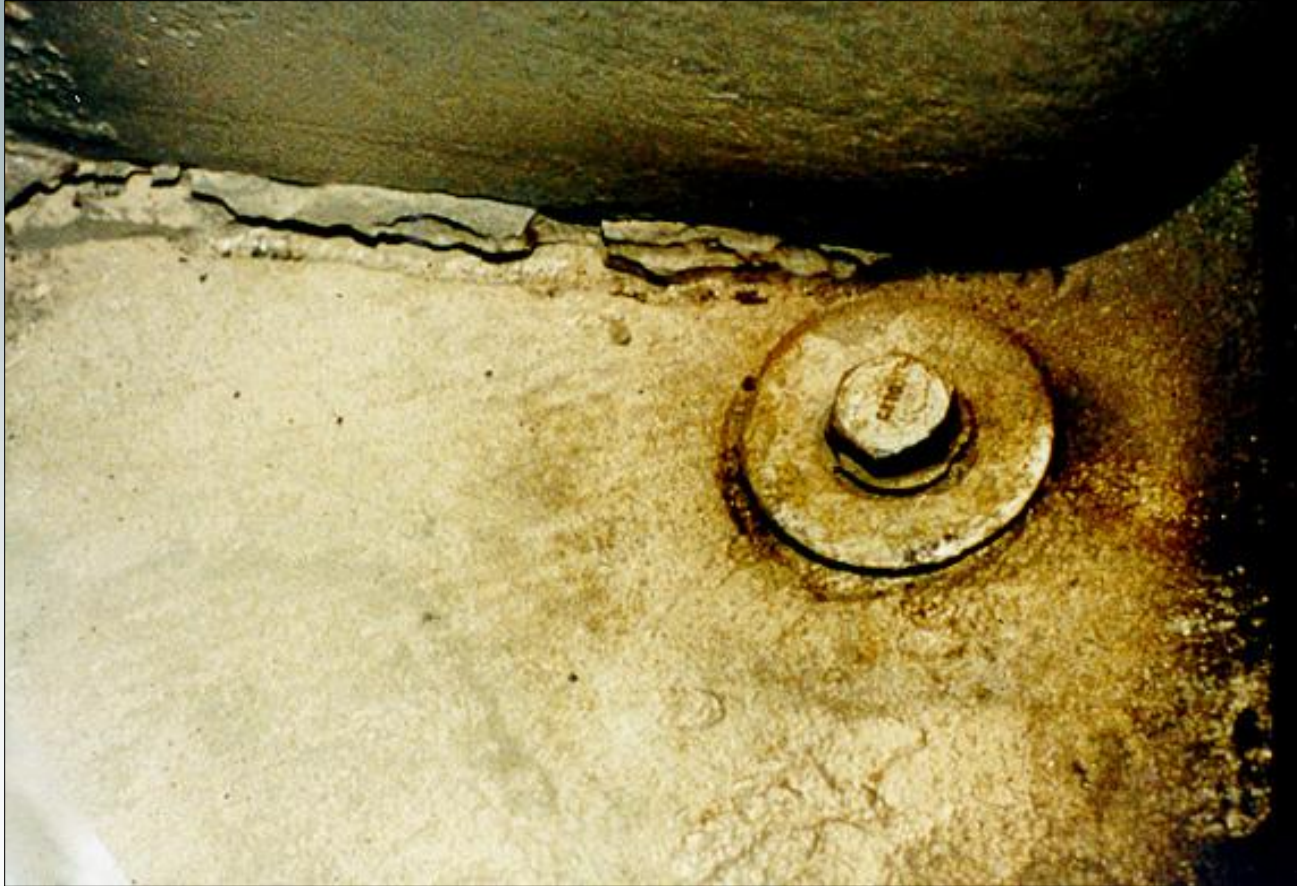
**Alloy C-276 base plate**

# Preferential attack of NiCrMo C-276 filler metal welds in FGD outlet duct

**Use overmatching composition welding products to offset iron dilution & elemental segregation in NiCrMo & FeNiCrMo corrosion resistant alloys and stainless steels**

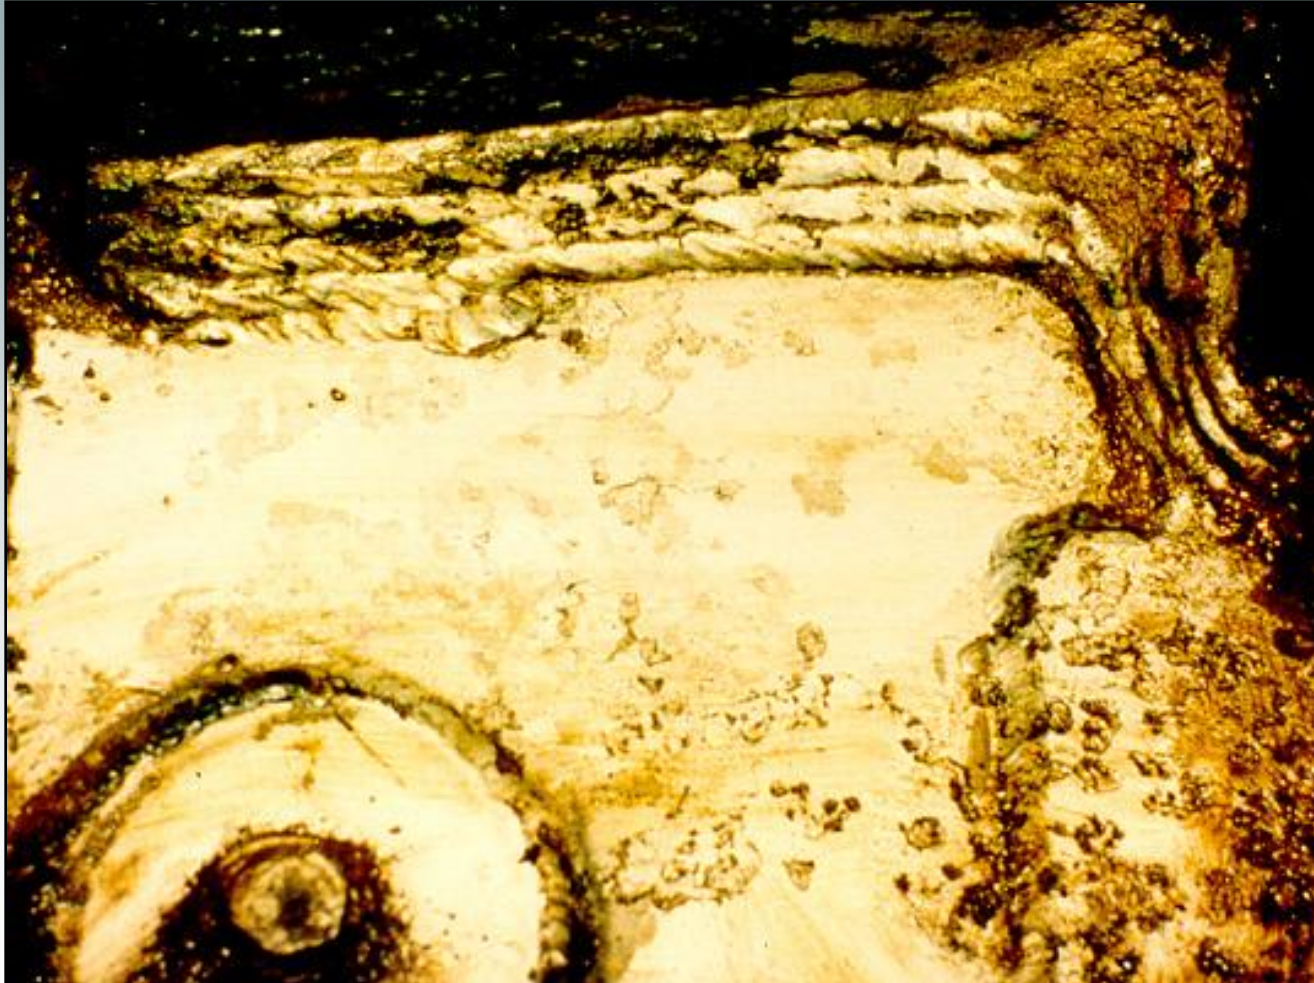
**Alloy C-276 Base plate**

# Overmatched NiCrMo 686 filler metal welds after six months FGD service
