Operation at low VIV angles

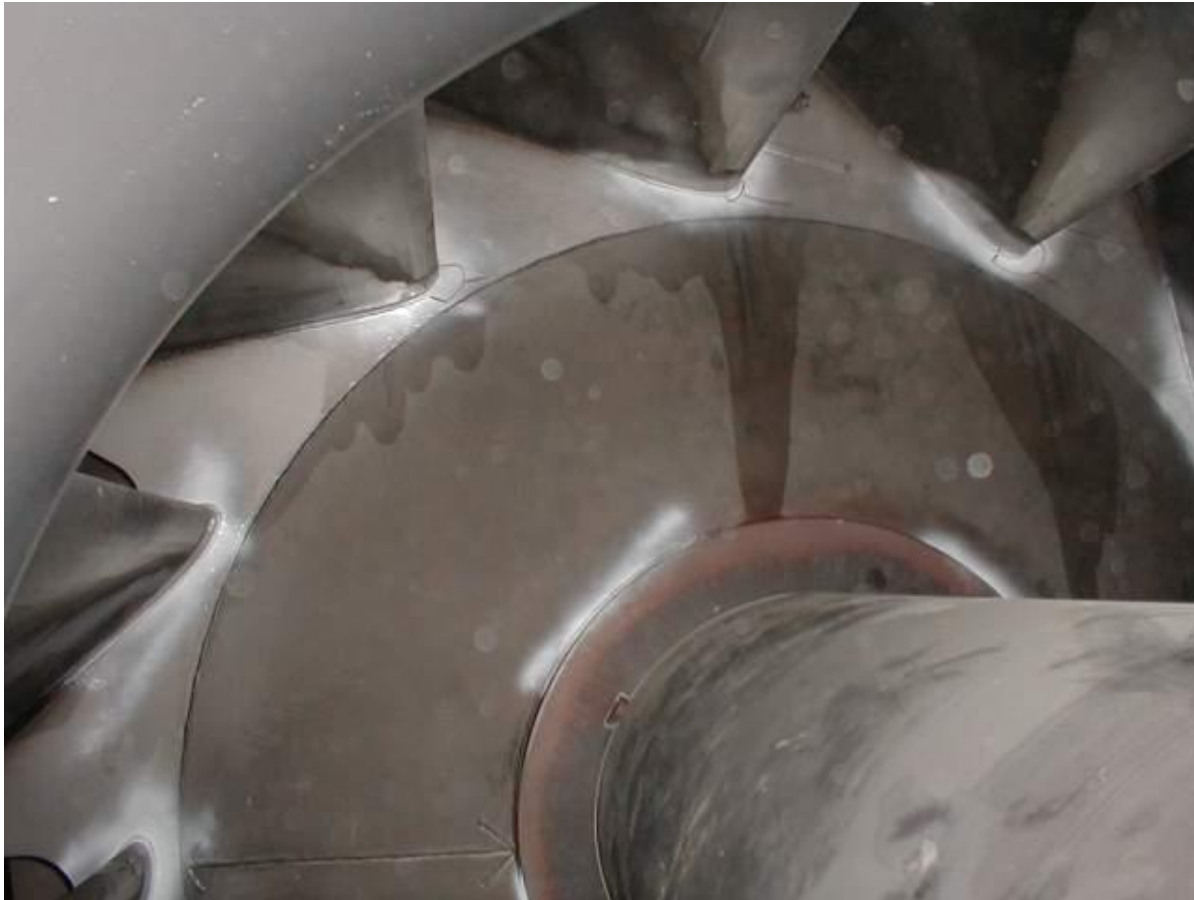
- Another fan manufacturer's Impeller Failure
