***Nickel Alloys Solve Corrosion Problems
in Wet Limestone FGD Systems***

McIlvaine Hot Topic Hour

Corrosion Issues and Materials for APC Systems

January 16, 2014

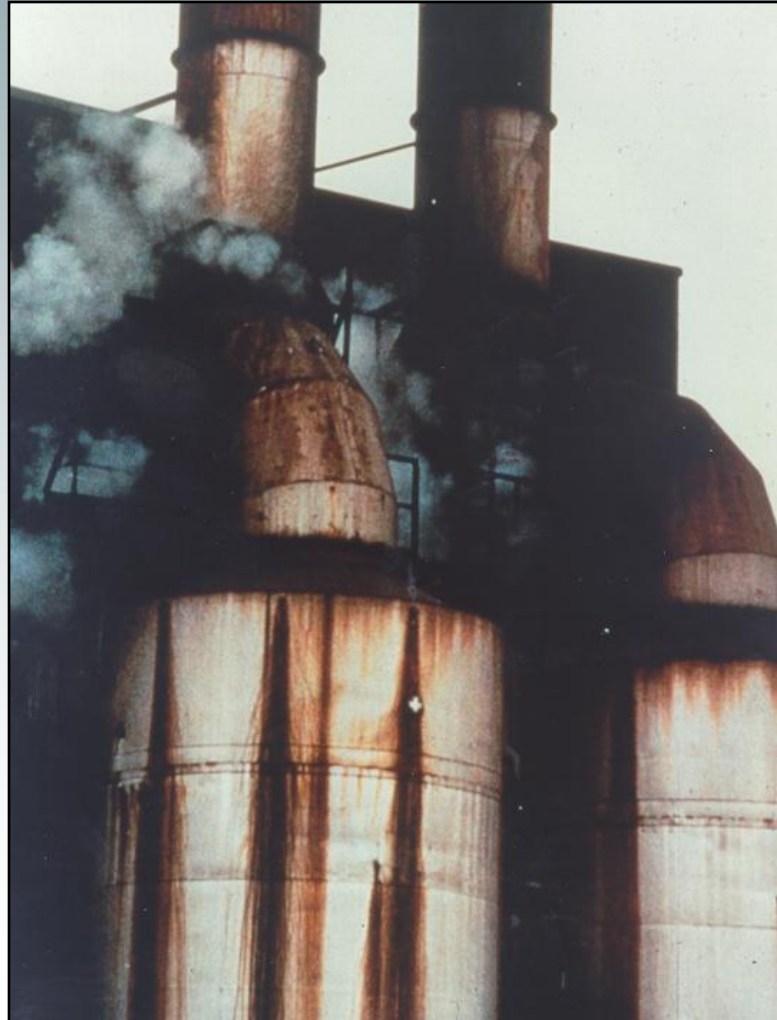
Premature Failure of Absorber Vessels due to Corrosion

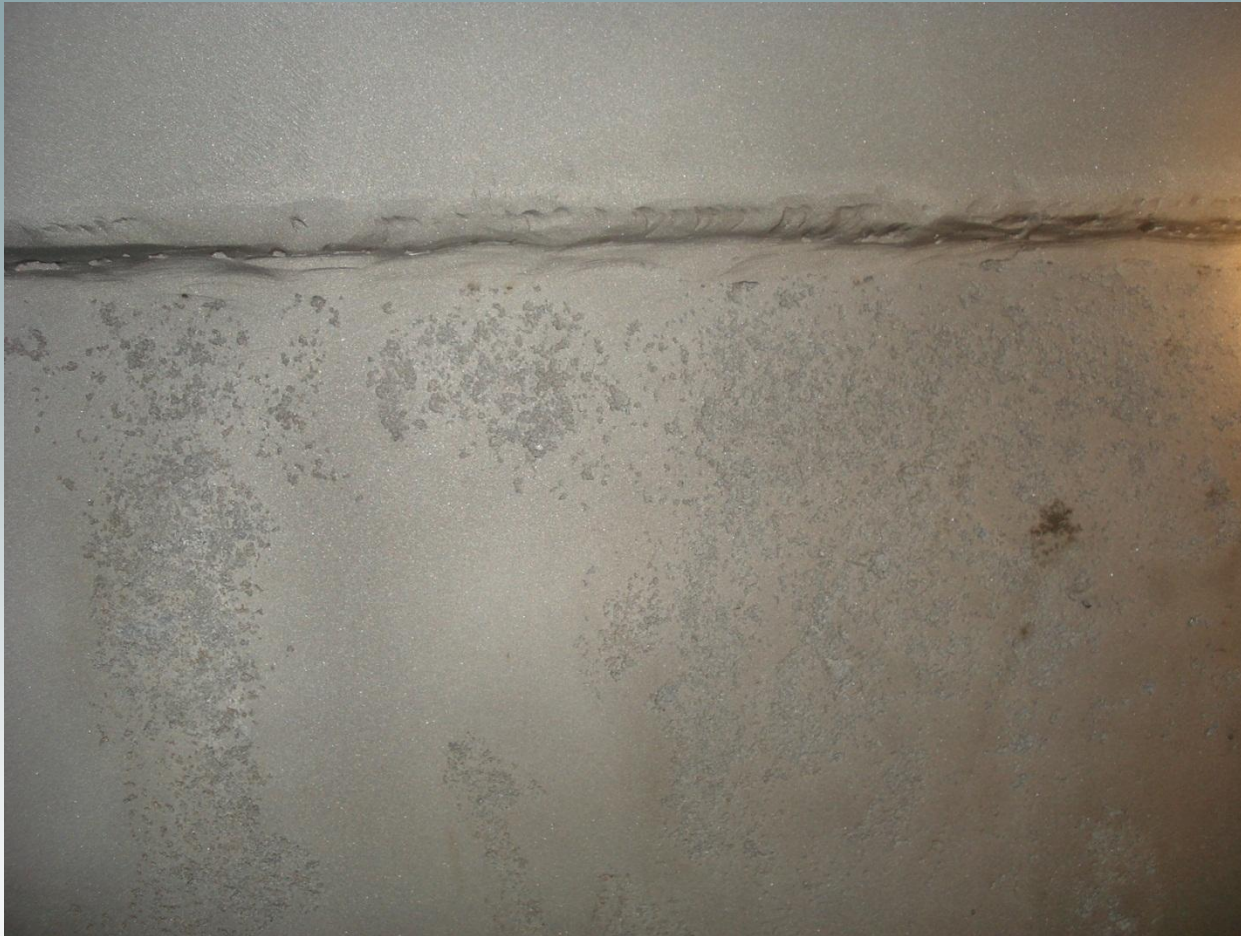
**Crevice corrosion of duplex steel
absorber wall adjacent to weld**

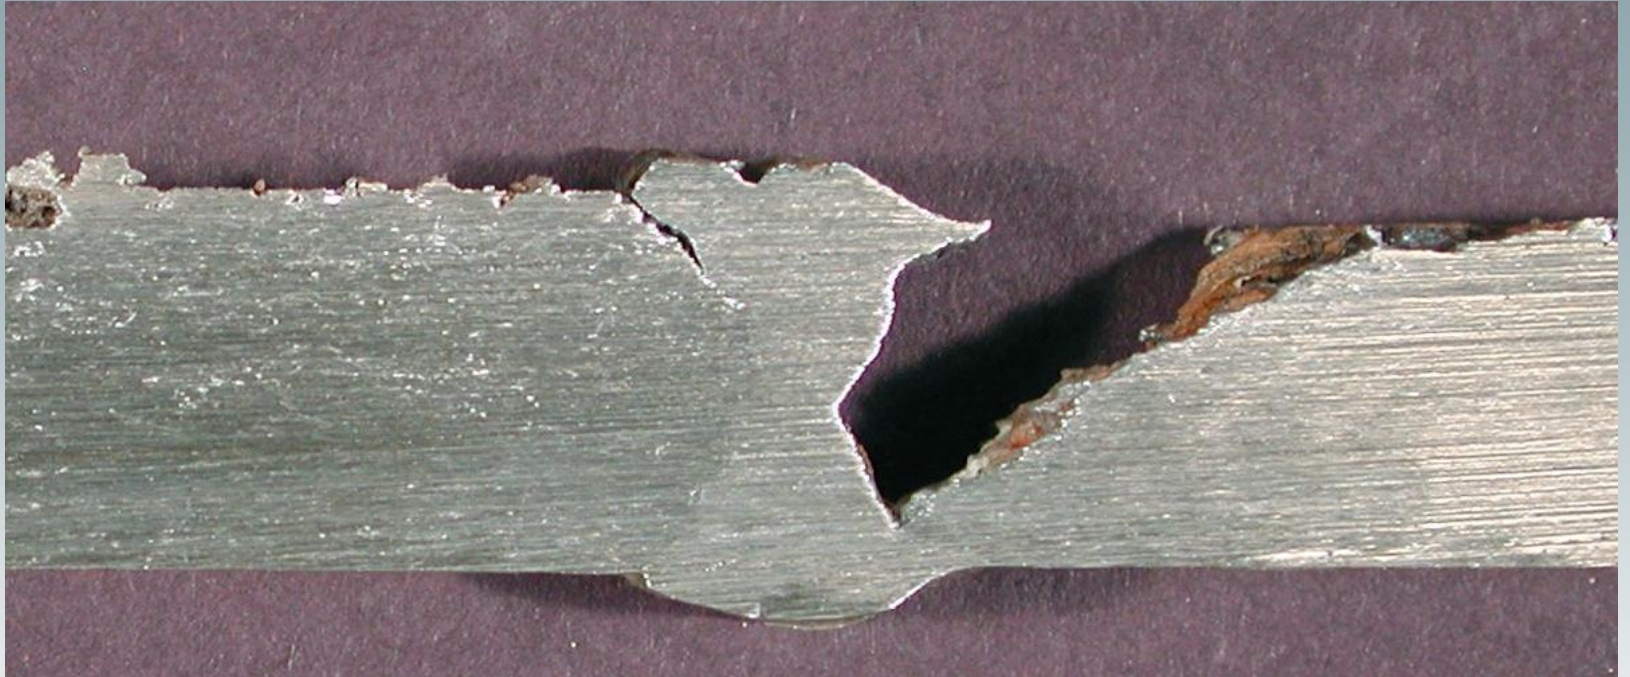
Corroded duplex stainless steel absorber wall joined with NiCrMo 625 welding product. The weld is not attacked but the base metal is nearly penetrated.

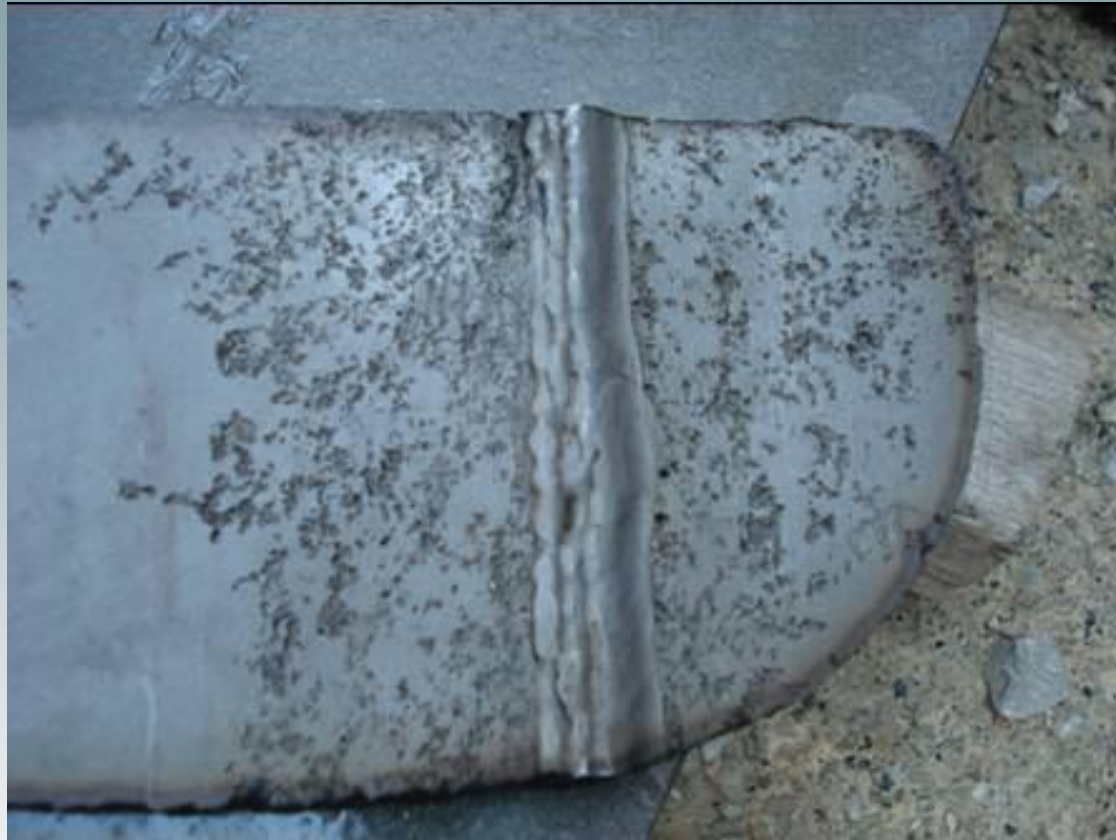
Crevice corrosion of a section of the duplex steel absorber wall that appears to be weld-related, perhaps due to mineral deposit build-up by “proud” welds? The nickel-alloy welds were not attacked.

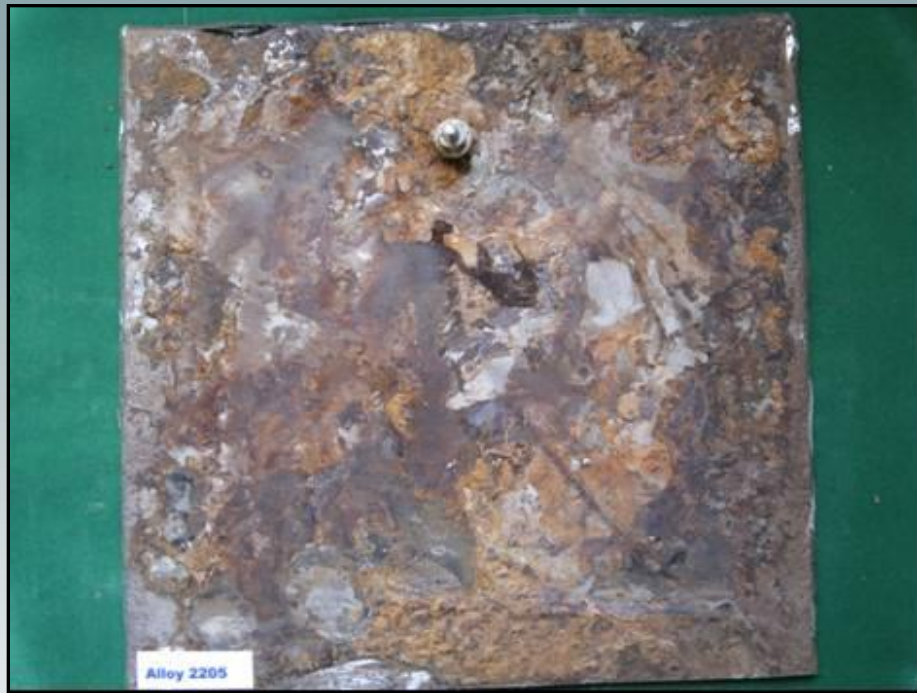
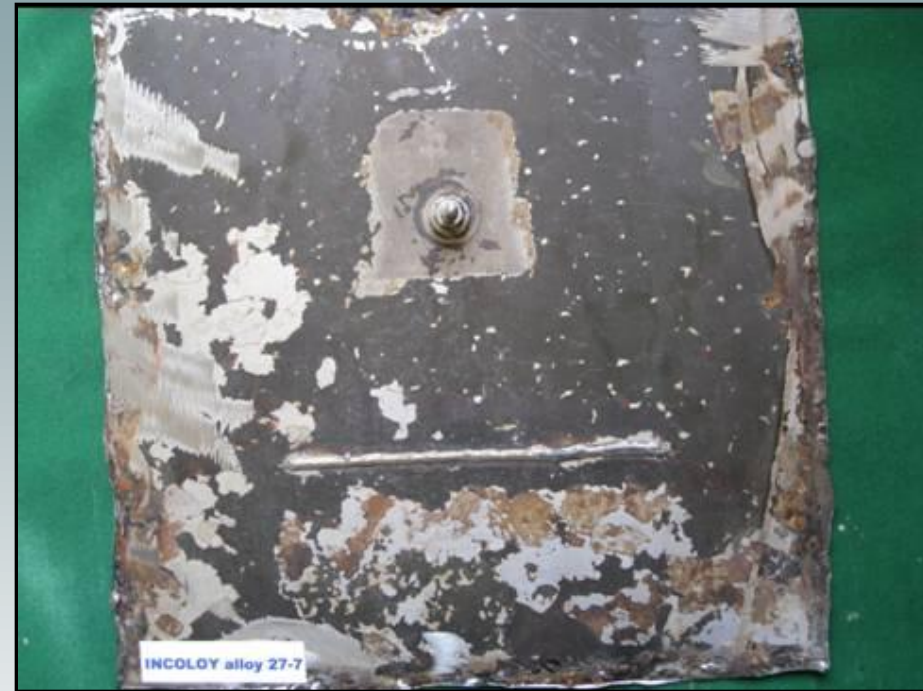
Duplex Steel (S31803)

Super-Austenitic Steel (S31277)

**Test panels exposed 7 months on the absorber vessel wall.
Mineral buildup is believed to have induced crevice condition.
Note adherent black film.**

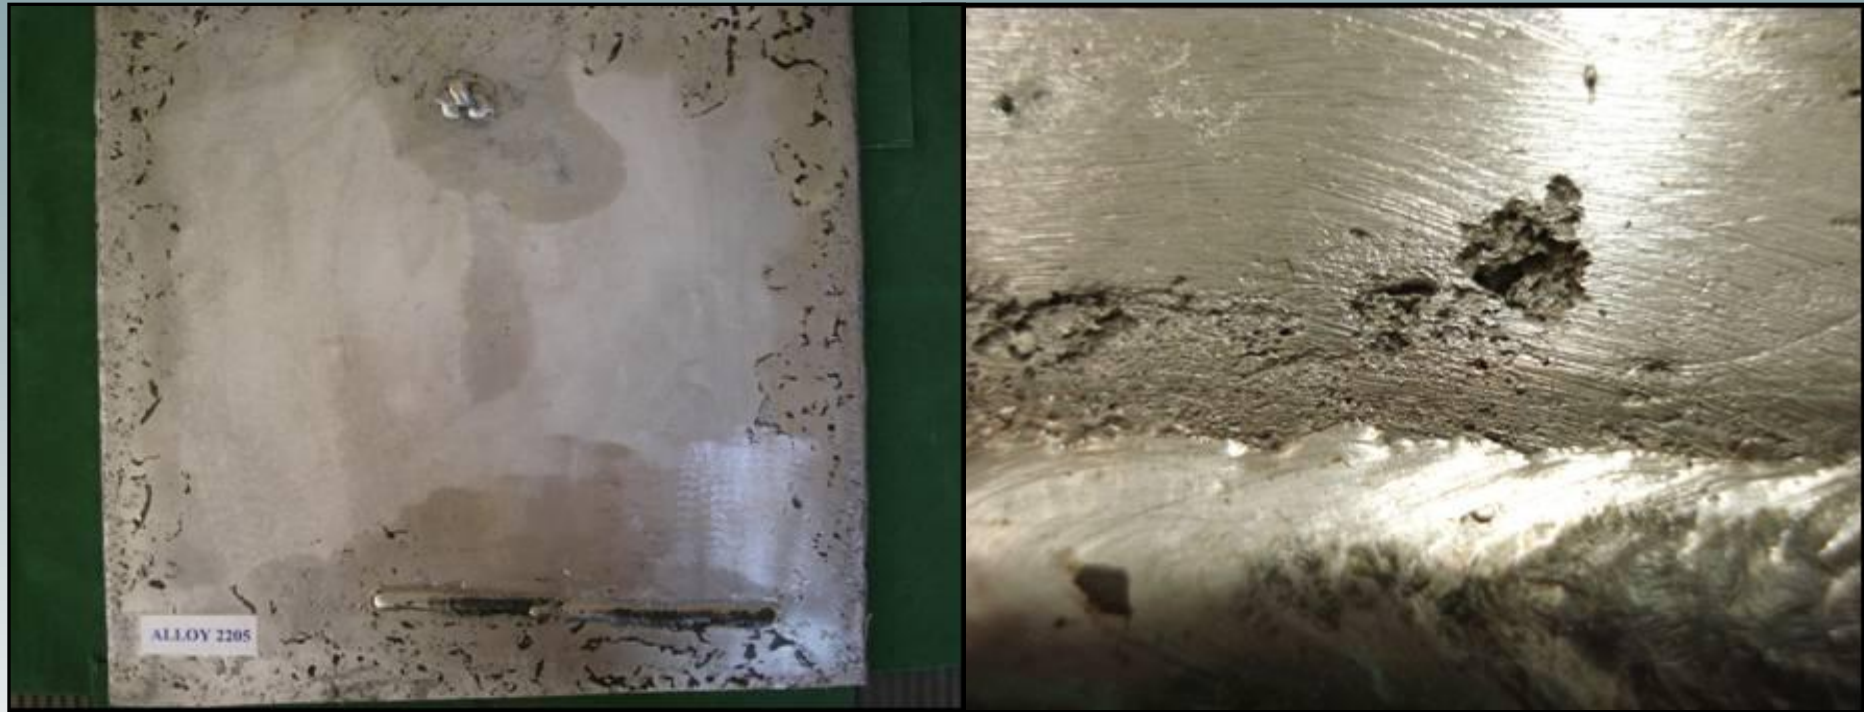
**Duplex steel test panel after cleaning.
Attack is evident, especially near the weld.**

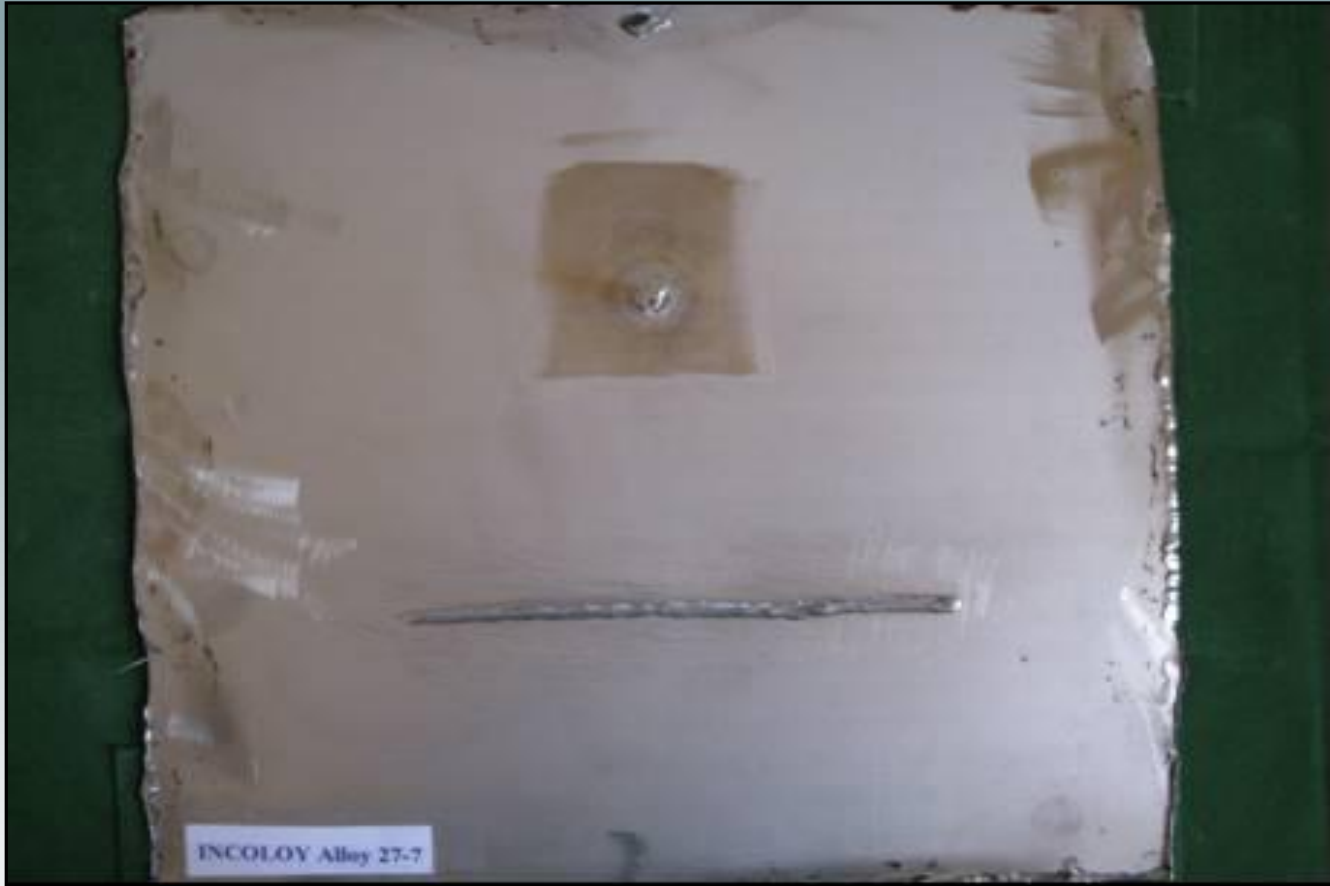
Super-austenitic steel (S31277) test panel after cleaning. No attack was found.

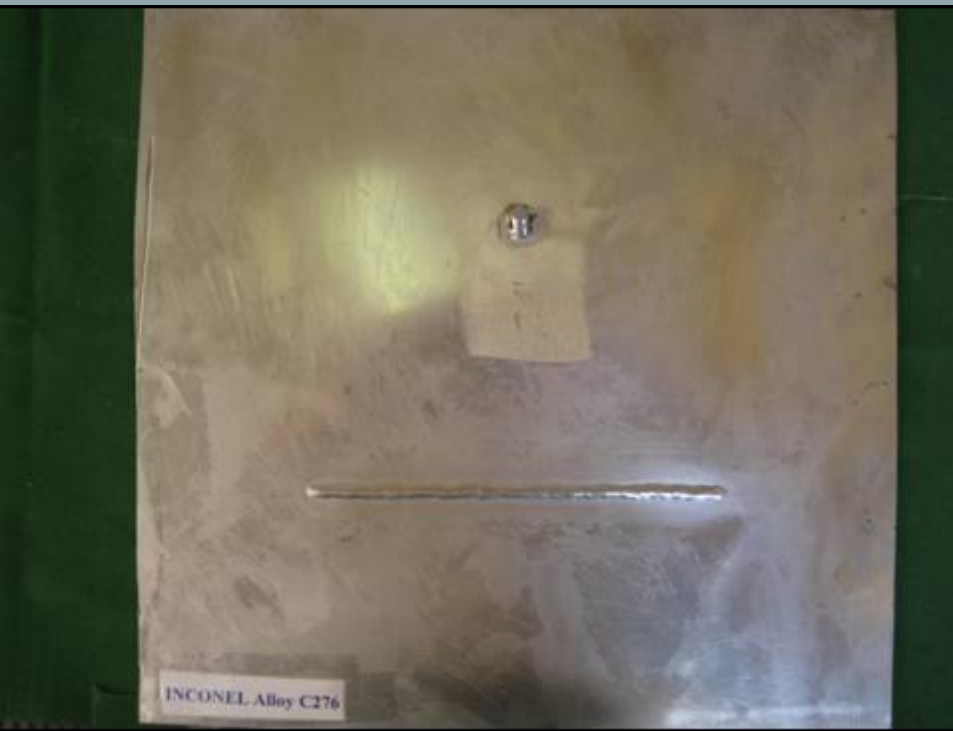
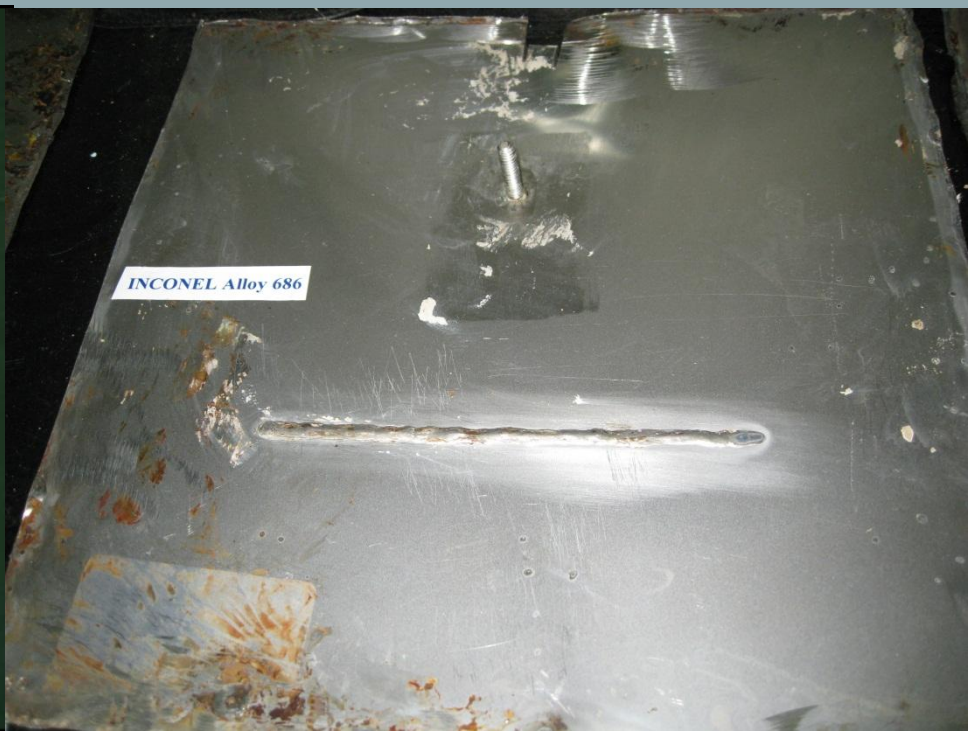
NiCrMo alloy N10276

NiCrMo alloy N06686

Alloy test panels after cleaning. No attack was found.

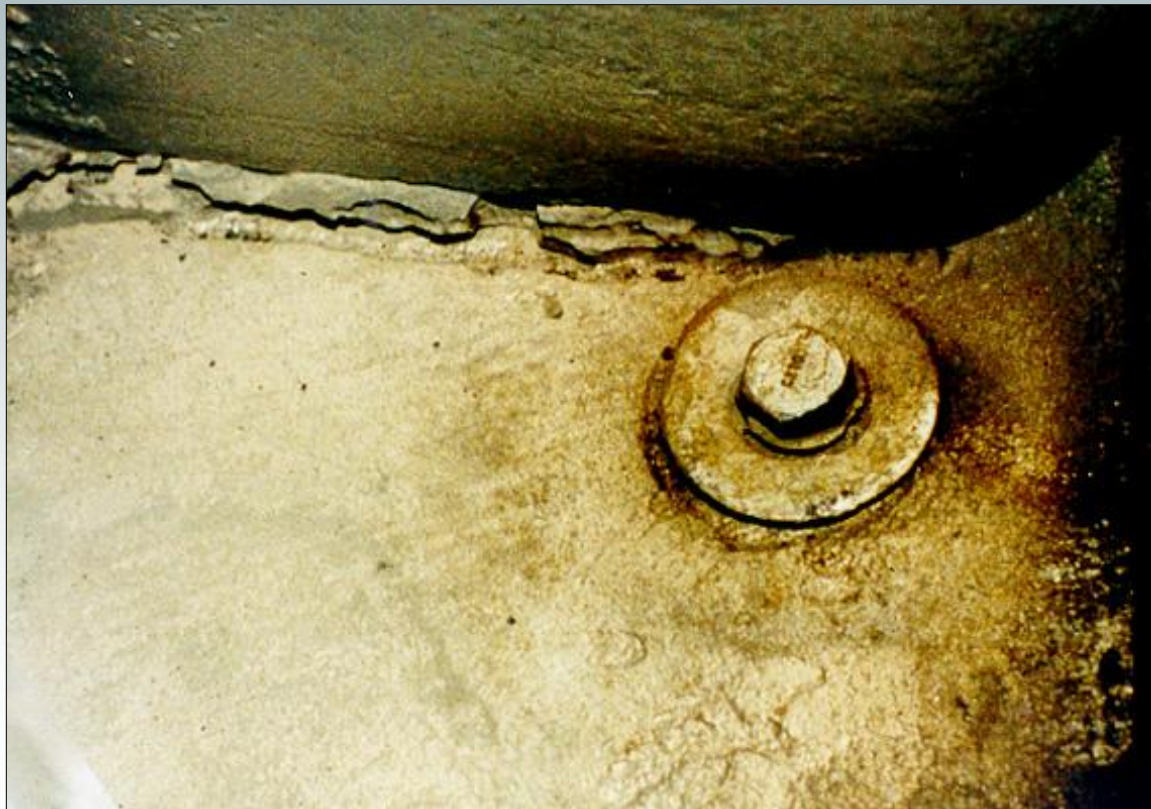
***Preferential attack of NiCrMo
C-276 filler metal welds in
FGD outlet duct***

Use overmatching composition welding products to offset iron dilution & elemental segregation in NiCrMo & FeNiCrMo corrosion-resistant alloys & stainless steels.

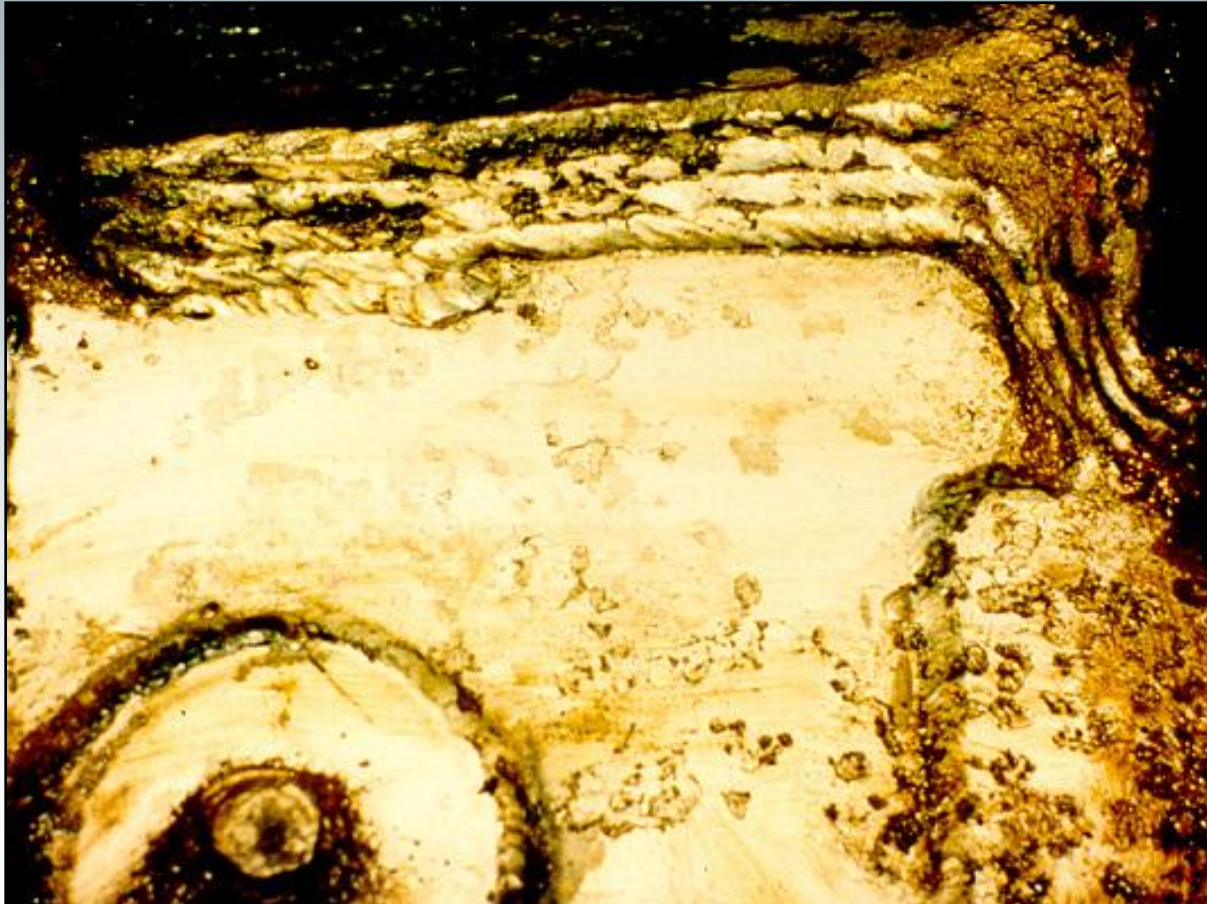
Overmatched NiCrMo 686 filler metal welds after six months FGD service

Overmatching composition welding products are required to produce fully resistant welds.

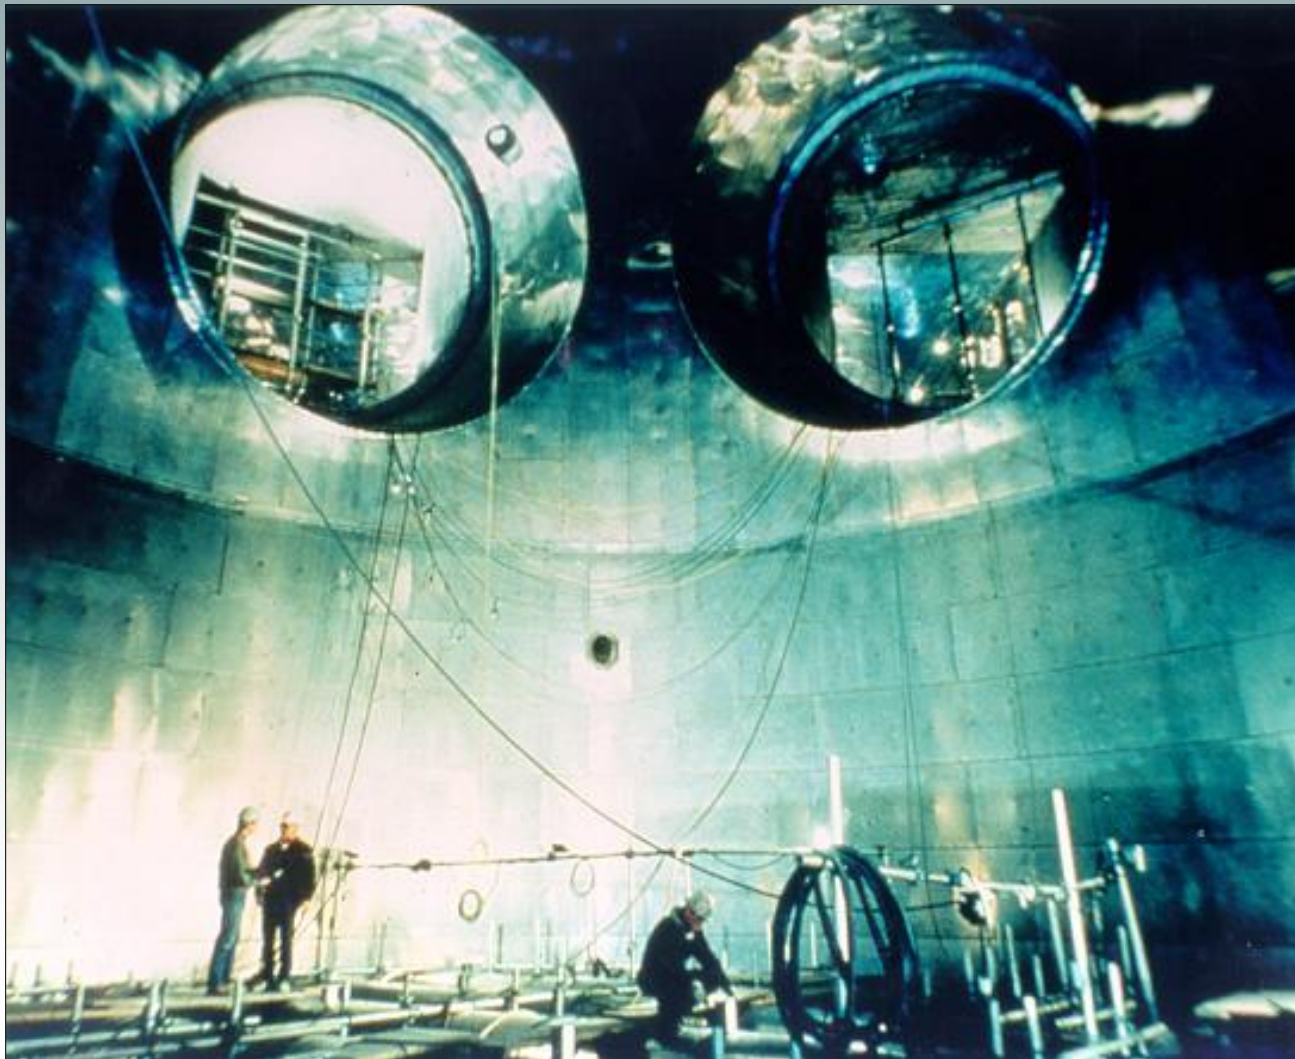
Nickel-Alloy, Wallpaper-Lined FGD Absorber Vessel

Wallpaper cladding is a viable repair scenario for corroded duplex steel absorber vessels.
