Evaluation of Drainage Layer Alternatives for Proposed Landfill Liner at the E.W. Brown Generating Station

Nicholas G. Schmitt, PE¹, and M. Brian Cole, PE²

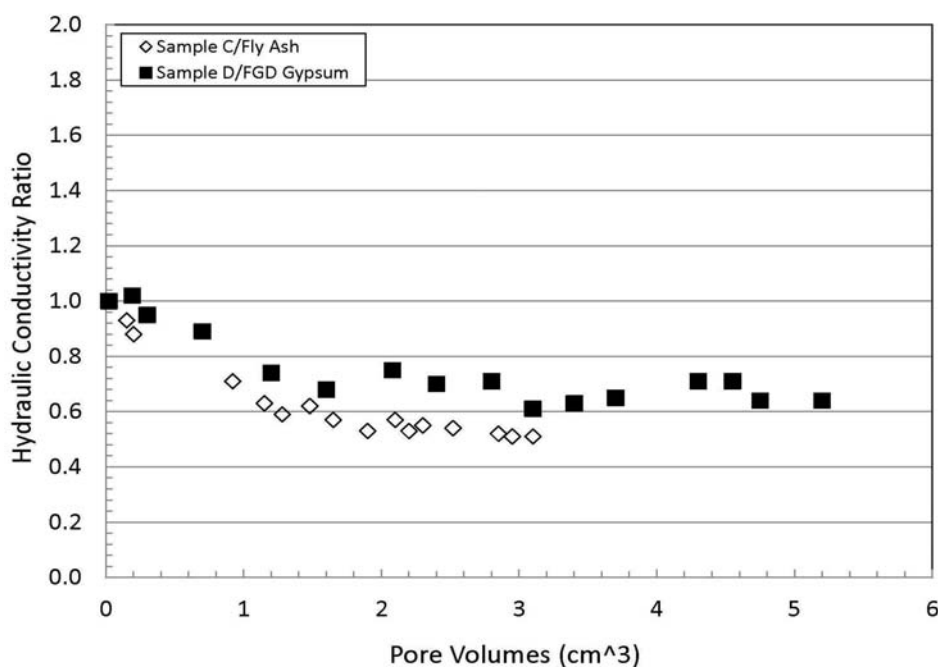
Figure 1 – HCR Results for Geocomposite with Plant CCPs

The geocomposite flow characteristics were tested with the plant's gypsum and fly ash by the Austin, Texas laboratory of TRI Environmental Inc. for hydraulic conductivity ratio (HCR) testing per ASTM D 5567 and transmissivity testing per ASTM 4716. As illustrated in Figure 1, the HCR value stabilized within two pore volumes with no further decrease. The geotextile forms a stable filter indicating no further decrease in hydraulic conductivity with time. Test conditions were selected to reflect the proposed landfill configuration: gradient = 0.02, time = 100 hours, boundary conditions = CCP/GDL/GM, pressure = 10,000 psf. Transmissivity results ranged between 4.3×10^{-3} to 6.7×10^{-3} m²/sec.

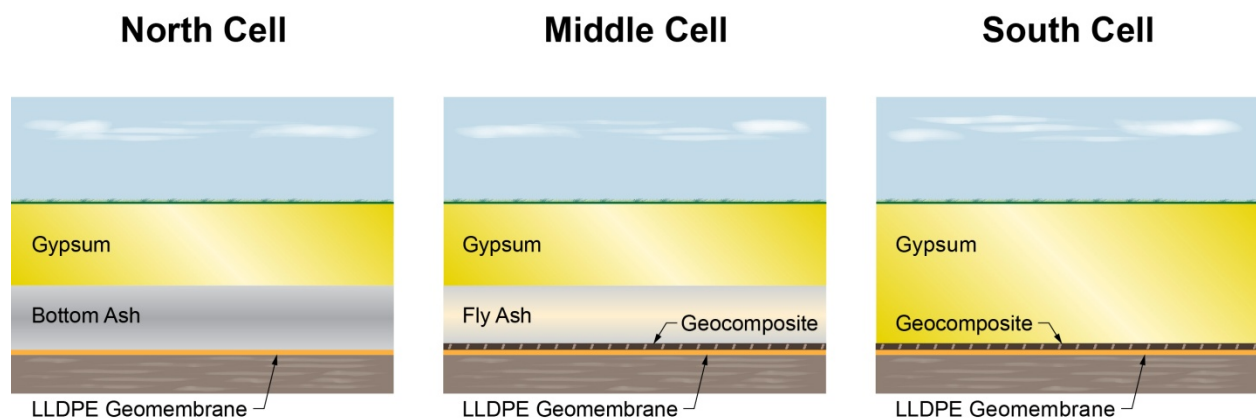
Figure 2 – Cross Sections of Each Test Pad Cell

The evaluation of the drainage layer options included constructing a test pad within the existing main pond to observe performance of three different configurations; two of which included the use of the geocomposite drainage layer and one using bottom ash for the drainage layer. Each of the cells of the tests pad were constructed approximately 40 feet long by 20 feet wide with the following configuration from the bottom to top, as illustrated in Figure 2:

- 1) South Cell – 60-mil LLDPE liner, geocomposite prototype, 24 inches of CCP gypsum protective cover.
- 2) Middle Cell - 60-mil LLDPE liner, geocomposite prototype, 12 inches of CCP fly ash, 24 inches of CCP gypsum protective cover.
- 3) North Cell - 60-mil LLDPE liner, 18-inch thick bottom ash drainage layer, 24-inches of CCP gypsum protective cover.

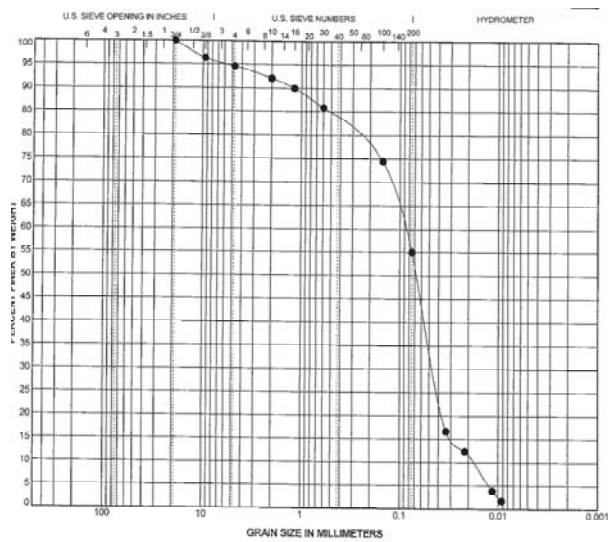
Though the gradations of the plant's gypsum and fly ash were considerably different from each other (as illustrated in Figure 3), both materials had a similar permeability of 1×10^{-6} cm/sec.

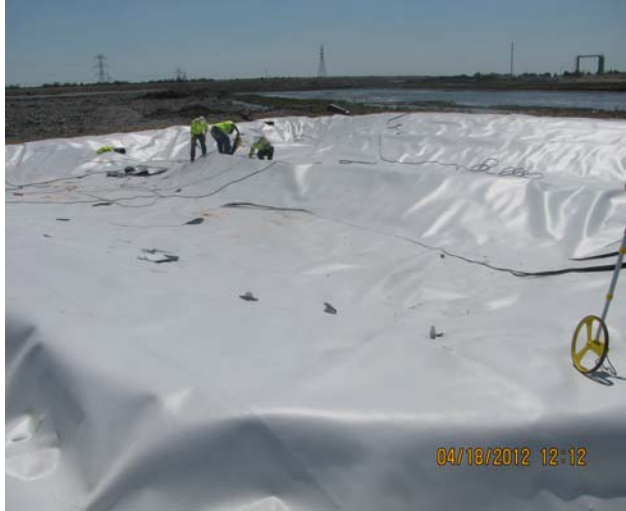
Figure 7- Geomembrane Installation

An AMEC technician oversaw construction of the test pad and placement of the CCP materials. After the subgrade work was completed, geomembrane was installed (see Figure 7). The geocomposite was then installed in accordance with the landfill specification, with the bottom geotextile of adjacent panels lapped, the geonet tied off, and the upper geotextile stitched together with a prayer seam (see Figure 8). Before the CCPs were spread over the geocomposite, plywood panels were placed over the geocomposite at the lowest central point inside the South and Middle Cells, just west of the west toe of the Divider Berm. When the evaluation period was over, this allowed AMEC to obtain geocomposite samples to check for signs of horizontal solids migration within the geocomposite. Samples were also obtained outside of the plywood footprint.

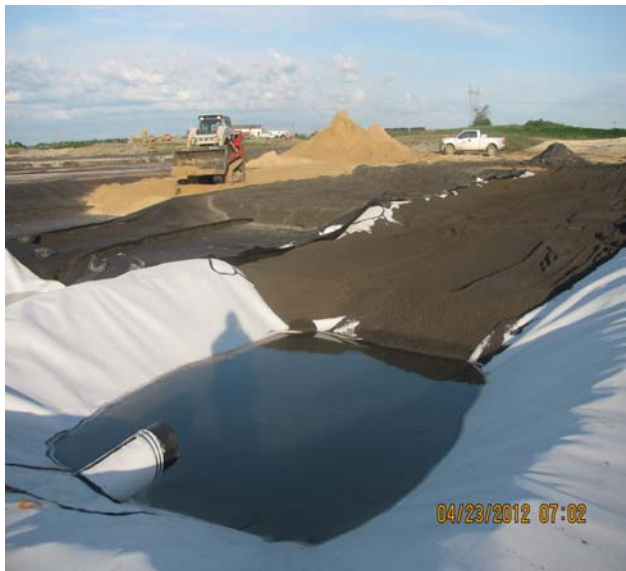
Figure 9 – Ash Placement

The North Cell did not contain geocomposite, but rather an 18-inch layer of bottom ash deployed directly over the geomembrane. This was the “control cell”, designed for the purpose of evaluating compatibility of the facility’s gypsum with a drainage layer constructed from its bottom ash. AMEC obtained a sample of the bottom ash to confirm that no more than 10% passed a # 100 sieve and no more than 5% passed a # 200 sieve. A layer of fly ash was added over the geocomposite in the Middle Cell, to see if it would provide a more favorable protective cover layer (see Figure 9).

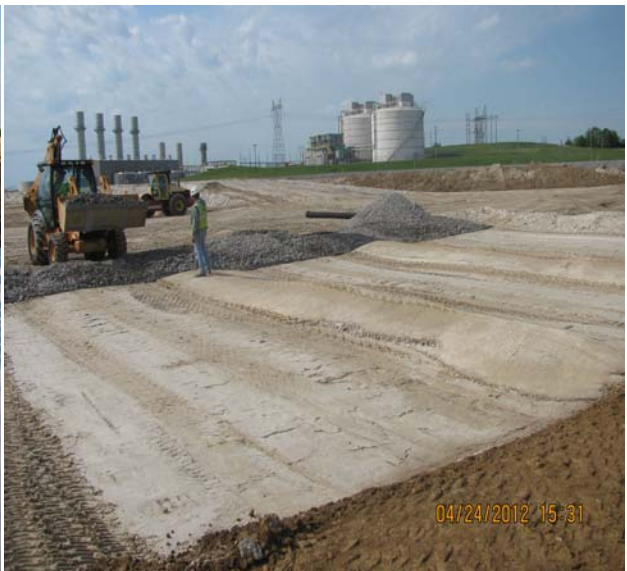
Figure 10 – Gypsum Placement

As shown in Figure 10, two feet of gypsum was then placed in each cell, placed in two lifts: an 18-inch layer beneath a 6-inch top layer. This upper layer of gypsum was compacted as necessary to achieve a minimum in-place dry density of 90% Standard Proctor. CCP material was spread over the liner system with an LGP bulldozer. When the CCP’s were placed, there was no exposed geocomposite showing, except for an 18 inch wide piece hanging down on the west side of the sump (South Cell and Middle Cell only). Gypsum was used to seal off the west side of the Divider Berm, with a 12-inch deep trench filled halfway with # 2 crushed stone running down the middle of the berm to divert run-off that might happen to flow across from the gypsum in the event of a cell overflow (this never occurred). The design incorporated 18 inches of standing water in the sumps, where gypsum or ash that “piped” through the drainage layer could accumulate. Geotextile sock filters and # 57 crushed stone were placed around the inlet of each 8-inch pipe spillway, to minimize the amount of gypsum or ash fines that migrated out via the spillway. Ultimately, these filters were removed when flow rates declined in a couple of the cells. Each spillway pipe included a standard boot seal where it penetrated the geomembrane.

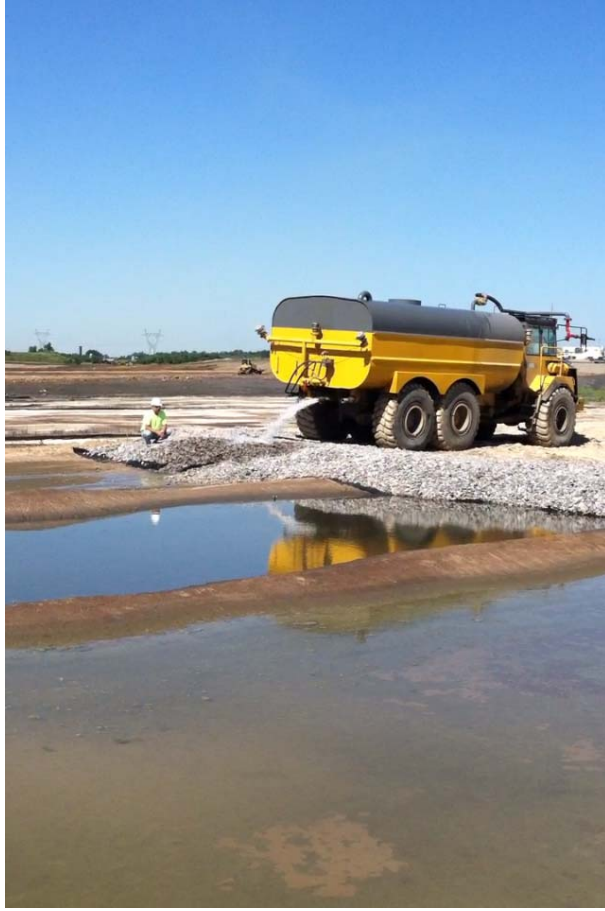
Figure 11 – Water Truck Dosing

During the two-month test pad evaluation period, two full 4000-gallon loads from a water truck were applied on a daily basis, as shown in Figure 11. More water was applied in the beginning in order to achieve material saturation (accounting for the fact that the permeability of both the fly ash and the gypsum are 1×10^{-6} cm/sec. Generally, there would still be standing water over the three cells when the crew went home for the day (see Figure 12), and it seeped into the underlying CCPs by the time they arrived the next morning. Water never topped over any of the perimeter berms surrounding the test pad.

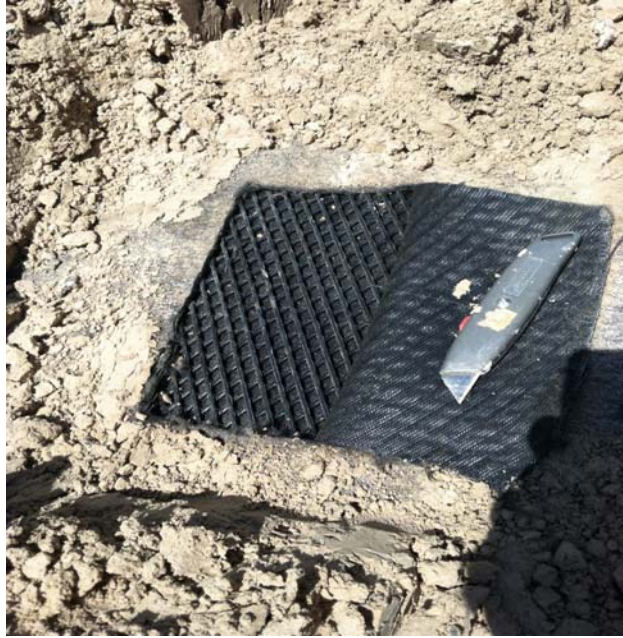
Figure 16 – Geocomposite investigation

When the test pad evaluation period was over, the sumps were pumped down and observed for signs of accumulated sediment. Very little sediment was observed in the South Cell. Some orange sediment had accumulated in the other two cells. Samples of geocomposite were exhumed from the beneath the test pad CCPs in the south and middle cells. The geocomposite samples were sent to TRI Environmental Inc. laboratories and tested under the conditions corresponding to the proposed landfill design, which were the same conditions used in the previous laboratory analysis. The transmissivities ranged from 4.6×10^{-3} to 4.9×10^{-3} m²/sec, reflecting no negative impact on transmissivity. Before and after values are within material variability which is common at those low gradients. The geocomposite samples cut from beneath the gypsum were remarkably clean, as illustrated in Figure 16.

Following completion of the field testing of the test pads, sections of geocomposite in the South and Middle Cells were uncovered and the top geotextile cut to expose the geonet to observe for solids intrusion. Although some minor orange staining was observed in the geocomposite from the Middle Cell, no CCP sediment intrusion was observed in either geocomposite sample. In addition to the visual observations, samples were cut from the installed geocomposite from both pads and sent to a laboratory for hydraulic conductivity testing using ASTM D 4716 method for a duration of 120 hours. The laboratory testing was conducted using the same project specific setups and materials used for construction of the test pads. The laboratory hydraulic conductivity testing was conducted using 5,000 psf and 10,000 psf confining pressures.
