BR-1876

## ***Corrosion in Alloy Wet FGD Absorber Reaction Tanks***

# Corrosion in Alloy Wet FGD Absorber Reaction Tanks

**Power Plant Air Pollutant Control “MEGA” Symposium**  
Baltimore, Maryland, U.S.A.  
August 20-23, 2012

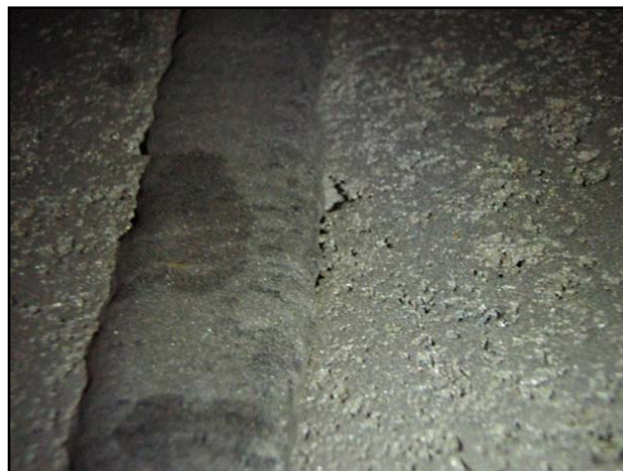
**Fig. 1** Aggressive corrosion near vertical weld.

Due to concerns about the unexpected corrosion of 2205 duplex stainless steel absorber reaction tanks, utilities have increased their inspections of such tanks. For those reaction tanks not showing any indications of the aggressive corrosion, some observations of a less severe surface etching and sub-surface pitting mechanism have been discovered (refer to Figure 2).

The aggressive corrosion sites observed in the absorber reaction tanks were covered by scale, but not all areas covered by scale exhibited visible corrosion. Corrosion varied from small pits to through-wall penetration of the shell. Numerous scale samples were collected from corrosion-covered areas during the May 2009 outage, and analyzed. Samples varied in visual characteristics, and were generally grouped by color: black, green, and rust/brown. The samples of hard, black scale were found to be rich in manganese and fluorine. The major elements in the dark green scale were fluorine and chromium. One hypothesis is that when fluoride,

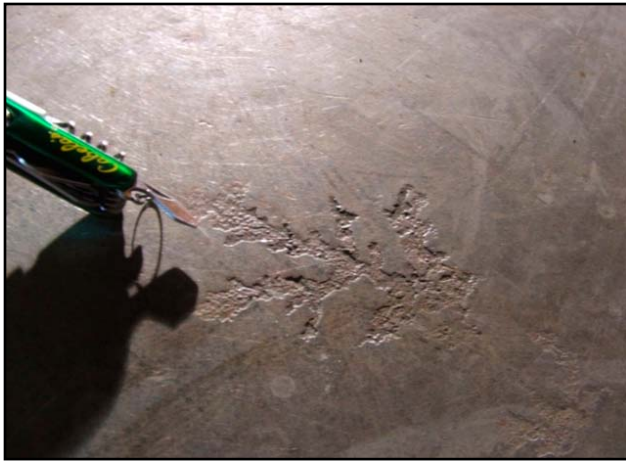
**Fig. 2** Less severe surface etching.

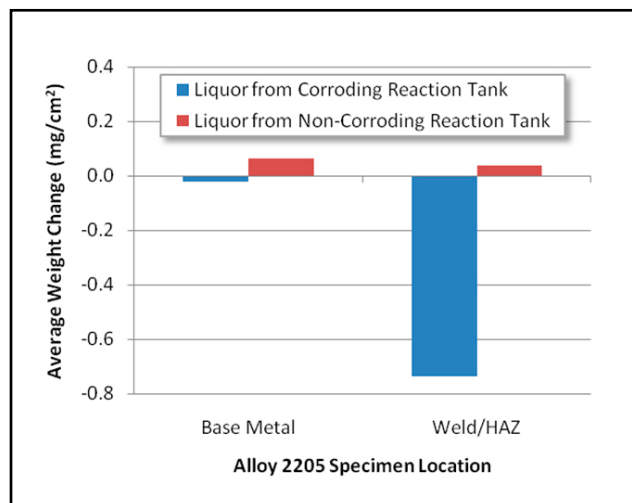
**Fig. 3** Change in corrosion after 44-day immersion.

From the results of the immersion testing, the authors conclude that the liquor from the aggressively corroded reaction tank caused corrosion not only to the area of welds and HAZ, but also to the base metal unaffected by welding (refer to Figure 3). Consistent with electrochemical testing done on absorber slurry liquor after filtering from eight plants, the liquor from the aggressively corroding reaction tanks showed a greater than 2.0 unit reduction in pH from the start to the end of the 44-day immersion test (refer to Figure 4), whereas the Control liquor experienced a 0.5 unit increase in pH.

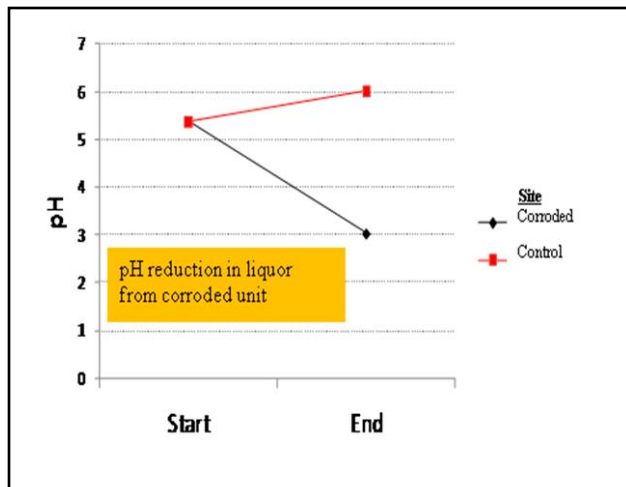
**Fig. 4** Change in pH of absorber slurry filtrate after 44-day immersion.

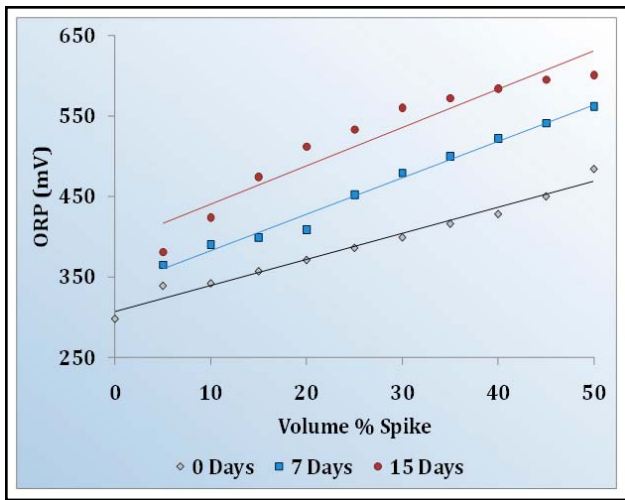
Fig. 7 ORP versus volume percent of spike.

(1) The reaction which causes  $Mn_xO_y$  to precipitate is accompanied by a reduction in pH, and an increase in ORP, as shown in Figures 6 and 7.

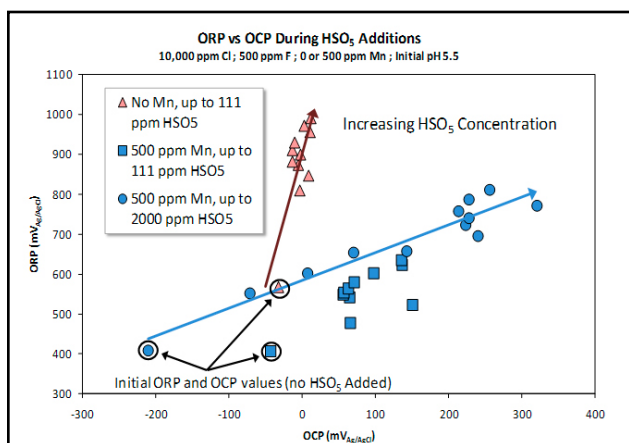
Fig. 11 ORP vs. OCP of Alloy 2205.

(5)  $HSO_5$  additions to a solution containing no Mn caused a drastic increase in the ORP of the solution, but little increase in the OCP of the Alloy 2205.  $HSO_5$  additions to a solution containing 500 ppm Mn caused a moderate increase

in the ORP of the solution, but also caused a significant increase in the OCP of the Alloy 2205 (refer to Figure 11). The OCP increase in Mn-containing solutions appears to be due to the precipitation of  $MnO_2$  as the  $HSO_5$  was added.

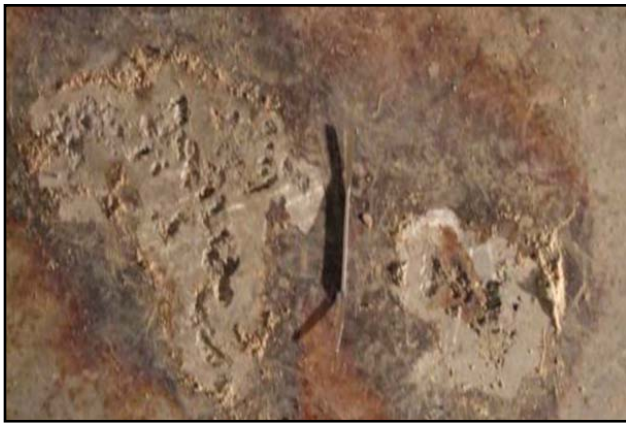
**Fig. 12** Visible localized under-deposit corrosion.

A less severe localized etching corrosion (refer to Figure 12), consistent with an under-deposit corrosion mechanism, has been observed in a number of Alloy 2205 absorber reaction tanks that were not experiencing the degree of corrosion associated with  $\text{Mn}_x\text{O}_y$  precipitation. This corrosion may also manifest as generalized pitting and/or oxide patinas, dependent upon the deposit composition and degree of deposit adherence. On a number of absorber reaction tanks showing no visible corrosion, random x-rays of the shell revealed sub-surface corrosion parallel to and perpendicular to the weld that appeared to initiate along the weld zone (refer to Figure 13).

Analysis of scale shows that it is predominantly gypsum, with a much higher fluoride concentration at the scale-alloy interface than elsewhere in the scale. It should be noted that the Alloy 625 filler metal is not being attacked, and that this type of corrosion and x-ray indications are not being found on absorber surfaces above the reaction tank liquid level.

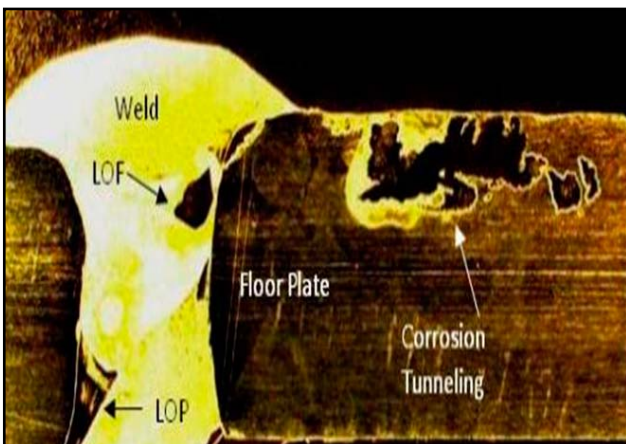
**Fig. 13** Perpendicular-to-weld sub-surface corrosion.

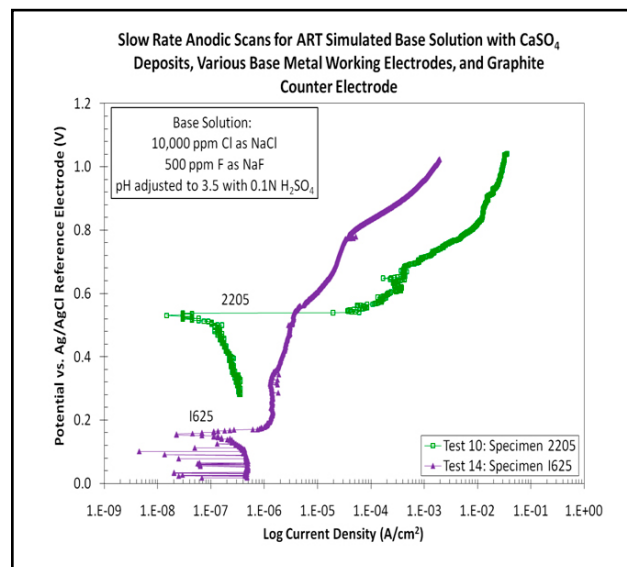
Fig. 15 Slow rate anodic scans.

As an example, the slow rate anodic scans (SRAs) for Alloy 2205 and Alloy 625 in CaSO<sub>4</sub> deposits are shown in Figure 15. The Alloy 2205 sample exhibited pitting/wastage corrosion, while the Alloy 625 sample exhibiting some staining but no pitting.

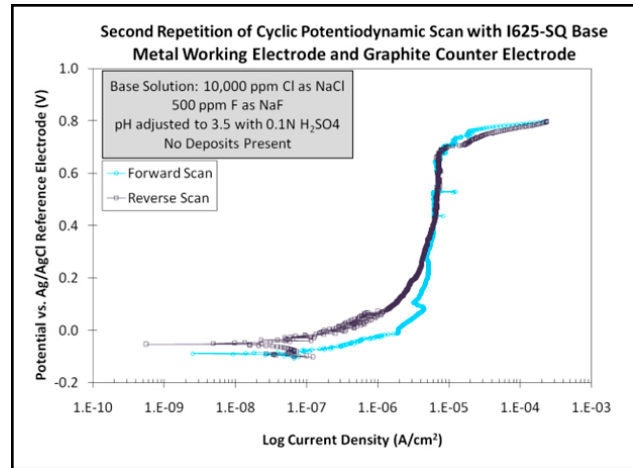
Fig. 17 Alloy 625 cyclic scan.

Figures 16 and 17 are the cyclic potentiodynamic scans (CPS) for Alloys 2205 and 625 respectively, with no deposits present. Note that there is a large hysteresis loop on the 2205 CPS (Figure 16) while the CPS for the 625 has essentially no hysteresis loop. The presence of a large hysteresis loop

in a CPS is an indication that the test material is susceptible to pitting in the environment tested.<sup>7,8</sup> The absence of a hysteresis loop is an indication that the test material is resistant to pitting corrosion in the environment tested.<sup>7,8</sup>
