Corrosion Studies on GeoBrom® HG520

Partial Immersion Study

brominated derivative products for mercury control

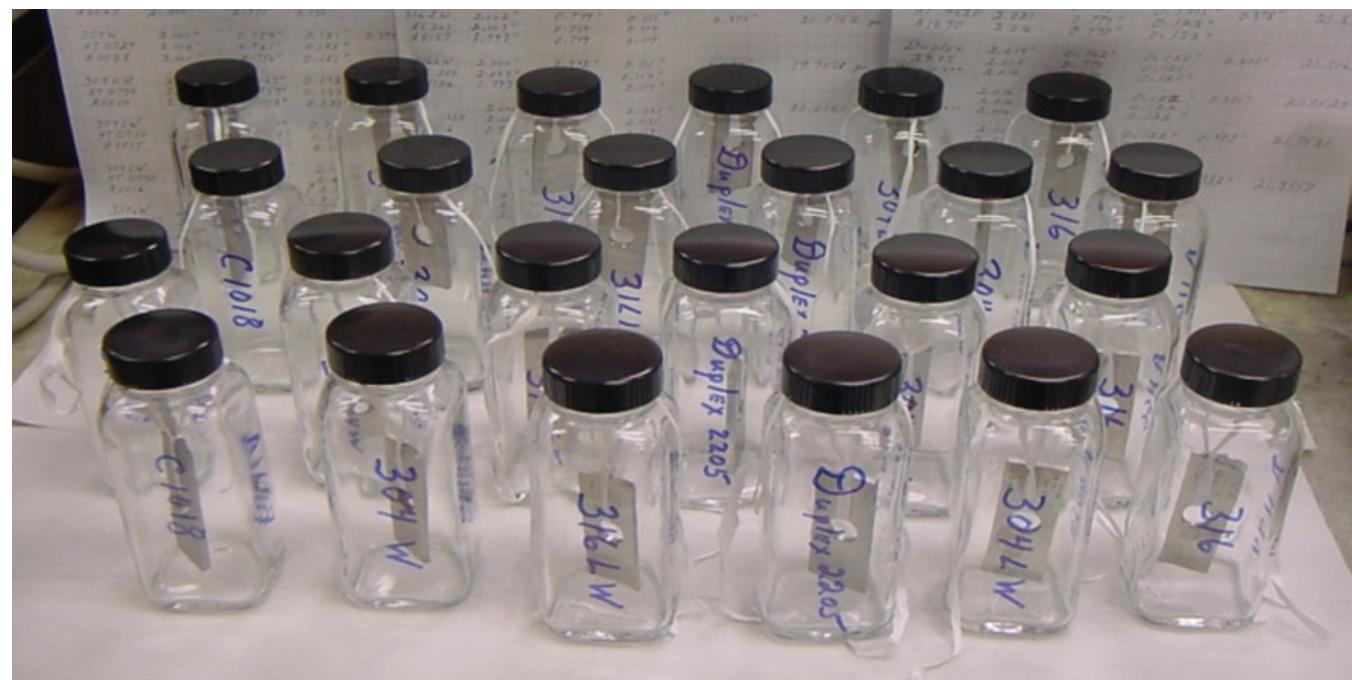
Figure 3

Test Coupons Before GeoBrom® HG520 Charged and Before 90-Day Exposure

To visually document condition of test specimens, pictures were taken before immersion tests, after, and after cleaning (see **figures 2-15**). Pitting occurred on stainless coupons where the rusty colored stains formed, which became noticeable after cleaning.

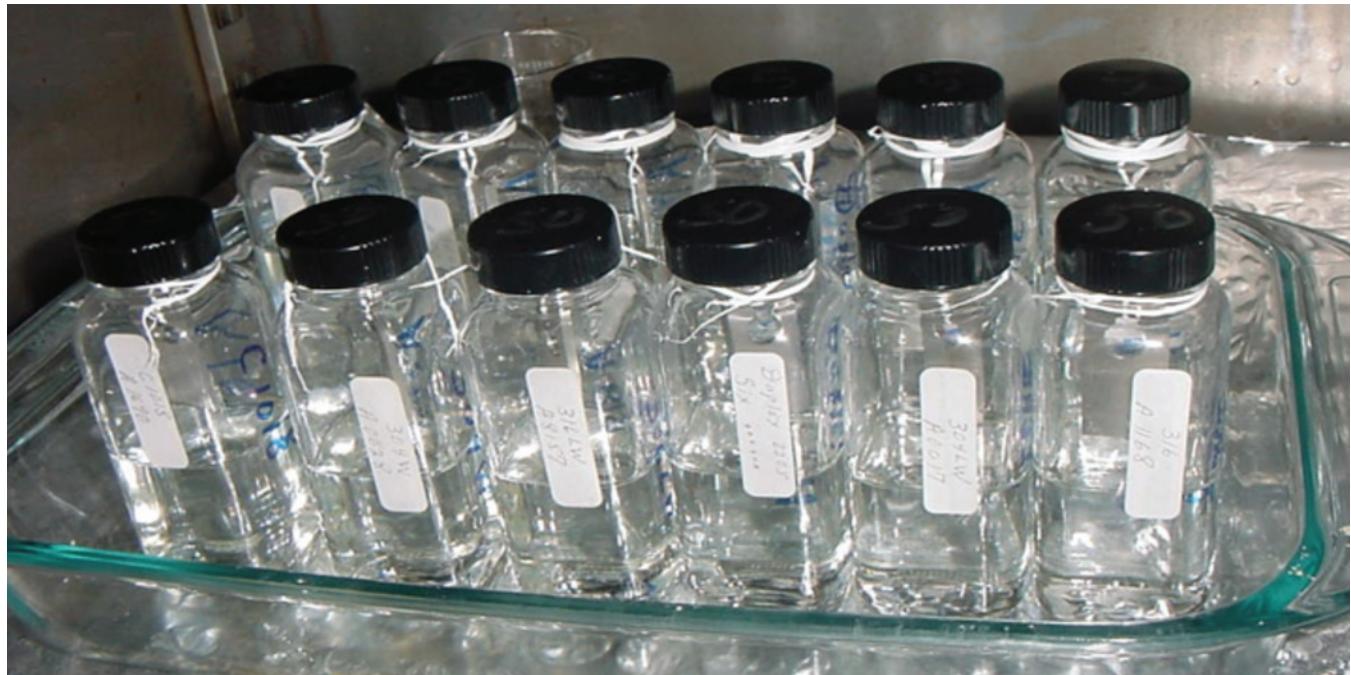
Figure 4

Test Coupons Before 90-Day Exposure at Above and Half Below Surface in GeoBrom® HG520

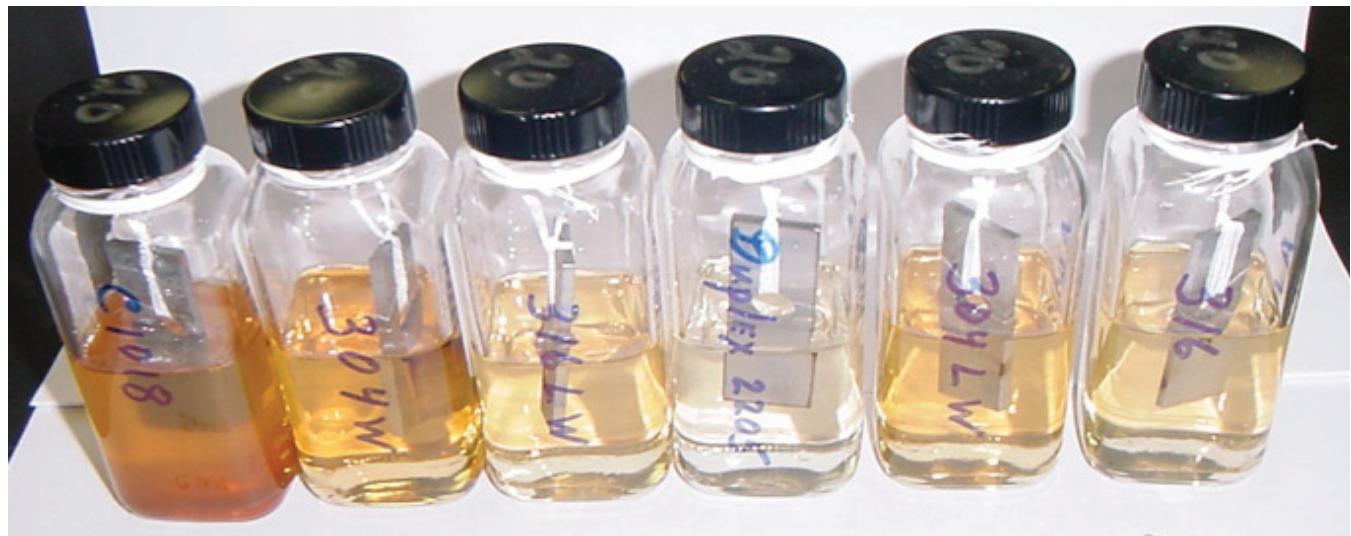
Figure 5

Test Coupons Half Above and Half Below GeoBrom® HG520 After 90-Day Exposure at 20° C

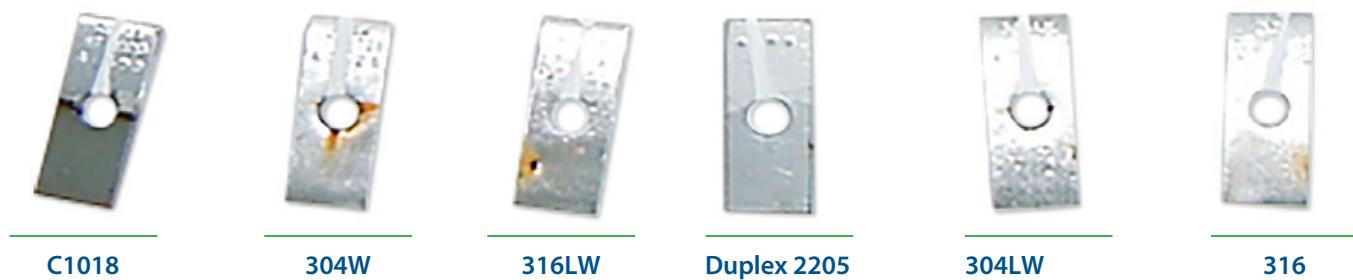
Figure 6

Test Coupons Half Above and Half Below GeoBrom® HG520 After 90-Day Exposure at 20° C

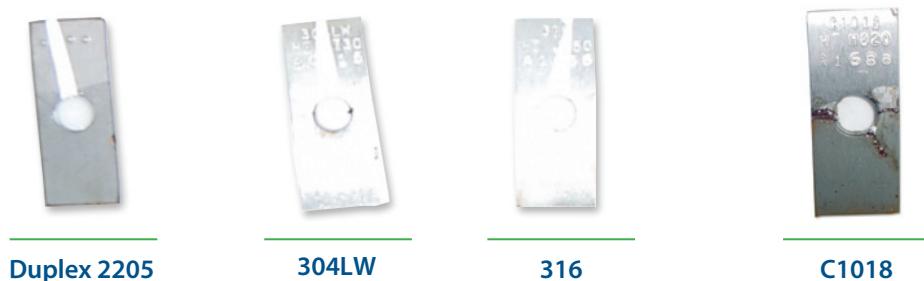
Figure 8

Test Coupons Before Cleaning After 90-Day Exposure at 20° C in GeoBrom® HG 520

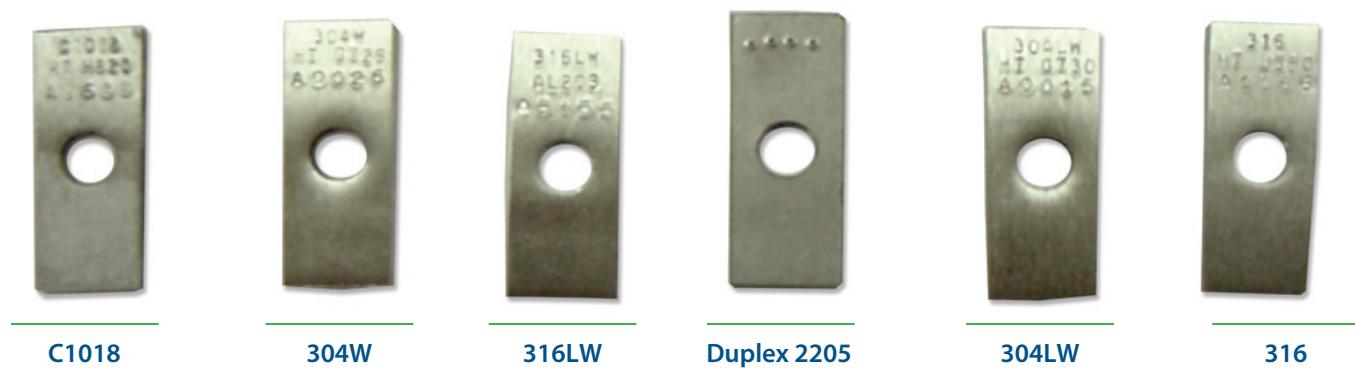
Figure 10

Test Coupons Half Above and Half Below GeoBrom® HG520 After 90-Day Exposure at 20° C After Cleaning

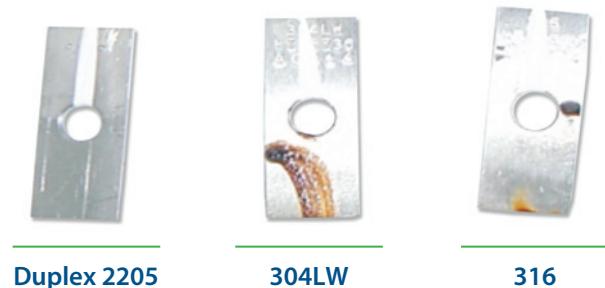
Figure 14

Test Coupons Half Above and Half Below GeoBrom® HG520 After 90-Day Exposure at 50° C Before Cleaning
