HIGH-PRESSURE VALVES: Why you should buy only premium valves

Bremco Inc's Reg and Bob Morse closed out the 2014 Combined Cycle Users Group meeting with a case history on the replacement of main steam valves for F-class heat-recovery steam generators. Their presentation illustrated the extensive, and expensive, effort required to replace large boiler valves. Likely, it will make you think twice about purchasing valves of any size for new HRSGs, or replacement valves for existing units, based on cost rather than on quality.

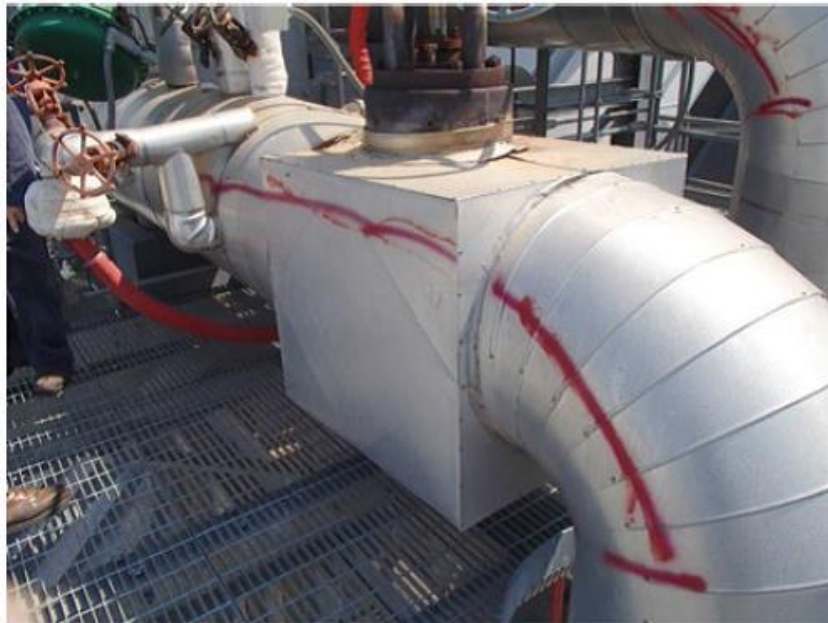
1. Pre-outage walkdown revealed an interference: The stop valve ordered to replace the original, shown above, would have required moving a P01 HP steam sample line. This expense was avoided by machining the valve body shorter before it was shipped from the manufacturer

The value of a comprehensive job walkdown was in evidence almost immediately. As ordered, the new reducer and valve would be longer than the original 16 × 12-in. valve and require the relocation of an HP-steam sample line. This would have been labor intensive and quite expensive, Morse said, explaining to the editors the work associated with field modifications of P91 piping—especially in locations difficult to access. The economical solution was to have the valve manufacturer machine the valve body shorter to avoid the interference.

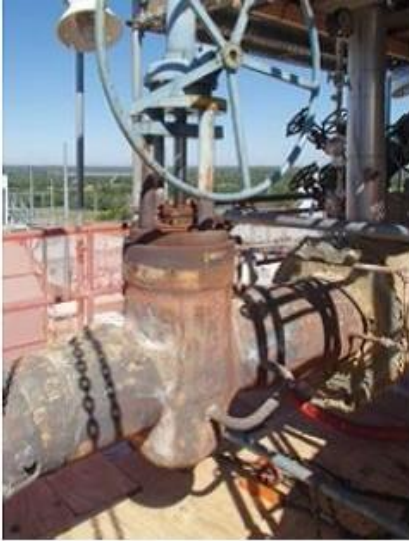
2. Original valve after insulation was removed

Issues with the large P91 valves on four HRSGs serving two 2 × 1 combined cycles at one plant dictated their replacement. Bob Morse, who managed the project onsite for contractor Bremco, began his narrative with the site visit conducted to plan the job. The original valve (Figs 1, 2) received steam from a 16-in. line on the boiler side and discharged it to the 12-in. HP steam system. The replacement valve purchased by the plant owner/operator was of a 12 × 12-in. configuration and required an inlet reducer.

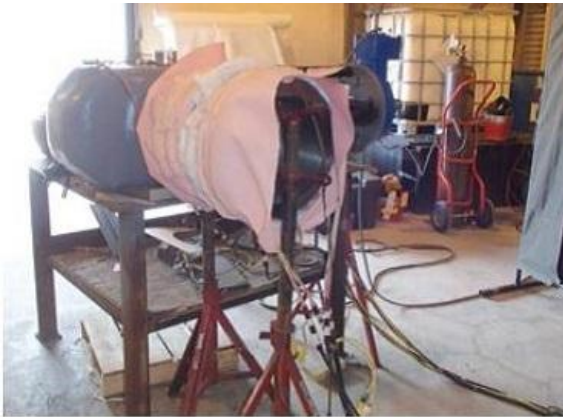
3. A 16 × 12 in. reducer was welded to the valve inlet to transition from the 16-in. line coming from the HRSG to the 12 in. stop valve. Heat-treatment step is in photo; all materials were P91. Welding and heat treatment were done at ground level

The reducer was welded to the valve at ground level in a plant area protected against the elements. A proper “field shop” benefits proper welding and heat treatment, which must be done to exacting code standards (Fig 3). This work was completed, and weld quality verified, prior to unit shutdown to minimize the outage time required for valve replacement.

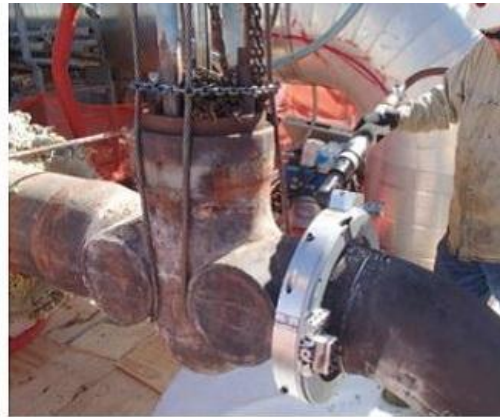
4. Valve is separated from 12-in. main steam piping

Another benefit to the pre-outage assembly of reducer and valve was that an exact measurement could be made to guide cut lines for removing the original valve, Morse noted (Fig 4). After that valve was cut out of the line, piping on both sides was counterbored and then beveled so the IDs of the pipe and the reducer/new valve would match up (Fig 5).

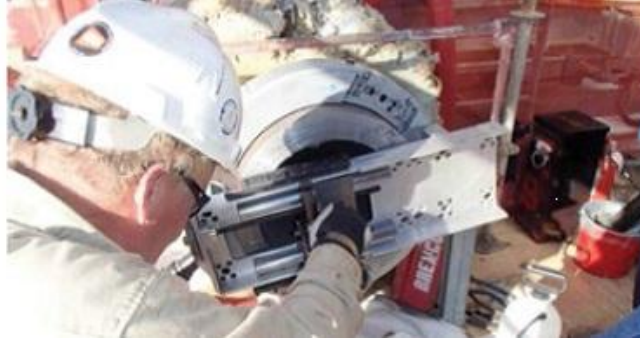
5. Pipe on both sides of the valve had to be counter-bored and then beveled to match the valve inlet and outlet IDs

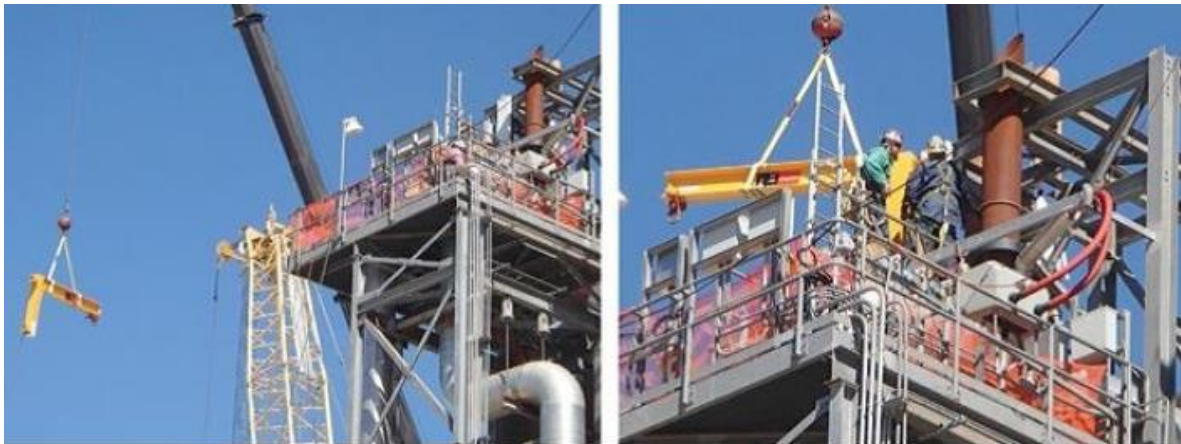
6, 7. Jib crane is "flown" to the top of the HRSG (left) and rigged in (right) to support the original valve during its removal

Installing a jib crane or davit arm at the top of each boiler helped to reduce the time the conventional crane was required (Fig 6). For example, it was used to support the original valve during its removal. The plant bought the davits and conducted the structural analysis required (Fig 7). Load tests (Fig 8) confirmed the boiler-top cranes "fit for duty." After use the davit arms are chained sideways for storage (Fig 9).

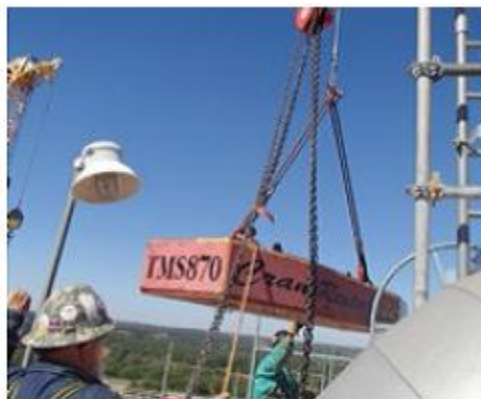
8. Safety first! Jib crane is load tested prior to use

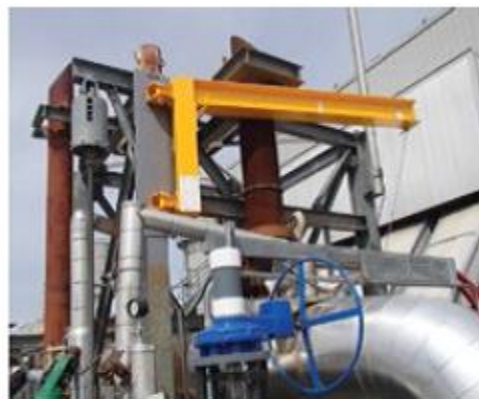
9. Jib crane was mounted to existing support steel and chained sideways for storage when not in use

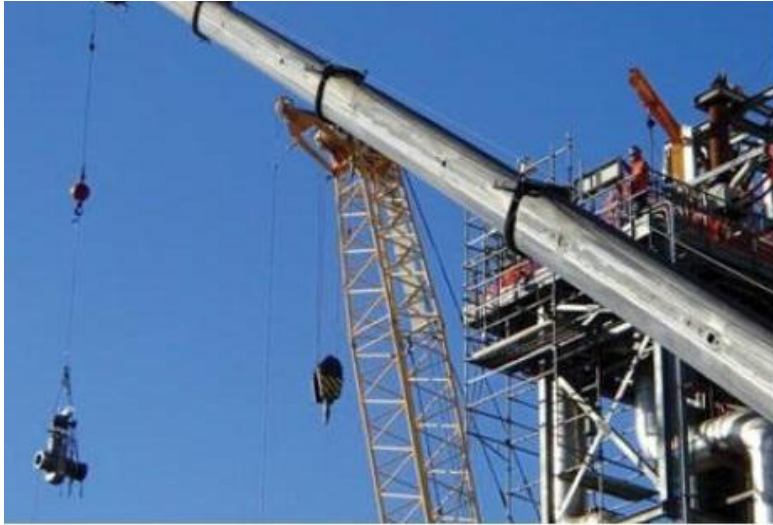
10. New valve is delivered for installation

Fig 10 shows the nominal 2-ton valve/reducer being lifted to the top of the HRSG for installation. This is a delicate process because P91 cannot be subjected to any abnormal stresses during handling/welding of the equipment (pipe, valve, etc) once the process of welding and/or machining starts, until after post-weld heat treatment is completed. In Fig 11, note the system of chain supports to hold the valve/reducer level and in position for welding without any side-to-side stress. **CCJ**

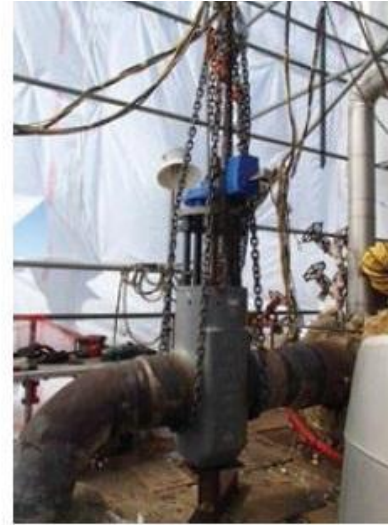
11. Several chainfalls were used to properly support and position the valve for welding
