THE COSTLY CONSEQUENCES OF AN ASH POND FAILURE

James W. Niehoff, PE Golder Associates Incorporated

TVA Kingston Power Plant

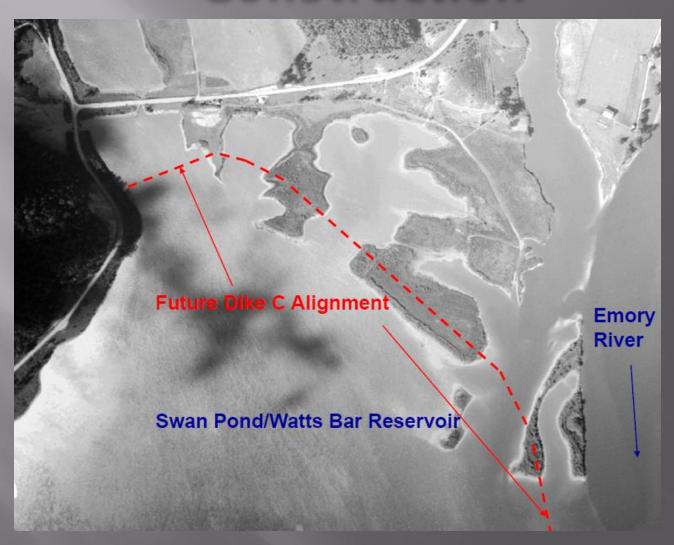
Ash Pond Area Prior to Construction

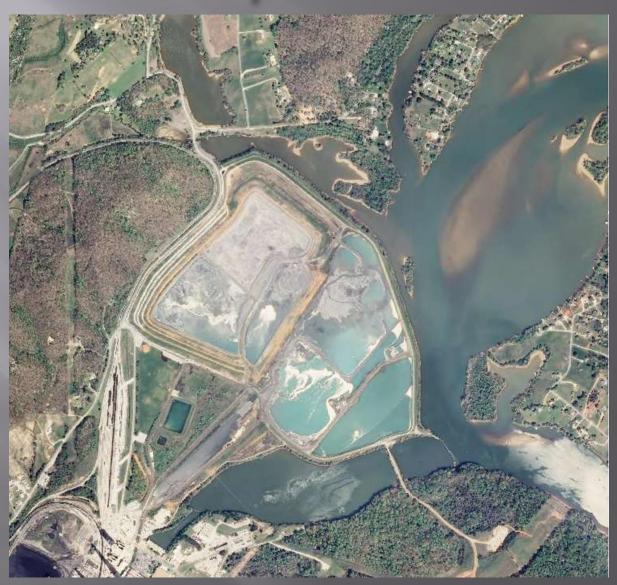
Ash Disposal - 2008

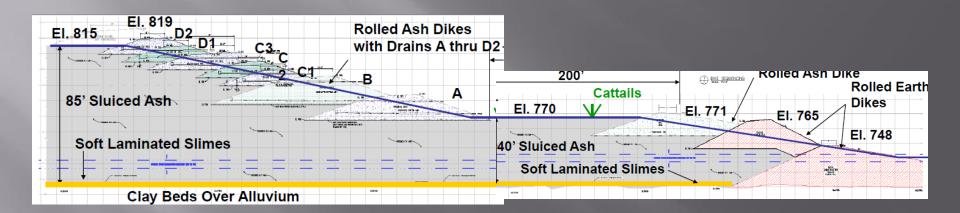
Pond Cross-Section

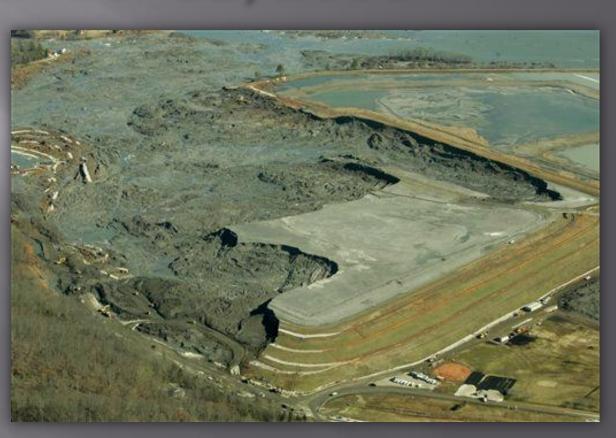
December 22, 2008

- -5.4 million cubic yards of ash lost from containment area
- -300 acres of land and reservoir covered with ash
- -15 homes damaged or destroyed

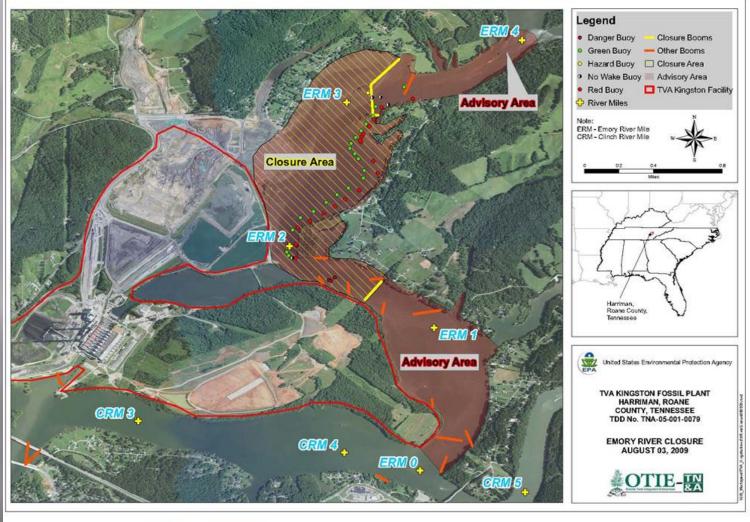
Extent of Spill
