From Worst ESP to Best

Santee Cooper Winyah Station
Unit # 3 ESP Upgrade 2011

Presented by Dennis Shanahan
Director of Business development
Clyde Bergemann Power Group

April 12, 2012

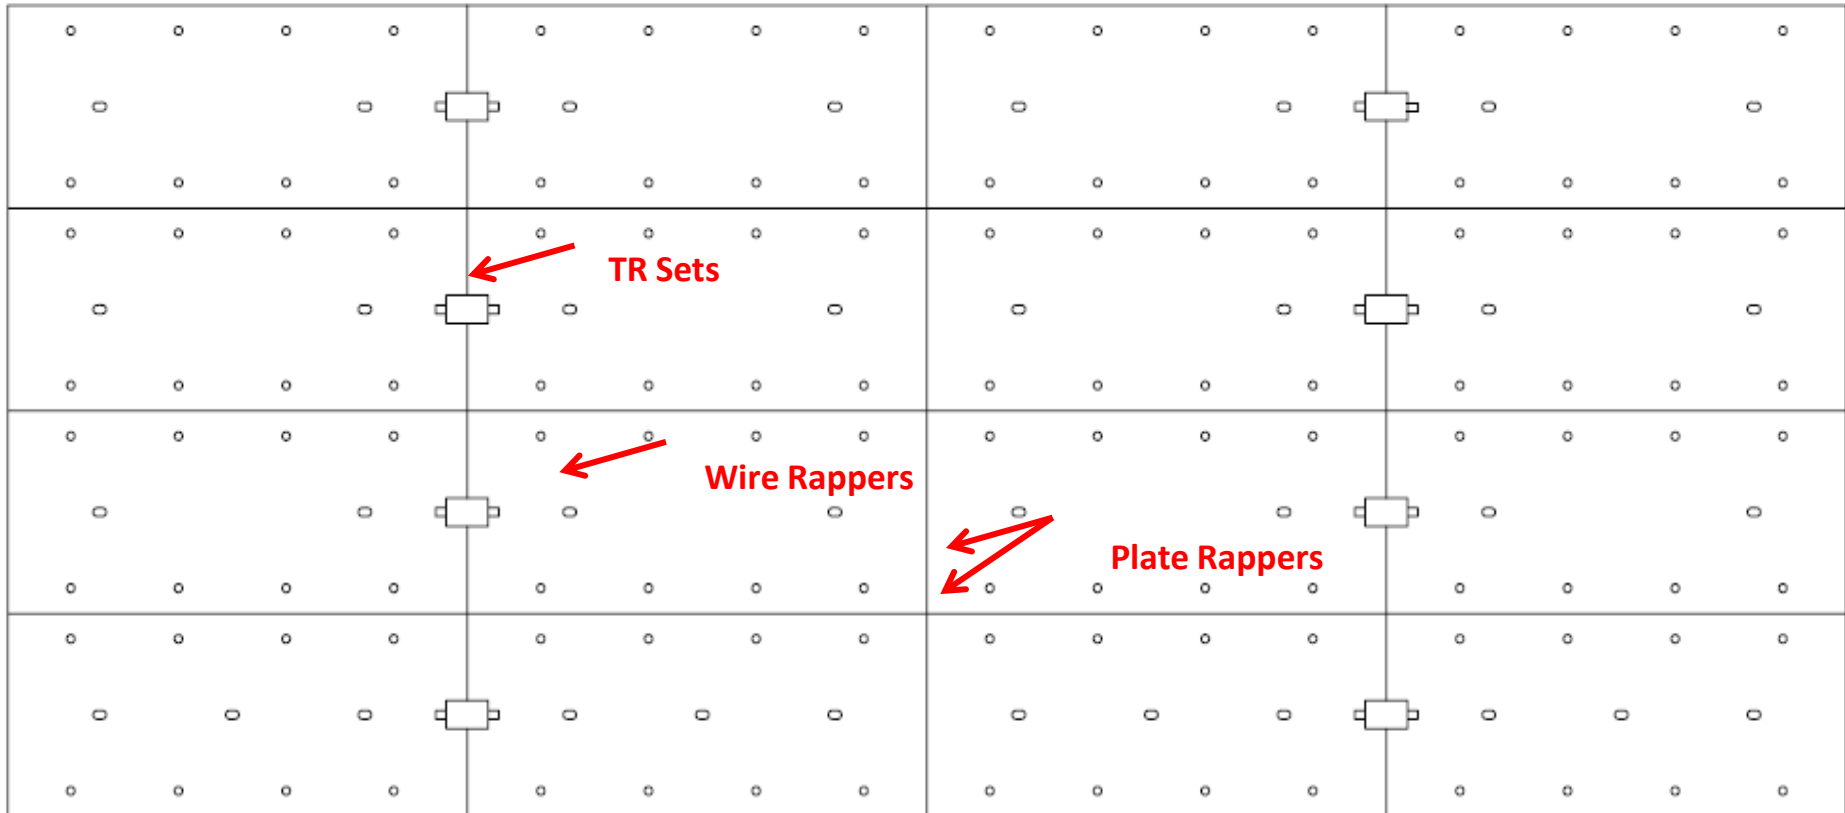
WINYAH 3 PRECIPITATOR, EXISTING CONFIGURATION

1. NO. OF PLATES = 576
2. SIZE OF PLATES = 30 FT x 9 FT.
3. SPACING OF PLATES = 9 IN.
4. TYPE OF DISCHARGE ELECTRODES: WIRES
5. NO. OF DE'S = 6720
6. VOLTAGE OF DE'S = 45 KV

7. NO. OF T/R SETS = 8
8. MECHANICAL SECTIONS = 16 (4 WIDE x 4 DEEP)
9. ELECTRICAL SECTIONS = 8 (2 WIDE x 4 DEEP)
10. NO. OF PLATE RAPPERS = 128
11. NO. OF DE RAPPERS = 36
12. NO. OF PERF PLATE RAPPERS = 8

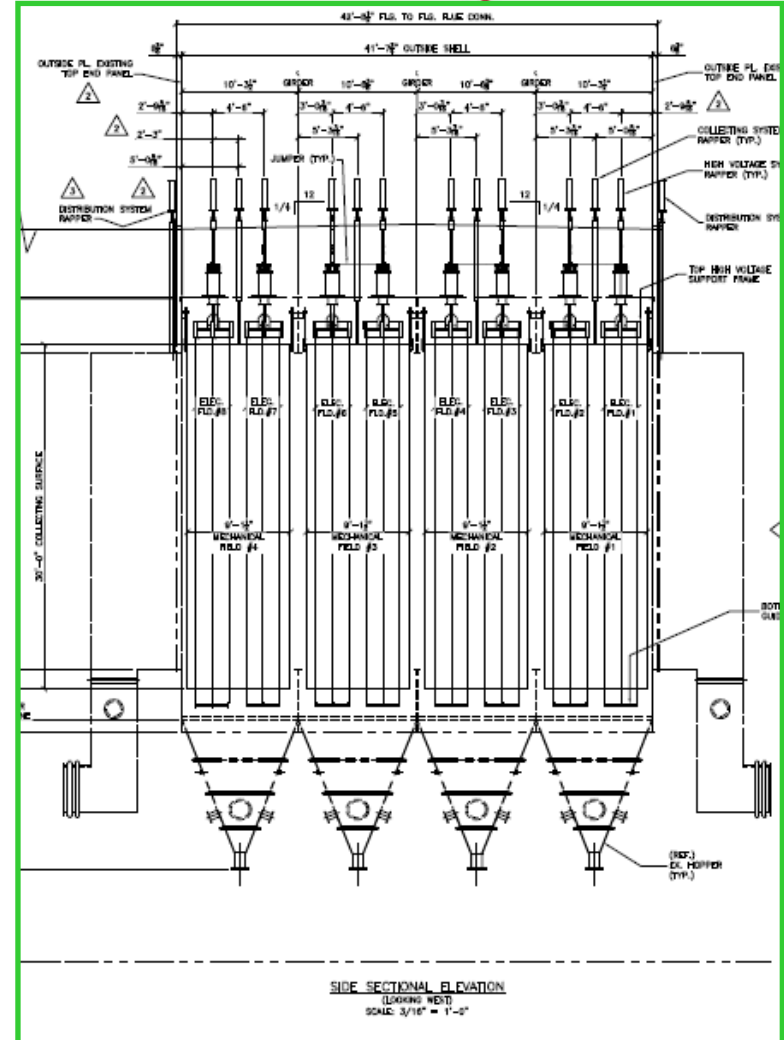
New Upgraded Internal Design

16 inch plate spacing and direct rapped collecting plates

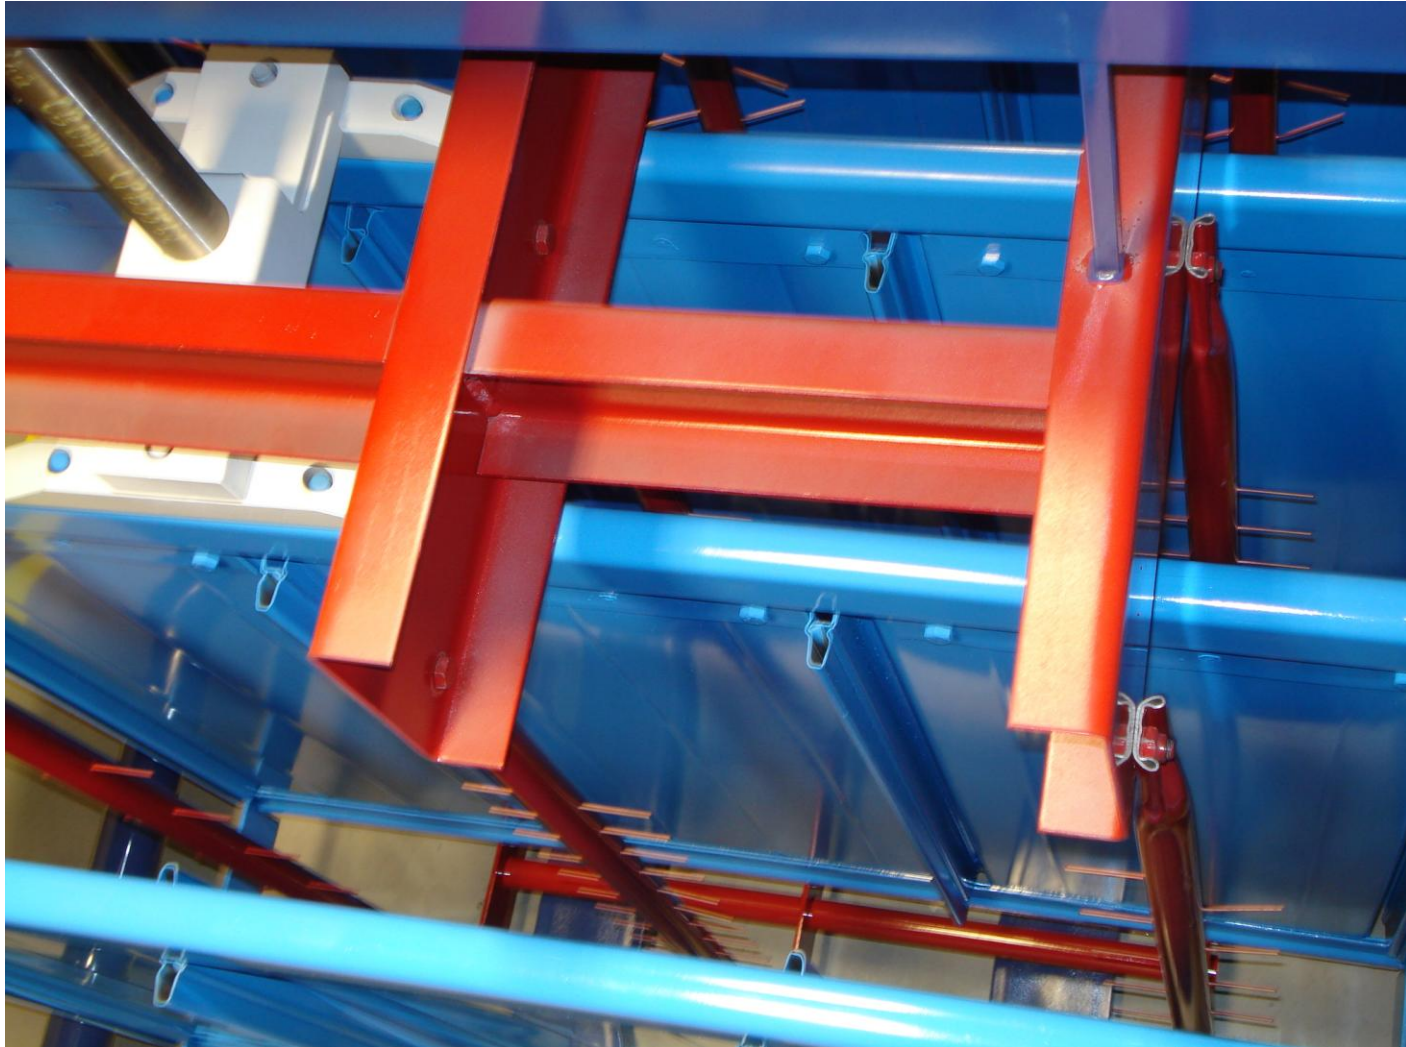
Customized Rigitrodes

STAGGERED PIN ARRANGEMENT

OPPOSED PIN ARRANGEMENT

- VARY:
- PIN LENGTH
 - DIRECTION
 - TUBE DIAMETER

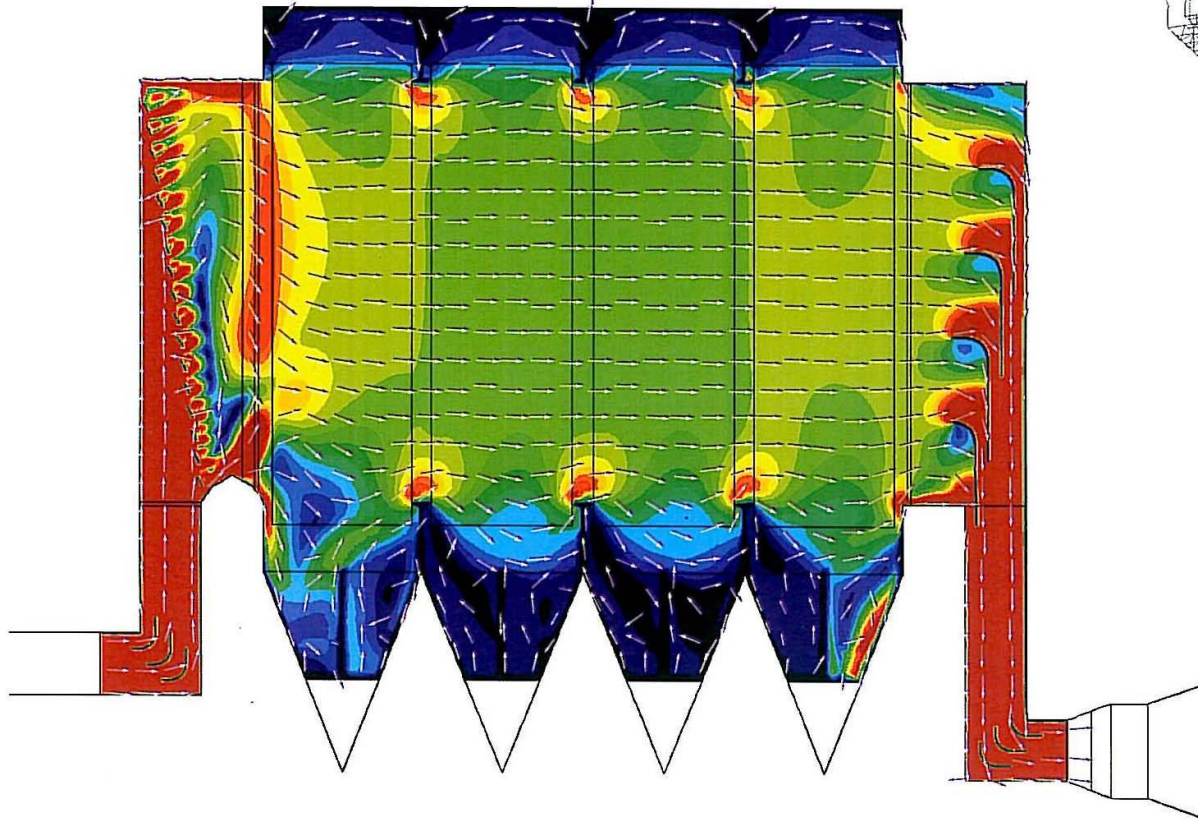
2010 Air Flow Design

Final Design Results

Side View: TP21

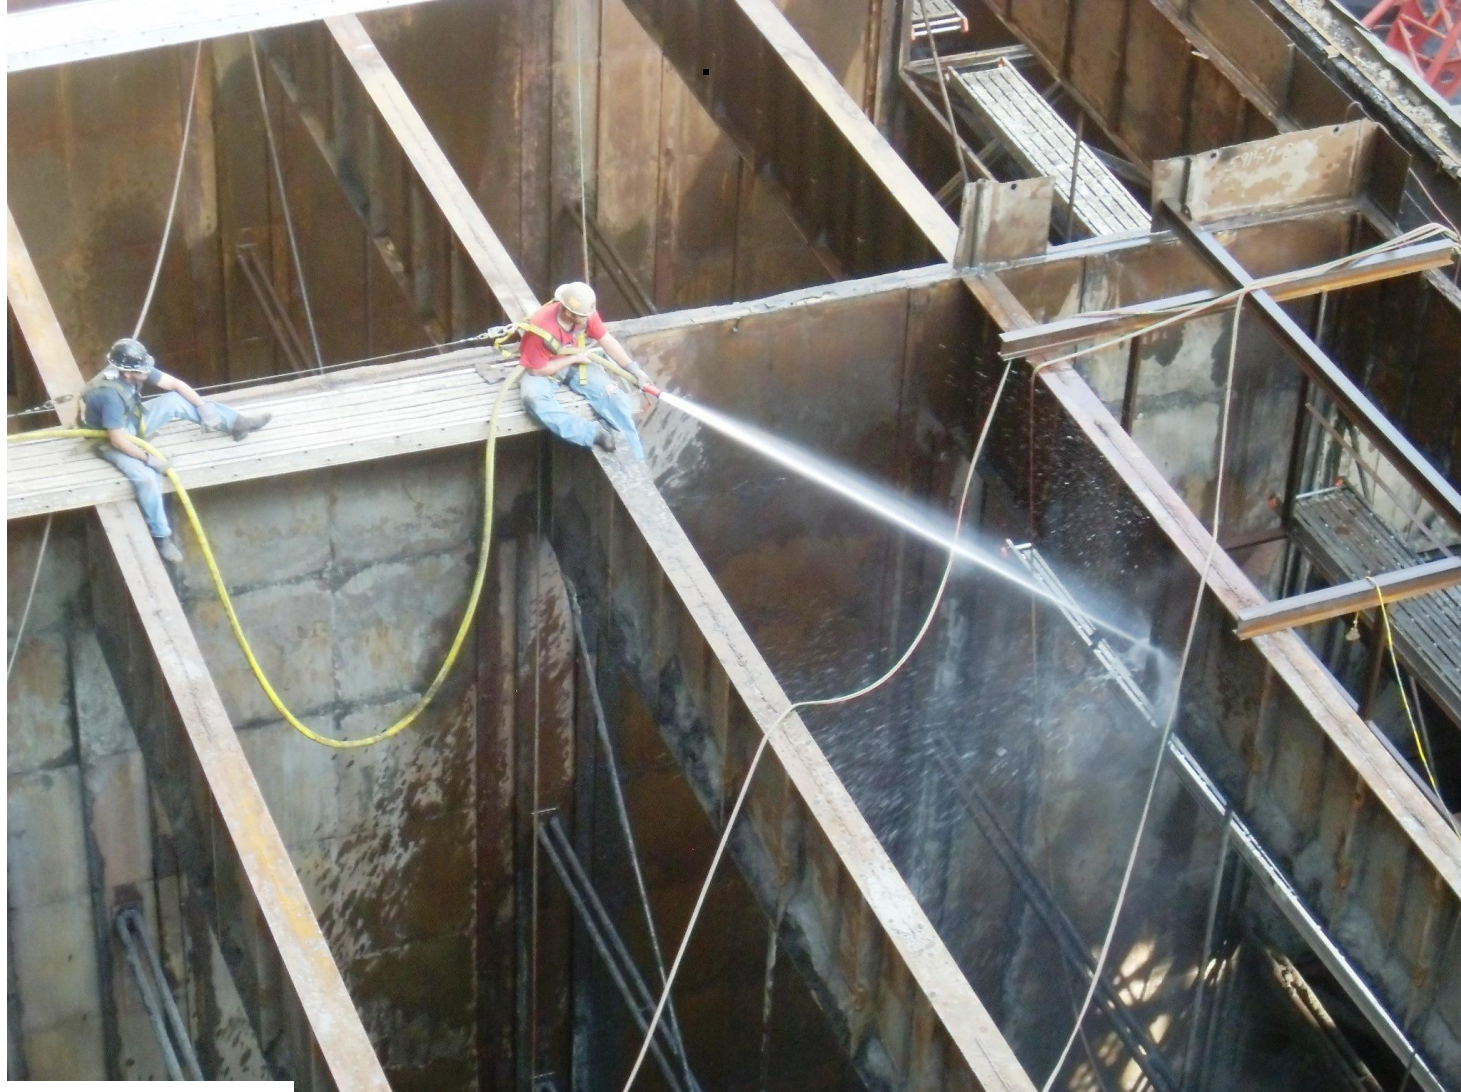
April 24, 2011 – Day 8

3 Support Girders were found to be corroded and were replaced

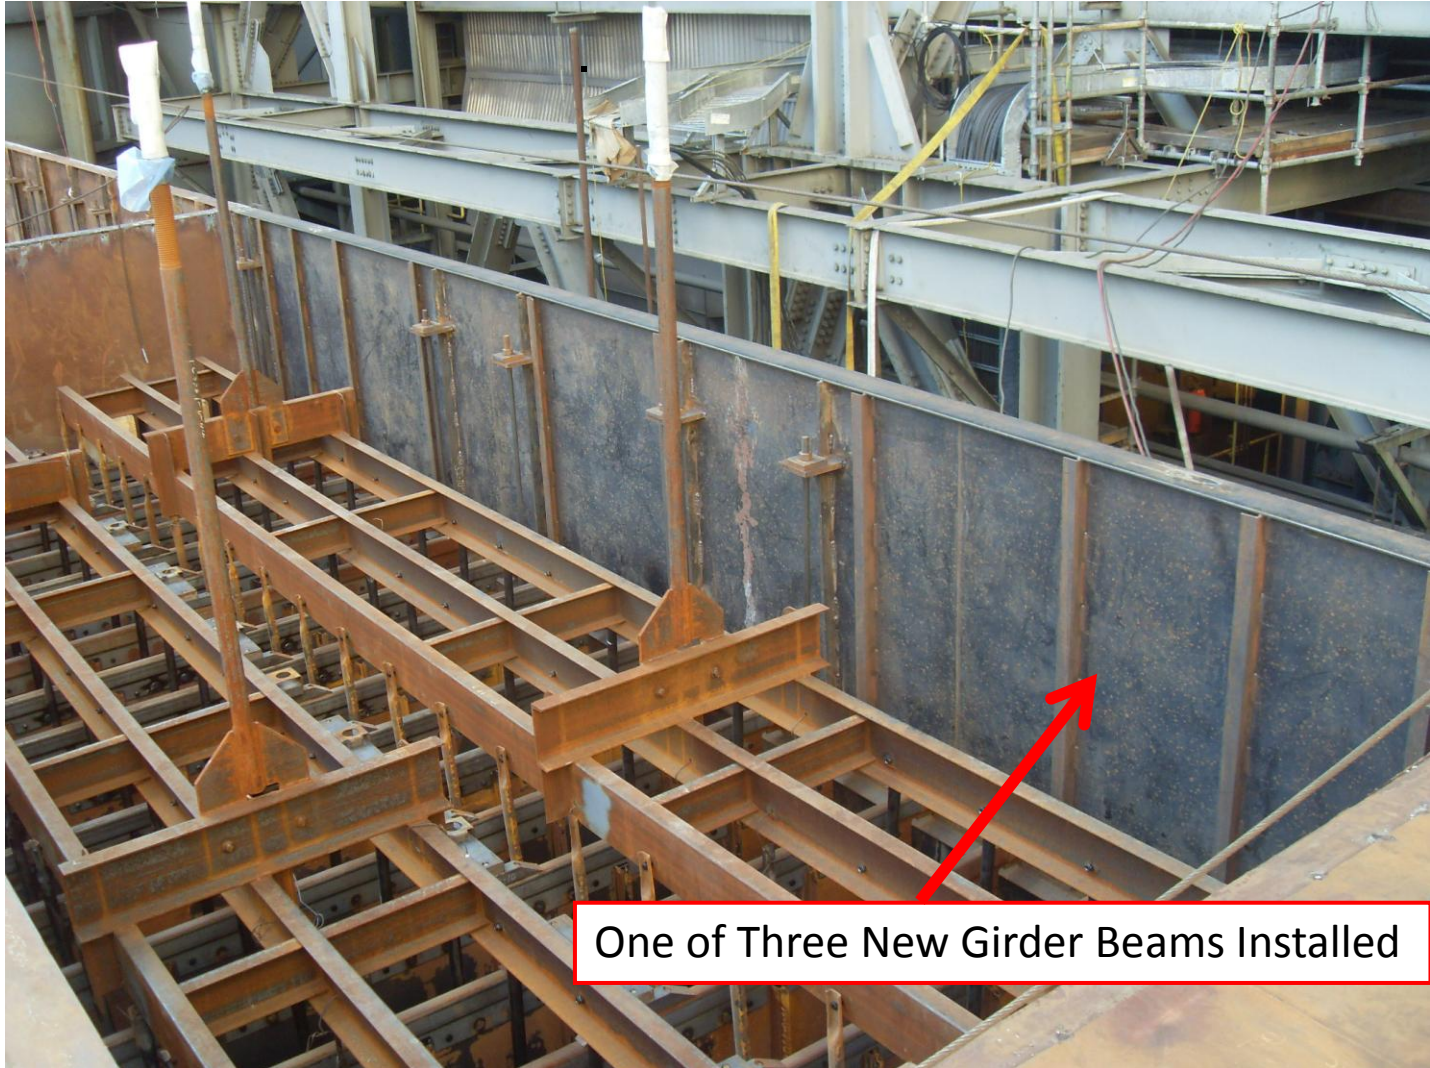
One of Three New Girder Beams Installed

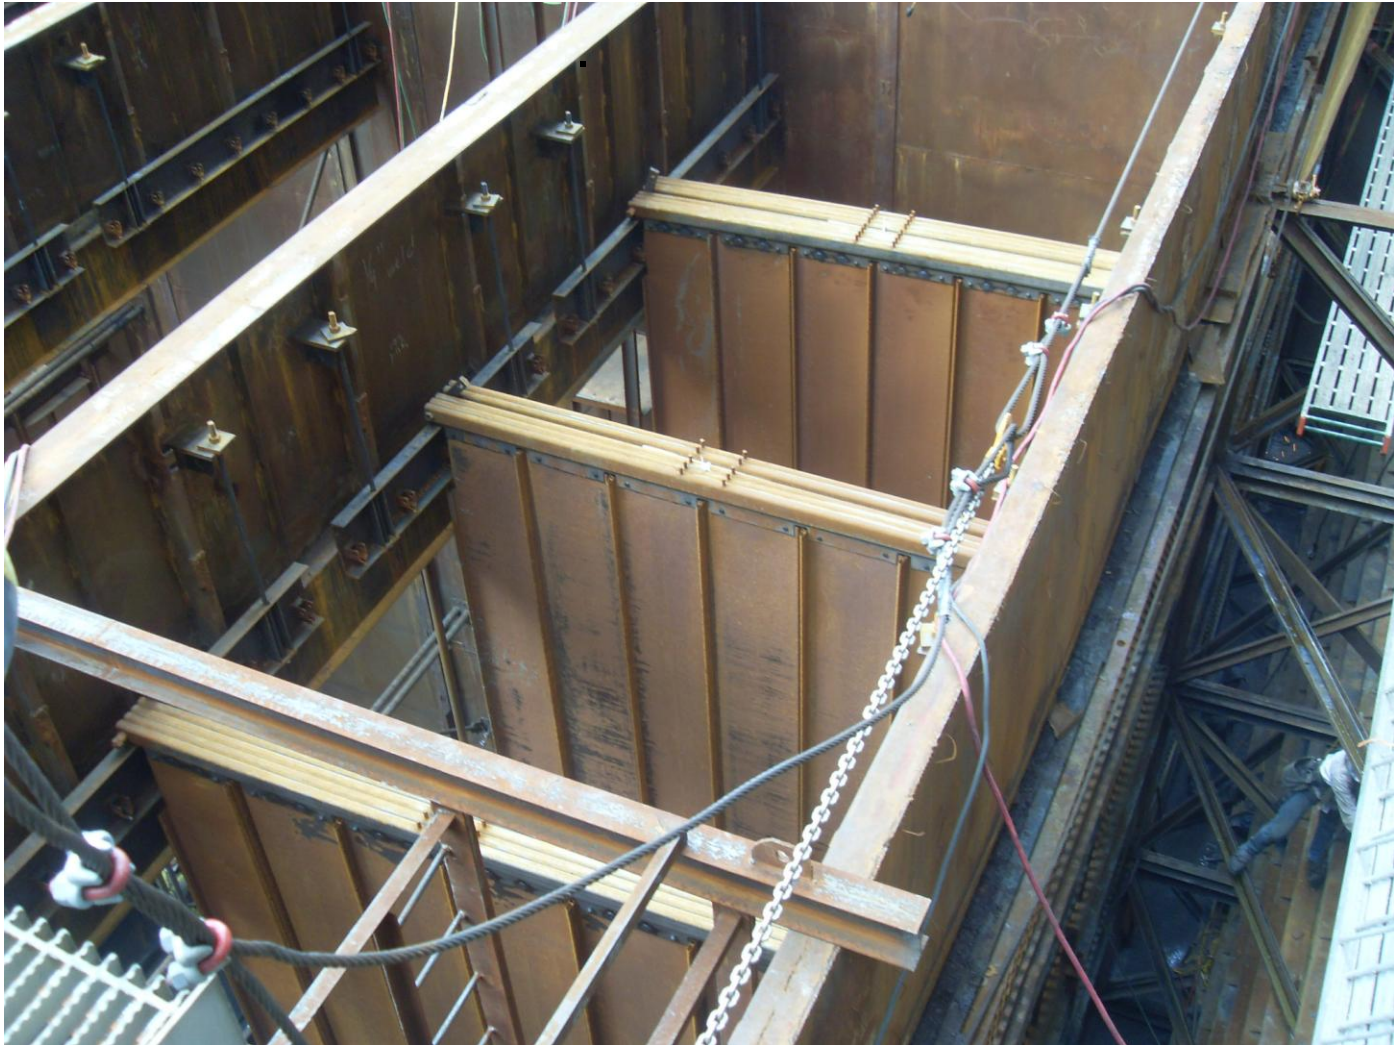
Modifications completed new collecting plates being installed

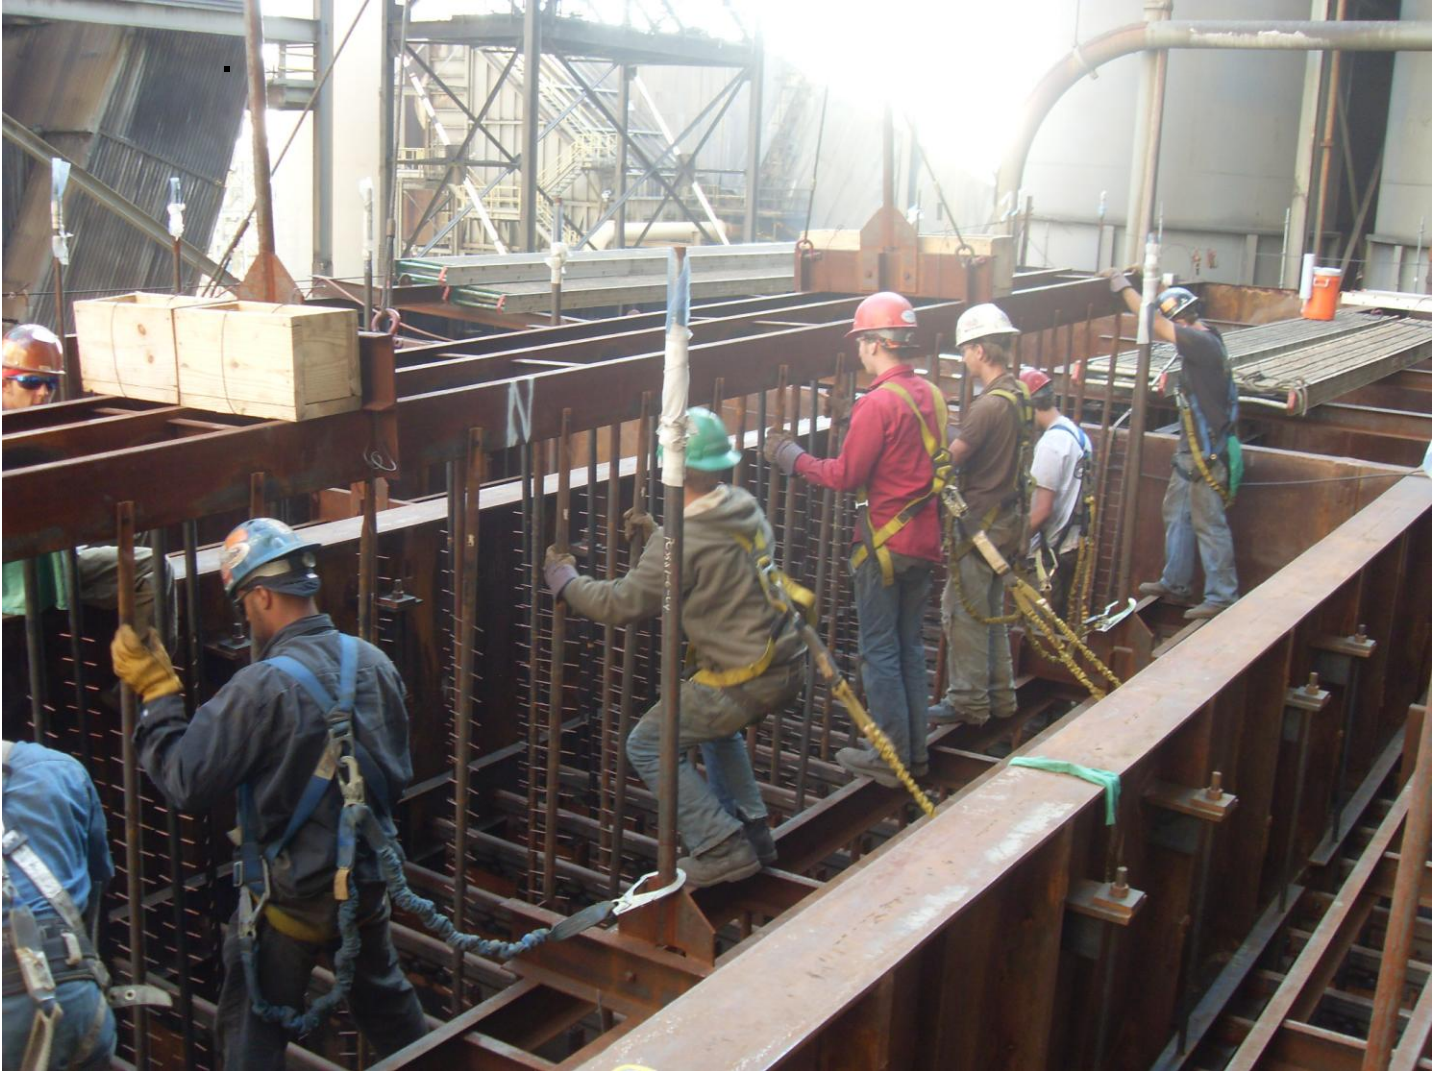
Discharge electrodes being installed and final Quality Inspections of the pins

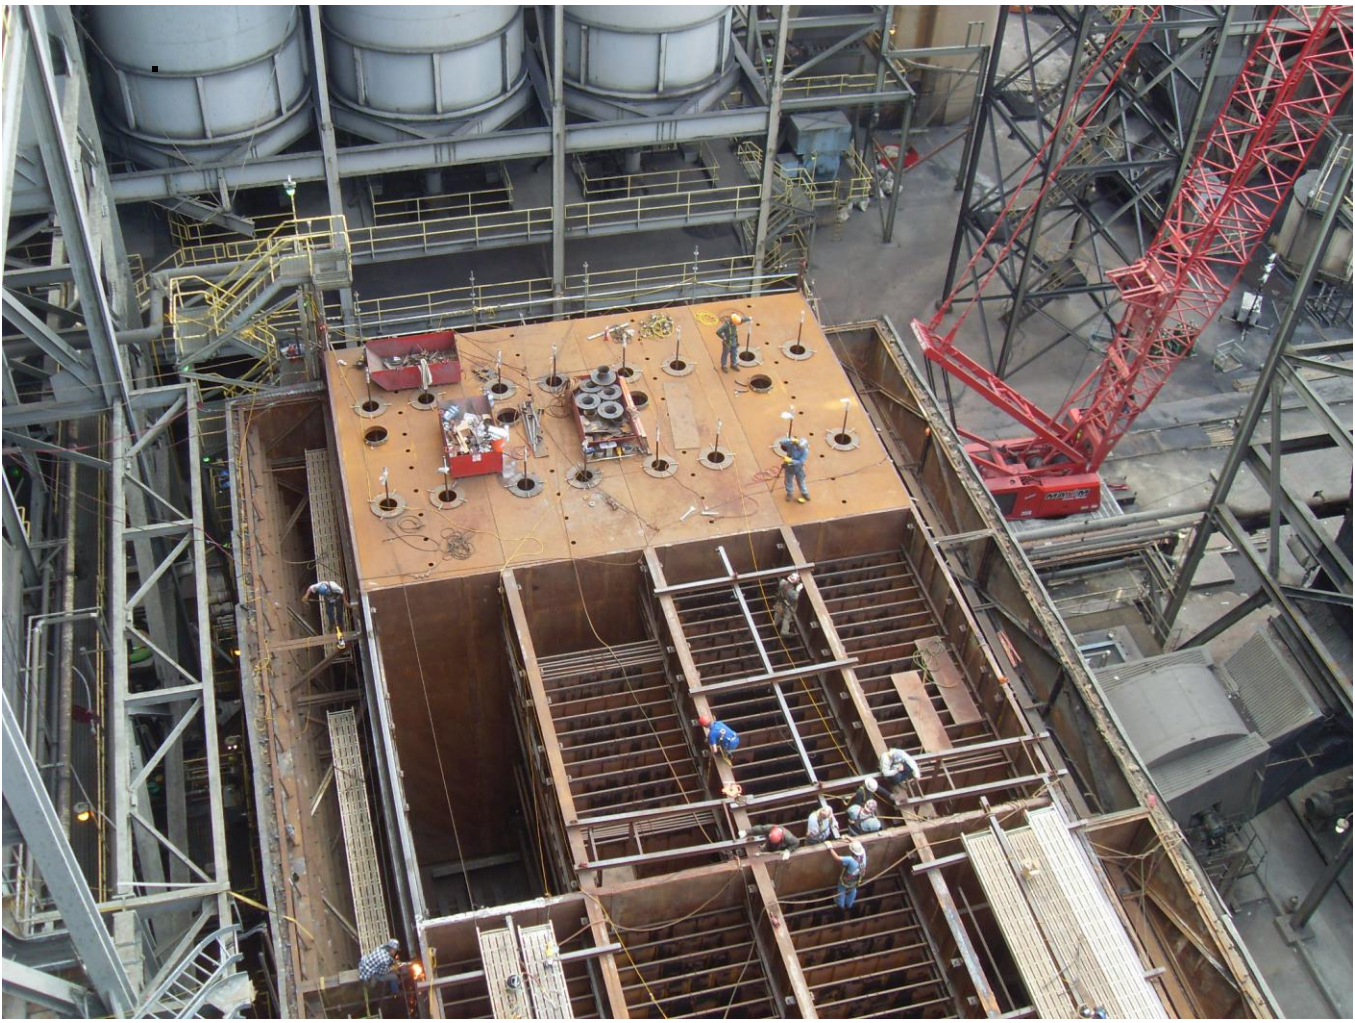
New collecting plates nearly complete and hot roof on one chamber

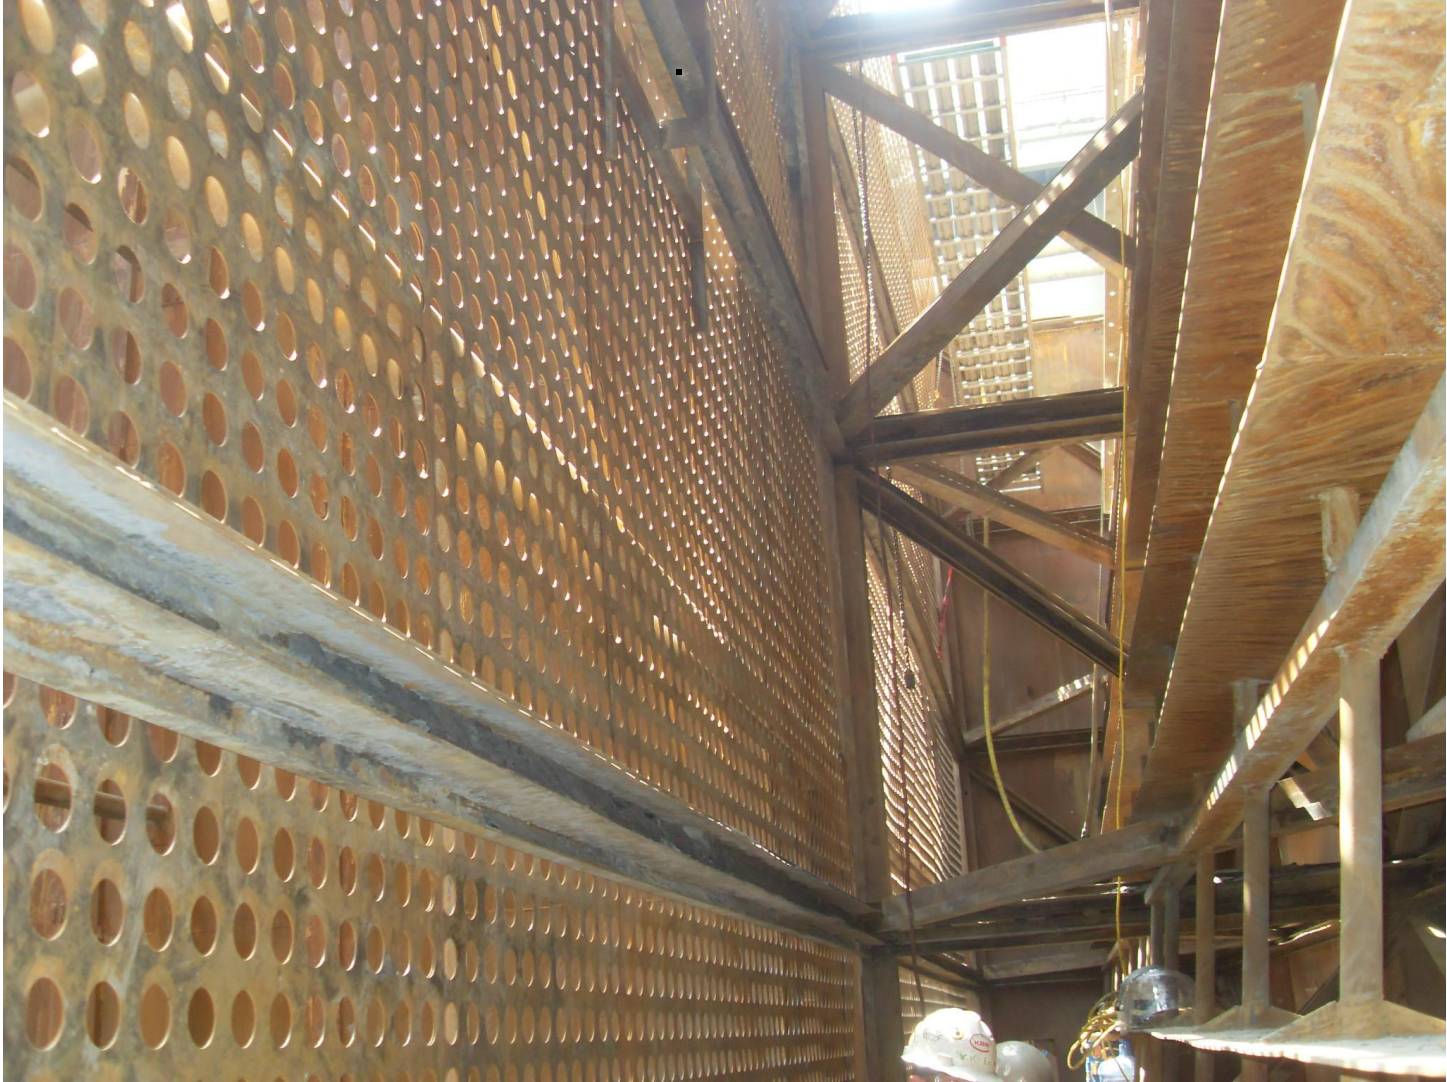
Model study results being installed

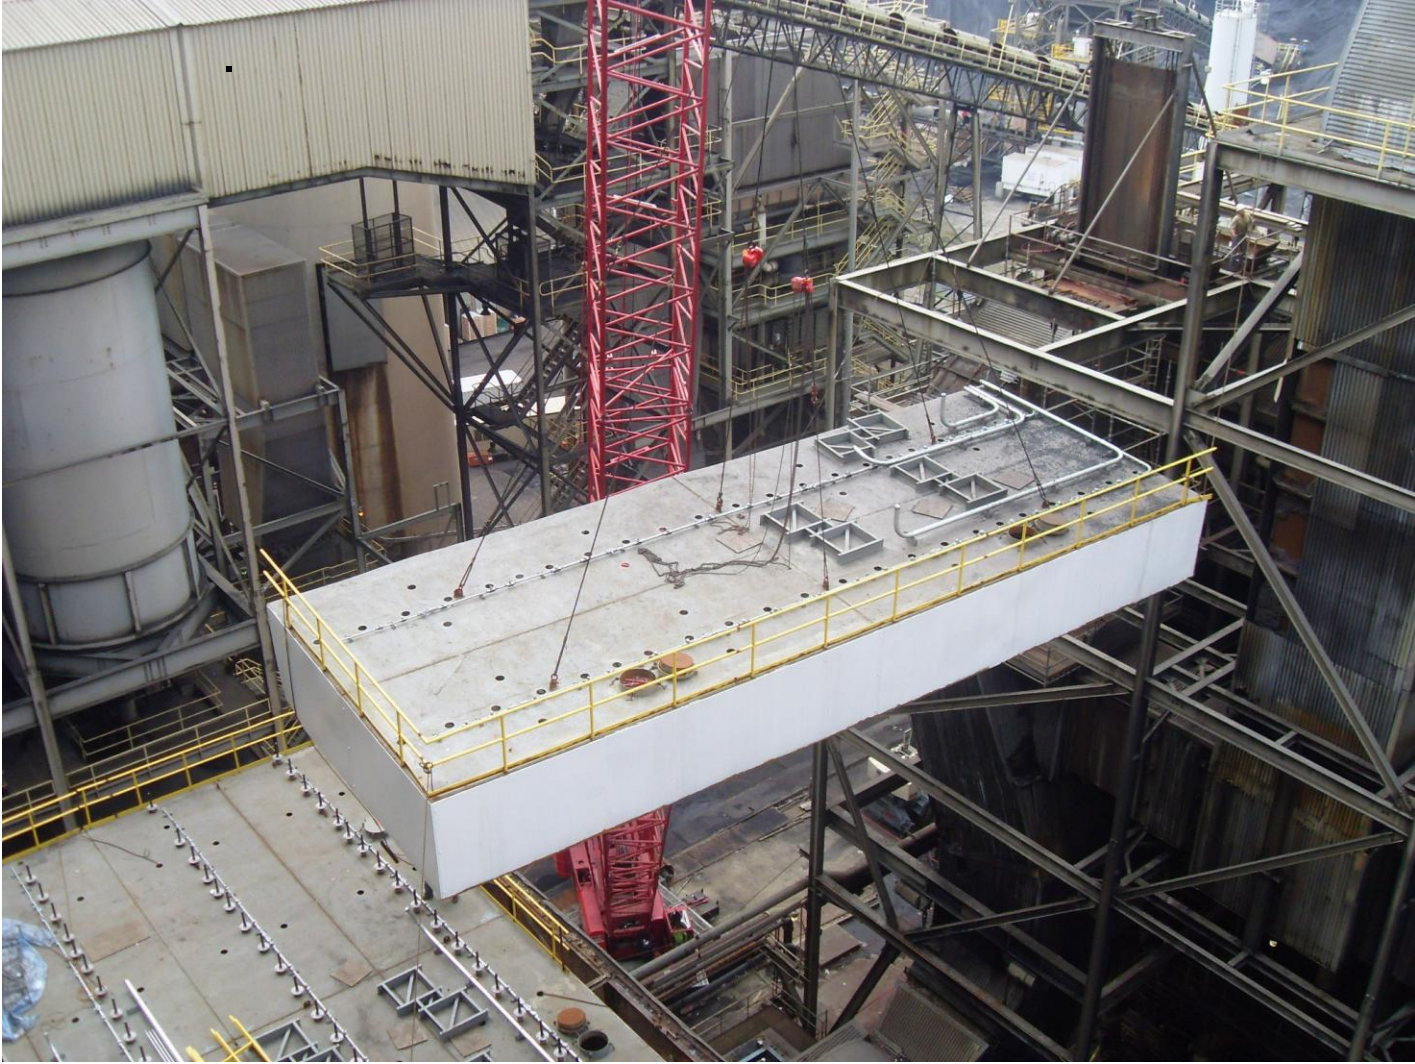
Penthouse section being lifted into place
