Accelerated Crevice Corrosion of Duplex Stainless Steels in Wet Limestone FGD Environments

Deba Maitra,
Special Metals Corporation
PCC Energy Group

Premature Failure of Absorber Vessels due to Corrosion

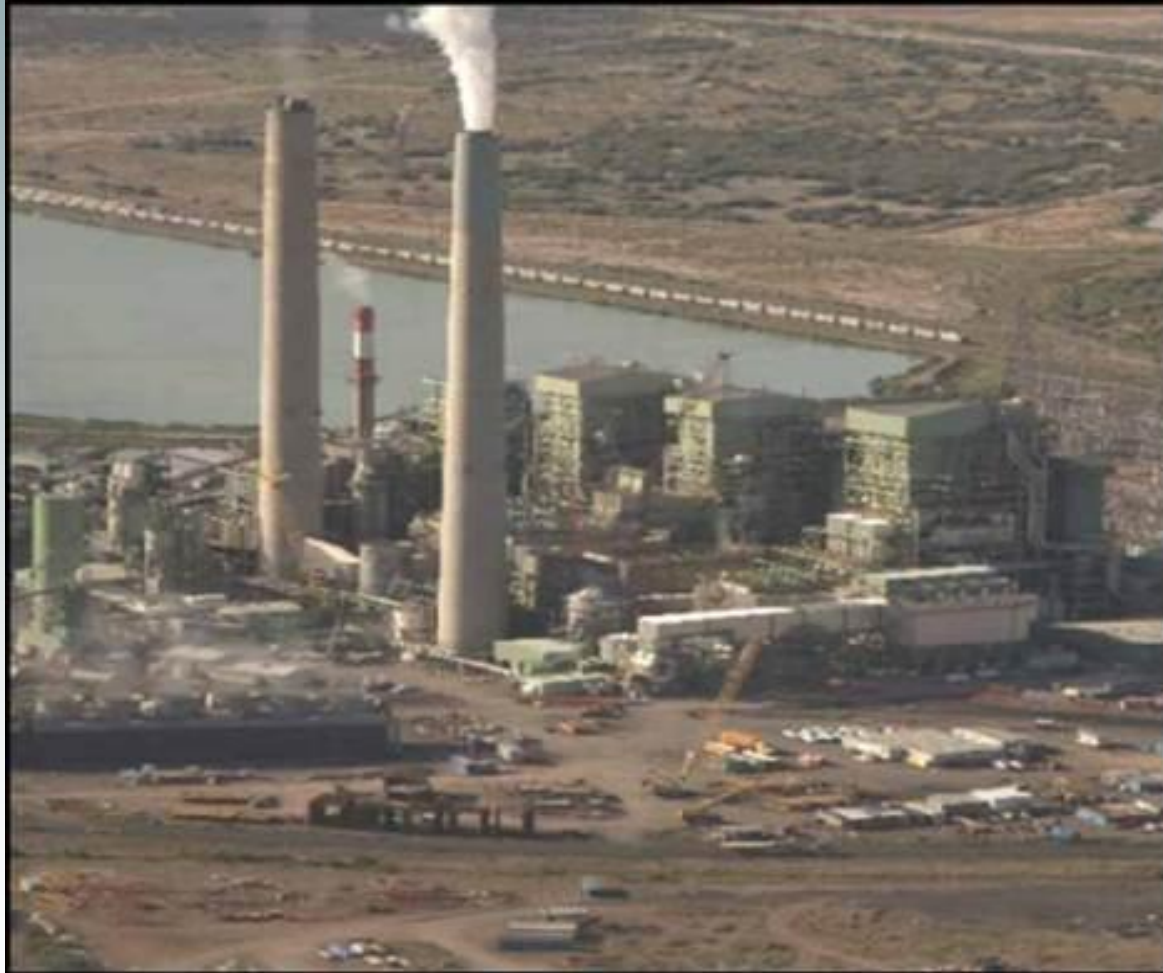
Super-Austenitic Steel Chimney Flue at APS-Cholla Station

27-7MO (S31277) plate joined with 686 (N06686) welding product
