# Accelerated Crevice Corrosion of Duplex Stainless Steels in Wet Limestone FGD Environments

JIM CRUM,  
Special Metals Corporation  
PCC Energy Group

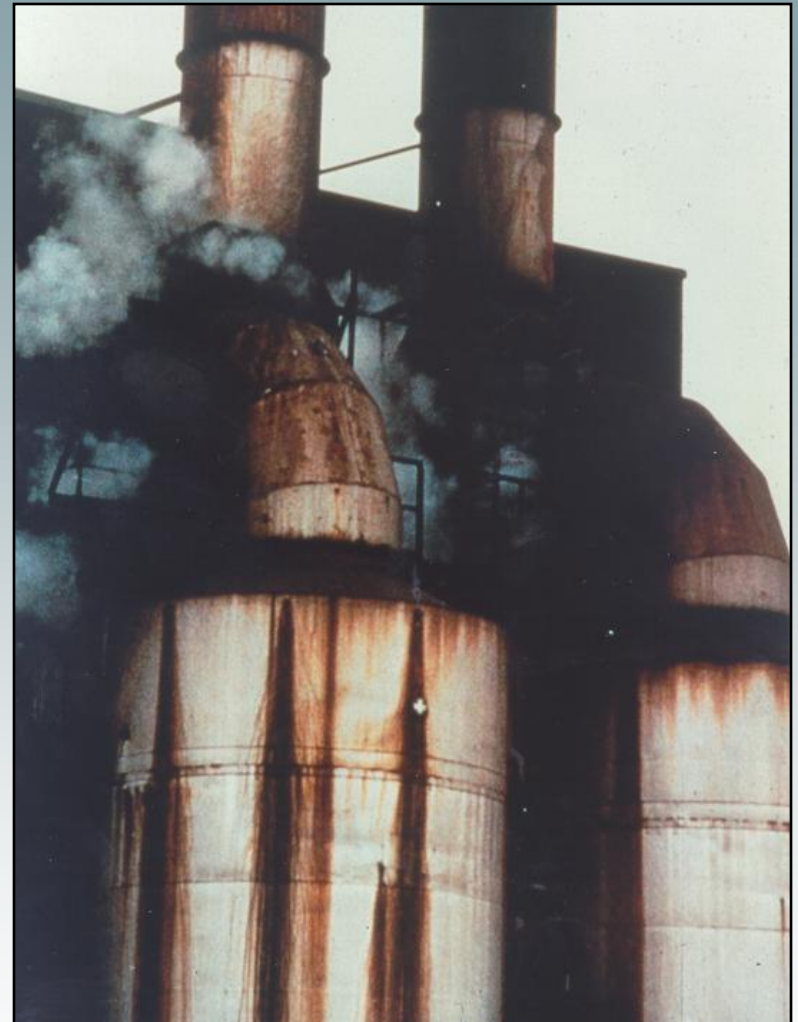
**Premature Failure of Absorber Vessels due to Corrosion**

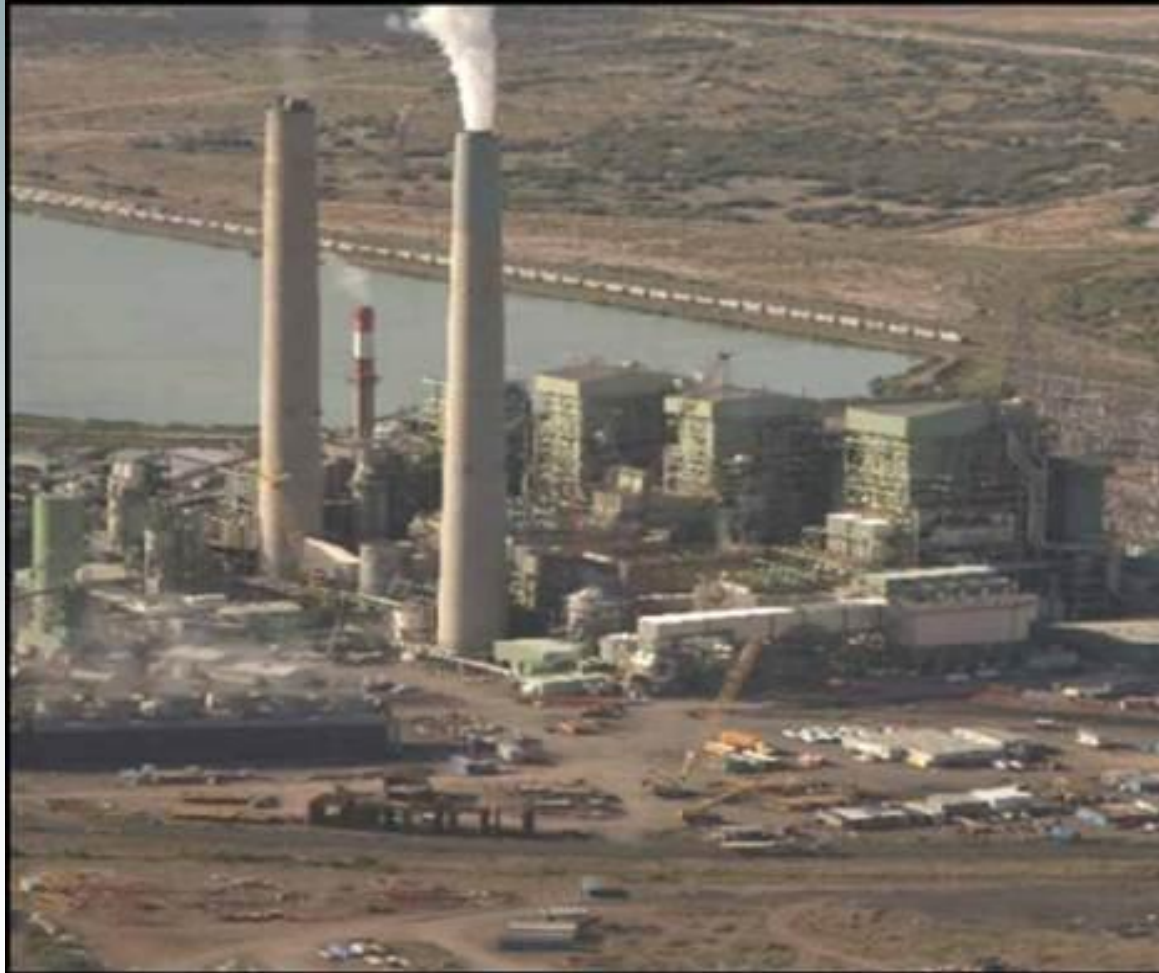
# Super-Austenitic Steel Chimney Flue at APS-Cholla Station

**27-7MO (S31277) plate joined with 686 (N06686) welding product**
