# Corrosion Studies on GeoBrom<sup>®</sup> HG520

## Vapor Space Study

## brominated derivative products for mercury control

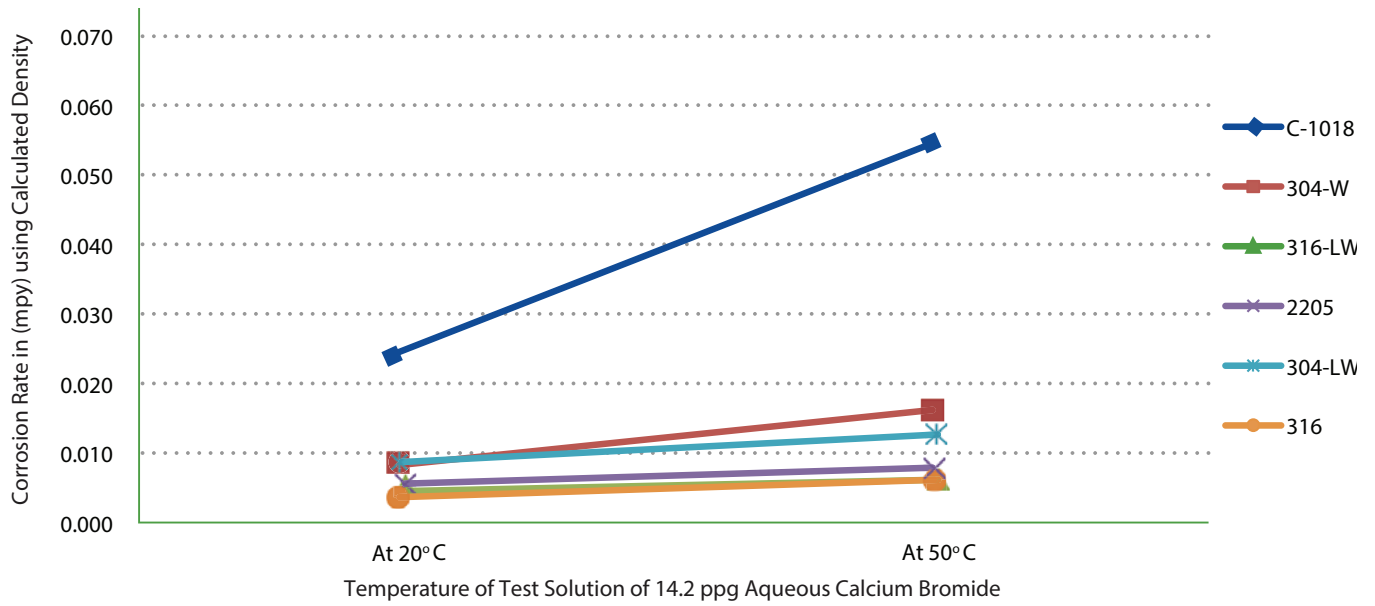
**Figure 1**

Corrosion Rate Trend Chart with Y Axis at 0 to 0.06 mpy Scale

Corrosion Coupons at 20° and 50° C Subsurface in GeoBrom® HG520 Calcium Bromide Solution

**Tables 1 and 2** provide data on test specimens at 20° C and at 50° C, respectively. Corrosion rates on all specimens were under 0.10 mpy rate. Mild carbon steel C-1018 gave the highest corrosion rate at 0.025 mpy at 20° C and 0.053 mpy at 50° C. Minor surface corrosion but no pitting was observed on C-1018 coupons. There was no surface corrosion or pitting observed on any remaining specimens suspended above the liquid by ~ 3/8 inches. C-1018 corrosion is likely due to humidity in headspace of bottle.

Corrosion rates for each specimen were charted to reflect trends over the two temperatures 20° C and 50° C (**see Figure 1**).

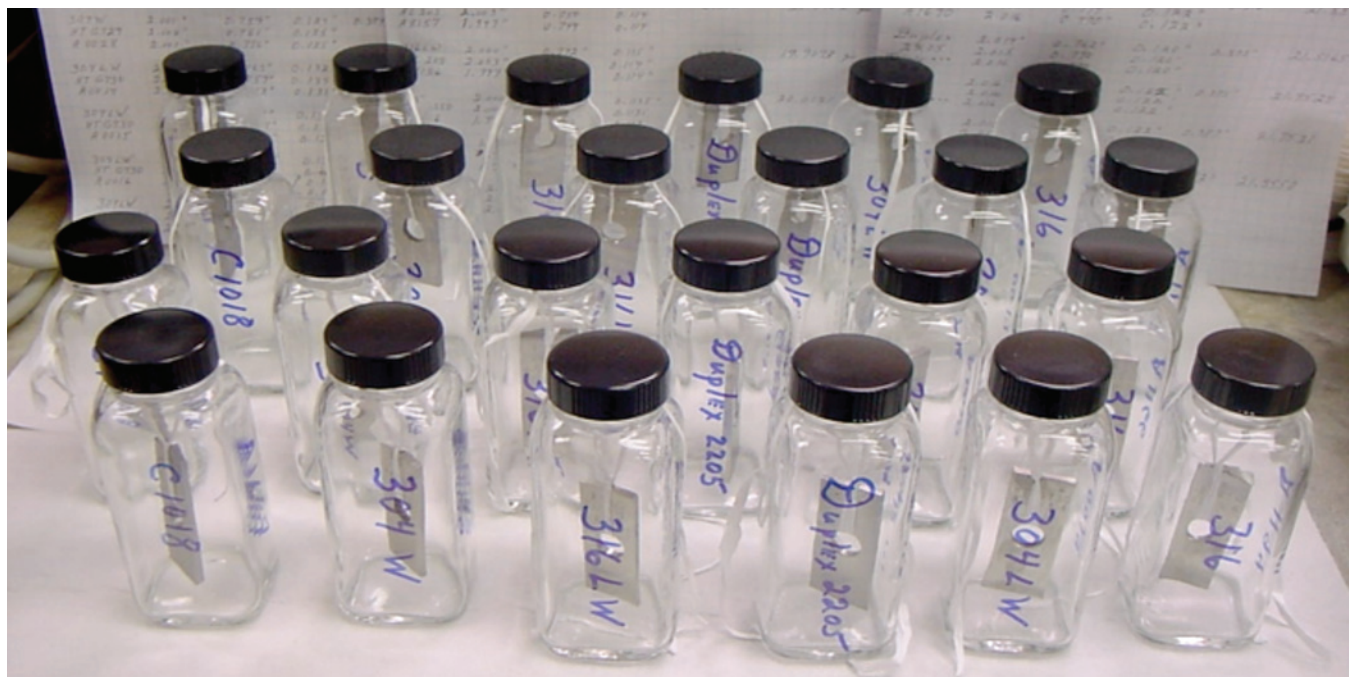
## Figure 2

Test Coupons Before 90-Day Above Surface Exposure at 20° C and 50° C

Metal test coupons with dimensions of ~ 2.0" x 0.75" x 0.125" were supplied by an outside vendor. The vendor prepared the coupons by abrading surfaces and stamping metal type and marking specimens with a unique identification number. Prior to using, coupons were cleaned using reagent grade aqueous HCl and a bristle brush followed by a thorough deionized water rinse, degreased using acetone, dried using hot air, then allowed to cool in desiccators. The clean, dry specimens were weighed and measured. Using forceps, a four place OHAUS Galaxy Model G160D analytical balance was used to attain initial weights for all coupons. Dimensions were established using a Starrett® Micrometer part # 436RL-1, EDP 51568 and a Starrett® Dial Caliper Part # 120Z, EDP 55951. Three measurements were taken on all dimensions and averaged for the length, width, and thickness. Pictures were taken to record coupon condition prior to vapor exposure tests.

To visually document condition of test specimens, pictures were taken before and after immersion tests (**see Figures 2-6**).
